Former Ayr Station Hotel Building Structural Condition

Independent Report

03 October 2019

Document reference: 399316/SNI/GLA/DOC/S2/REP/002

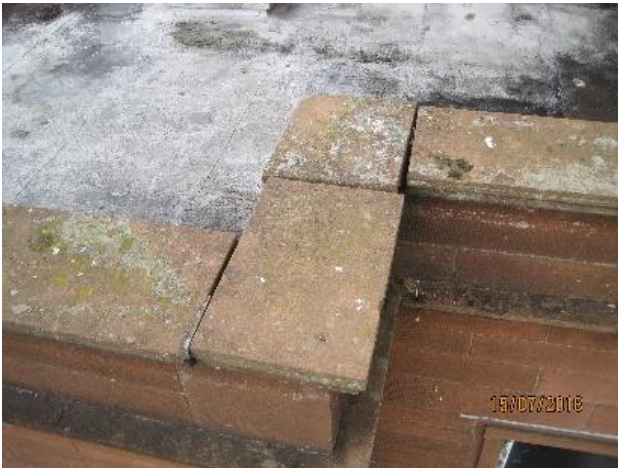
Photo 6: Loose Capping Stone – south/west corner

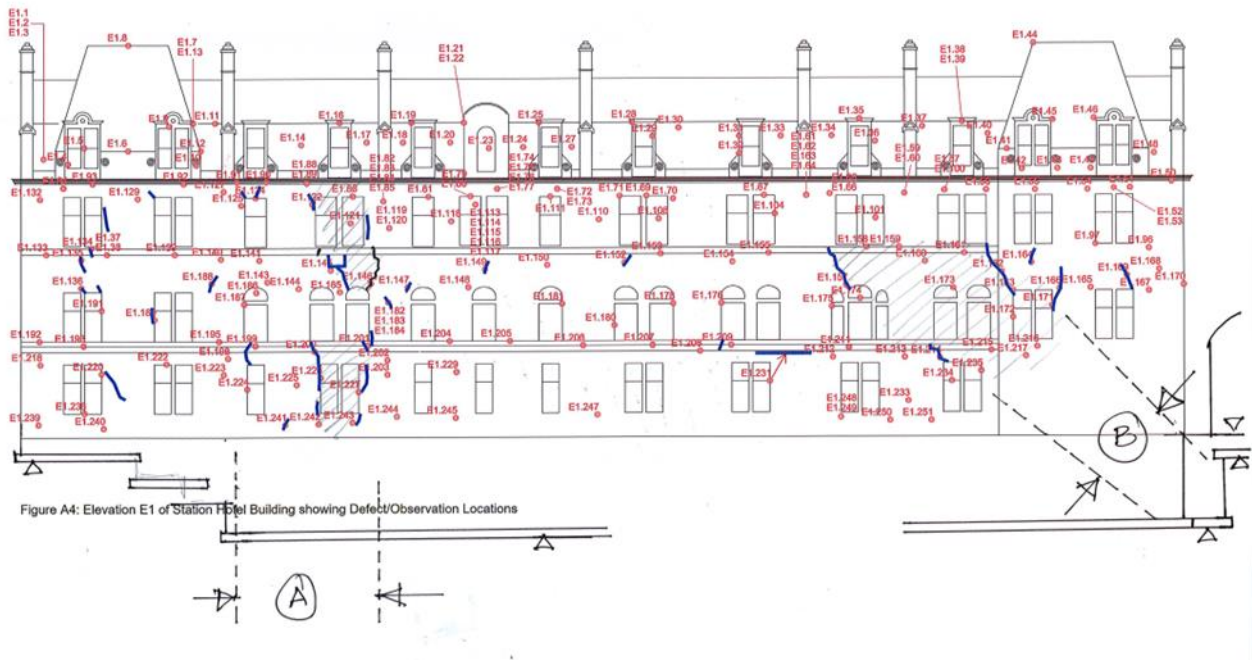
Three areas of vertical and diagonal 'pattern-type' cracking: one on the south and two on the east elevations of the south section of the building were established that are considered to be significant. Figure 2 shows the pattern-type cracking on the east elevation.

Figure 2: East Elevation showing 'patter-type' cracking in areas A and B

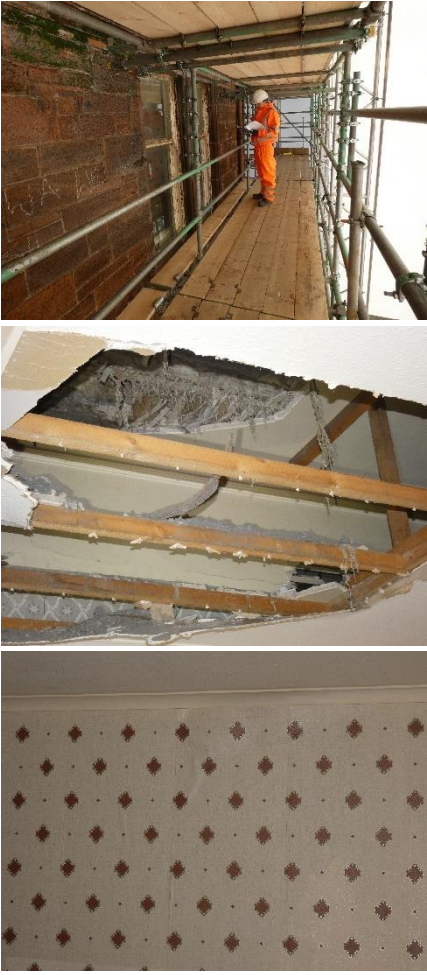
Defect ID	Photo Source	Defect Description	Defect Location	Crack Orientation	Crack Width (mm)	Crack Length (mm)	Comments	Photo	Severity Category
WE2.1	P1010 226-243	Collapsed ceiling plaster, Staining	Bedroom 204	n/a	n/a	n/a	Localised collapse of false ceiling and original ceiling above it, approx. defect area 3x4m (25% of ceiling) located adjacent en suite (226, 238) Peeling and bubbling of wallpaper in upper (lighter) areas of walls (241) Possible mould and signs of dampness on lower (red) sections of walls (243)

<p>Green</p> <p>Amber</p> <p>Green</p>

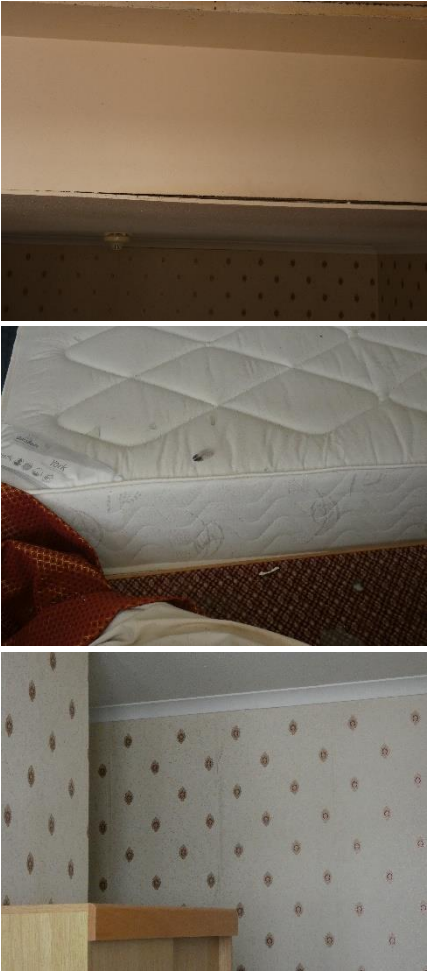
Defect ID	Photo Source	Defect Description	Defect Location	Crack Orientation	Crack Width (mm)	Crack Length (mm)	Comments	Photo	Severity Category
WE2.4	P1010 177-201	Evidence of vermin, Staining, Other	Bedroom 208	n/a	n/a	n/a	Uneven ceiling with slight bulging noted (200, 201) Evidence of possible vermin (193) Minor staining to wallpaper (190)

Green Green Green

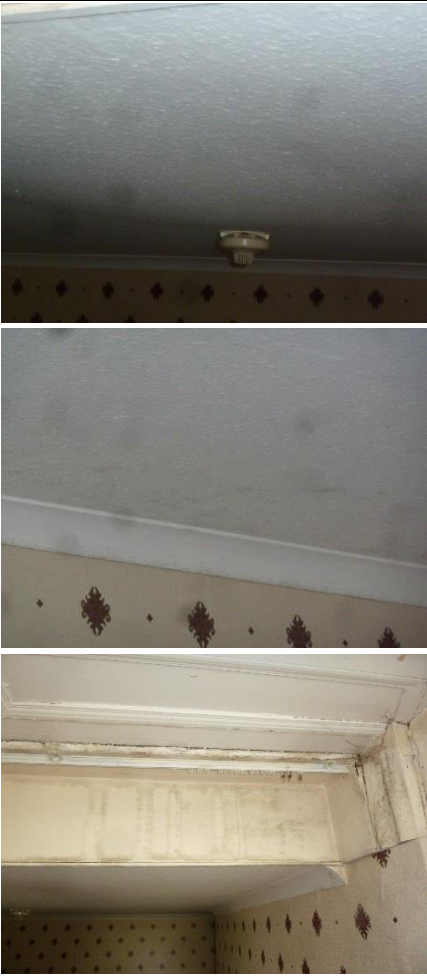
Defect ID	Photo Source	Defect Description	Defect Location	Crack Orientation	Crack Width (mm)	Crack Length (mm)	Comments	Photo	Severity Category
WE2.6	P1200 775-786	Collapsed ceiling plaster, Dampness/water ingress, Collapsed wall plaster, Dampness/water ingress, Evidence of vermin	Bedroom 212	n/a	n/a	n/a	Bulge to plasterboard ceiling. Possible indication of future collapse (782) Dampness/water ingress (783) Collapsed plaster to wall to right hand side of window (784) Dampness/water ingress (785) Evidence of vermin (786)

Amber Amber Amber

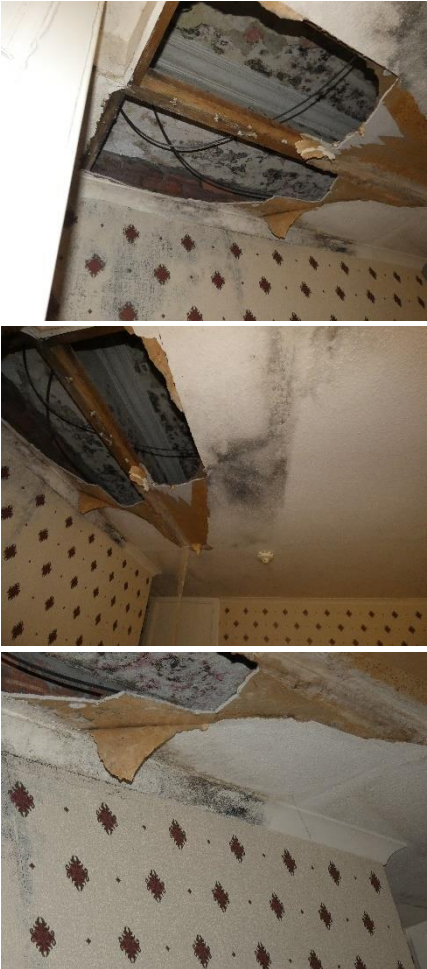
Defect ID	Photo Source	Defect Description	Defect Location	Crack Orientation	Crack Width (mm)	Crack Length (mm)	Comments	Photo	Severity Category
WE2.7	P1010 094-115	Collapsed ceiling plaster, Staining	Bedroom 214	n/a	n/a	n/a	Localised collapse of false ceiling at corner of room (109) Black staining to ceiling, possibly mould (107) Staining to cornice (112) Staining to wall above false ceiling (113) Staining to wall below false ceiling (110, 115)

Amber Amber Amber

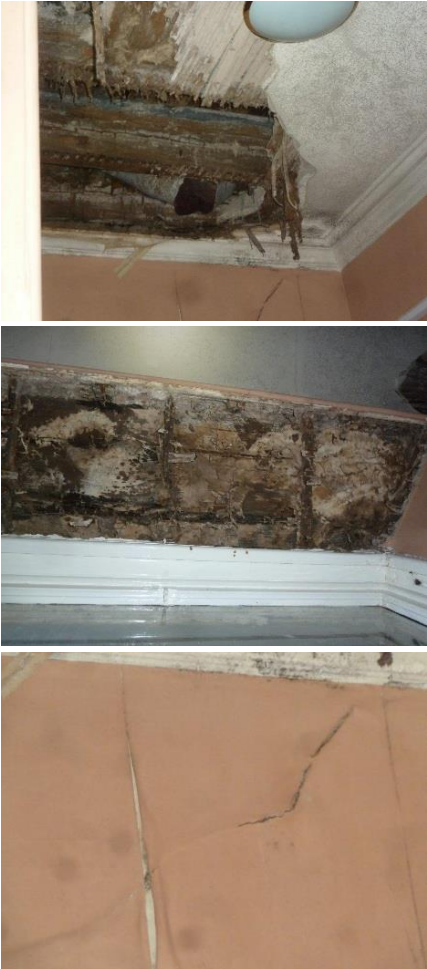
Defect ID	Photo Source	Defect Description	Defect Location	Crack Orientation	Crack Width (mm)	Crack Length (mm)	Comments	Photo	Severity Category
WN2.4	P1200 818-837	Collapsed ceiling plaster, Timber degradation, Plaster crack, Dampness/water ingress	Hallway (adj. Bedroom 203)	Diagonal	1	300	Plaster collapse to main ceiling above, approx. 2m2 area (825) Evidence of timber degradation of suspended floor joists above (826-828) Plaster crack (829) Water ingress, loss of plaster to ceiling directly above window (830-834) Dampness/water ingress (835) Dampness/water ingress (836) Dampness/water ingress (837)

<div style="background-color: red; color: white; padding: 5px;">Red</div> <div style="background-color: red; color: white; padding: 5px;">Amber</div> <div style="background-color: red; color: white; padding: 5px;">Amber</div>

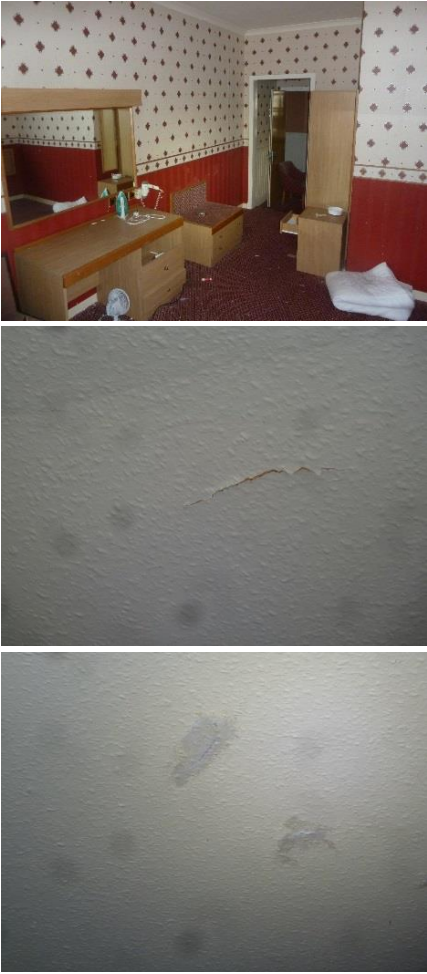
Defect ID	Photo Source	Defect Description	Defect Location	Crack Orientation	Crack Width (mm)	Crack Length (mm)	Comments	Photo	Severity Category
WS2.2	P1200 685-693	Plaster crack, Dampness/ water ingress	Bedroom 203	Horizontal	>1	10	Plaster crack (691) Dampness/water ingress (692, 693)

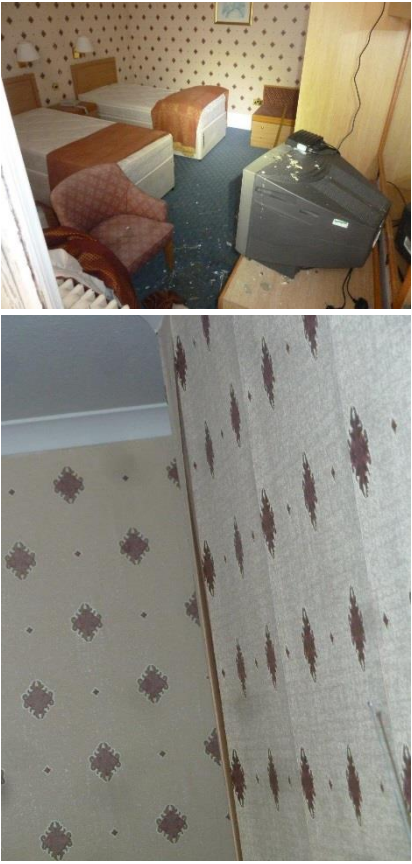
Defect ID	Photo Source	Defect Description	Defect Location	Crack Orientation	Crack Width (mm)	Crack Length (mm)	Comments	Photo	Severity Category
WW2.2	P1200 694-699	Evidence of vermin, Dampness/ water ingress	Bedroom 207	n/a	n/a	n/a	Evidence of vermin (698) Peeling wallpaper. Possible evidence of dampness behind (699)

<p>Green</p> <p>Green</p>

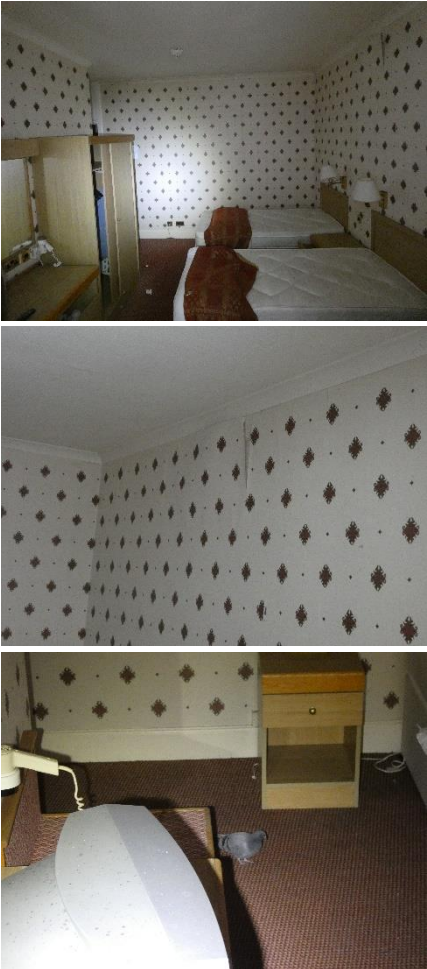
Defect ID	Photo Source	Defect Description	Defect Location	Crack Orientation	Crack Width (mm)	Crack Length (mm)	Comments	Photo	Severity Category
WW2.5	P1010 034-050	Evidence of vermin, Other	Bedroom 215	n/a	n/a	n/a	Peeling wallpaper and slight bulge behind wallpaper noted (034/048) Evidence of vermin (050)

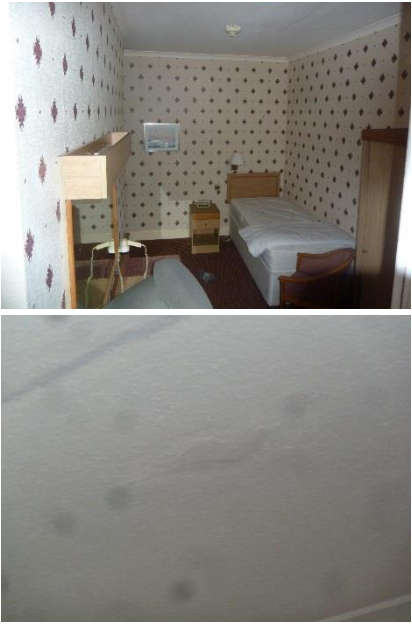
Defect ID	Photo Source	Defect Description	Defect Location	Crack Orientation	Crack Width (mm)	Crack Length (mm)	Comments	Photo	Severity Category
WW2.6	P1200708-713	Dampness/ water ingress, Evidence of vermin	Bedroom 217	n/a	n/a	n/a	Evidence of pigeon infestation (712) Evidence of damp staining to ceiling behind finishes (713)

<p>Green</p> <p>Green</p>

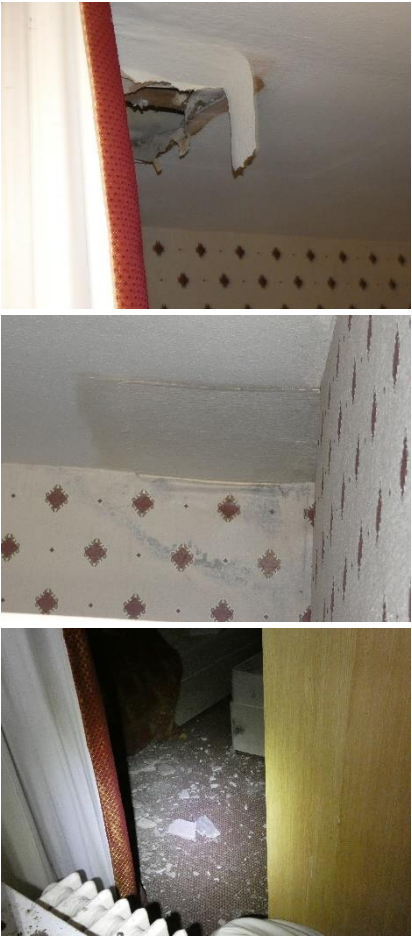
Defect ID	Photo Source	Defect Description	Defect Location	Crack Orientation	Crack Width (mm)	Crack Length (mm)	Comments	Photo	Severity Category
WE3.1	P1000556-568	Collapsed ceiling plaster, Staining, Other	Bedroom 324	n/a	n/a	n/a	Partial collapse of ceiling plaster (561) Stain noted on wall and ceiling (564, 565) Debris from collapsed ceiling on floor (567)

Amber
									Green
									Green

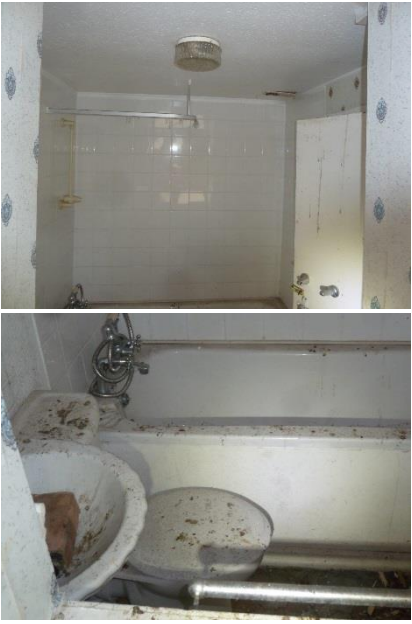
Defect ID	Photo Source	Defect Description	Defect Location	Crack Orientation	Crack Width (mm)	Crack Length (mm)	Comments	Photo	Severity Category
WE3.6	P1200 628-630	Evidence of vermin	En suite (adj. Bedroom 314)	n/a	n/a	n/a	Evidence of vermin (630)

Green

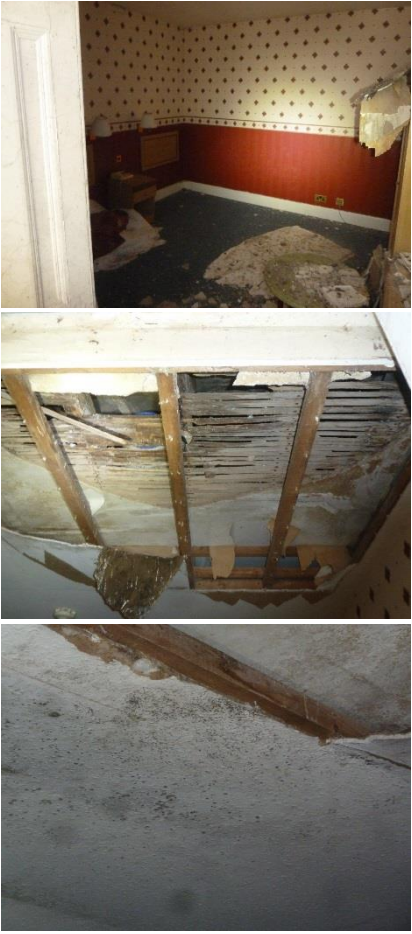
Defect ID	Photo Source	Defect Description	Defect Location	Crack Orientation	Crack Width (mm)	Crack Length (mm)	Comments	Photo	Severity Category
WE3.8	P1200 631-640	Collapsed ceiling plaster, Dampness/water ingress, Evidence of vermin	Bedroom 312	n/a	n/a	n/a	Plaster collapse to suspended ceiling and main ceiling above (635) Dampness/water ingress (639) Evidence of vermin (640)

<p>Amber</p> <p>Amber</p> <p>Amber</p>

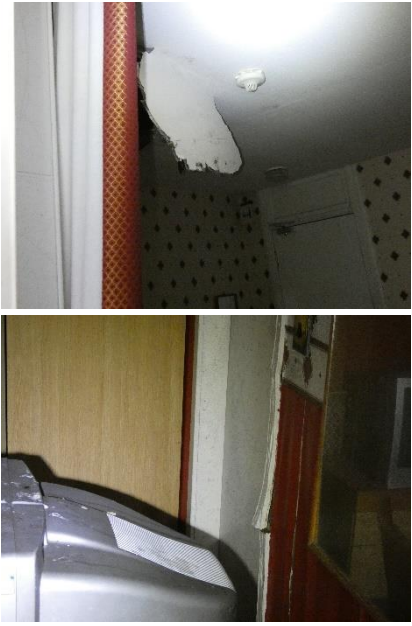
Defect ID	Photo Source	Defect Description	Defect Location	Crack Orientation	Crack Width (mm)	Crack Length (mm)	Comments	Photo	Severity Category
WE3.9	P1000 601-610	Collapsed ceiling plaster, Deteriorating/rotting timber	Bedroom 310	n/a	n/a	n/a	Localised collapse of ceiling plaster (604) Timber to door frame warped (606)

Amber Amber

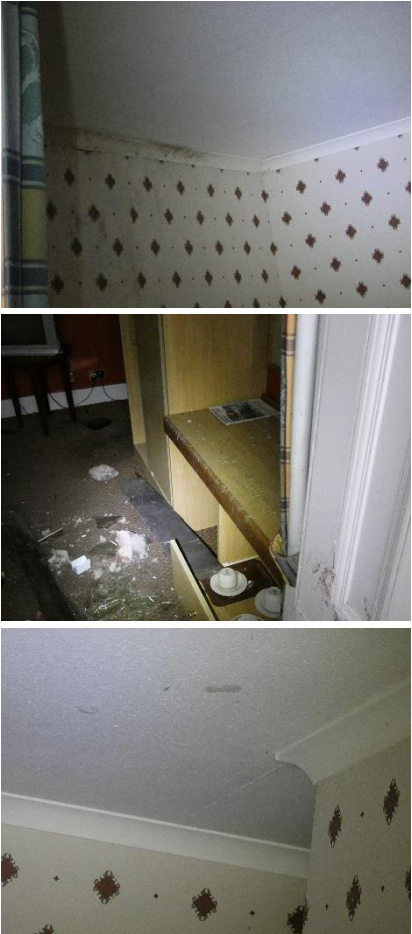
Defect ID	Photo Source	Defect Description	Defect Location	Crack Orientation	Crack Width (mm)	Crack Length (mm)	Comments	Photo	Severity Category
WE3.11	P1000 611-623	Collapsed ceiling plaster, Evidence of vermin, Staining	Bedroom 306	Horizontal	1	500	Staining at cornices (614) Evidence of vermin (615, 616) Minor ceiling crack (620)

Green

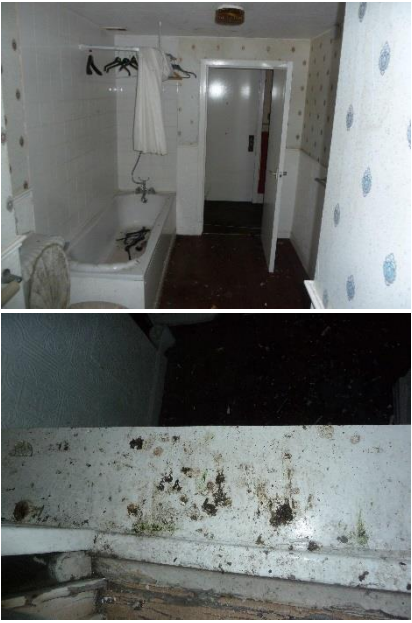
Defect ID	Photo Source	Defect Description	Defect Location	Crack Orientation	Crack Width (mm)	Crack Length (mm)	Comments	Photo	Severity Category
WE3.12	P1200 649-653	Dampness/water ingress, Evidence of vermin	En suite (adj. Bedroom 304)	n/a	n/a	n/a	Dampness/water ingress (651, 652) Evidence of vermin (653)

Green

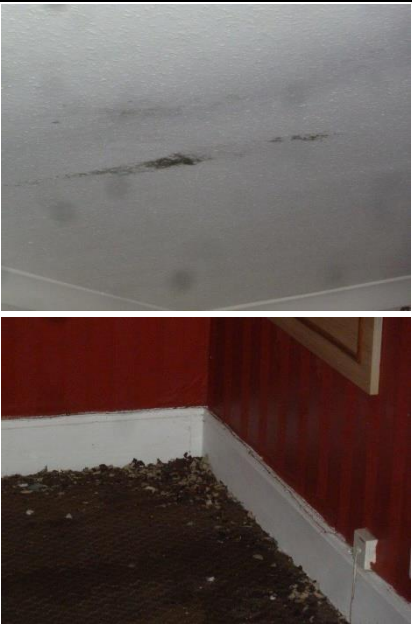
Defect ID	Photo Source	Defect Description	Defect Location	Crack Orientation	Crack Width (mm)	Crack Length (mm)	Comments	Photo	Severity Category
WE3.13	P1200 654-659	Dampness/water ingress, Evidence of vermin	Bedroom 304	n/a	n/a	n/a	Dampness/water ingress (659) Evidence of vermin (658)

Green

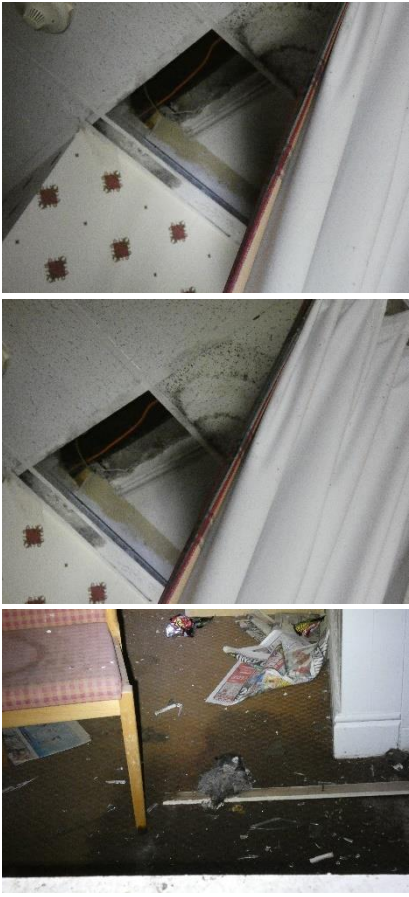
Defect ID	Photo Source	Defect Description	Defect Location	Crack Orientation	Crack Width (mm)	Crack Length (mm)	Comments	Photo	Severity Category
WS3.1	P1000 760-773	Collapsed ceiling plaster, Evidence of vermin, Staining and water ingress	Bedroom 303	n/a	n/a	n/a	Missing false ceiling tiles (771, 773) Staining to false ceiling tile (770) Evidence of vermin and damp patch on floor indicating water ingress (764)

<p>Green</p> <p>Green</p> <p>Amber</p>

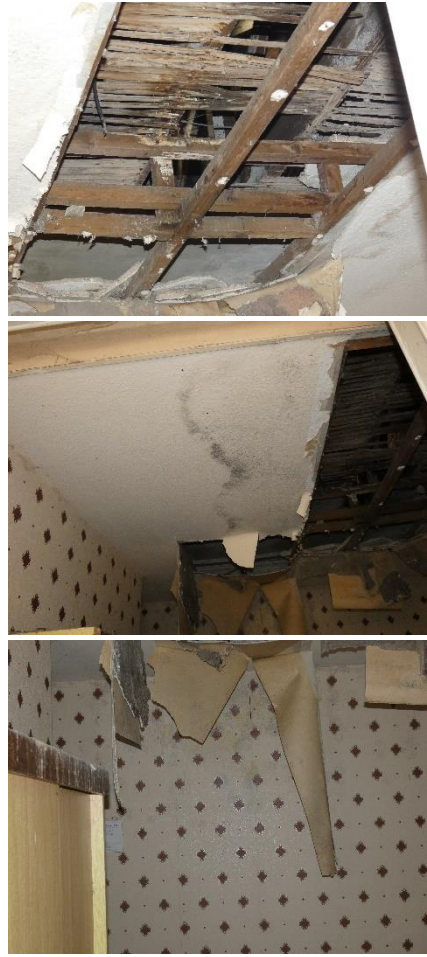
Defect ID	Photo Source	Defect Description	Defect Location	Crack Orientation	Crack Width (mm)	Crack Length (mm)	Comments	Photo	Severity Category
WW3.1	P1000 941-973	Collapsed ceiling plaster, Evidence of vermin, Staining	Bedroom 321	n/a	n/a	n/a	Significant collapse of false ceiling and original ceiling above it, roof void above visible (949-952) Staining on ceiling (955) Staining on wall (953) Evidence of vermin (947)

<div style="background-color: red; color: white; padding: 5px; text-align: center;">Red</div> <div style="background-color: red; color: white; padding: 5px; text-align: center;">Amber</div> <div style="background-color: red; color: white; padding: 5px; text-align: center;">Amber</div>

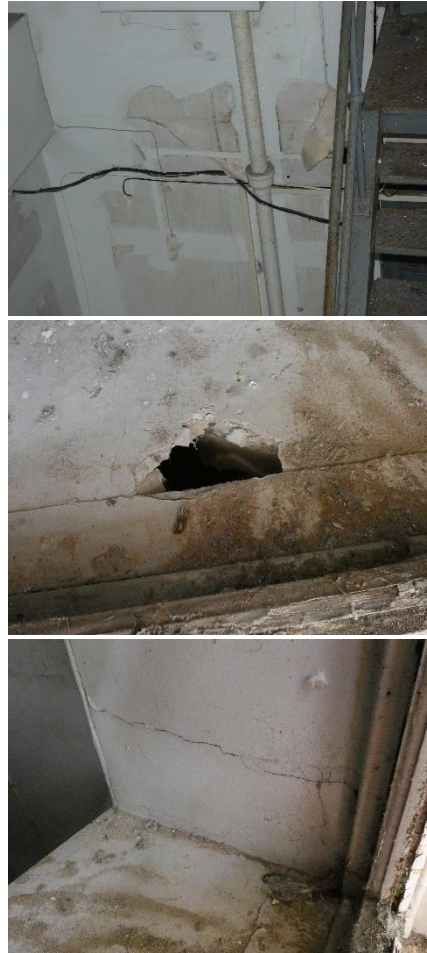
Defect ID	Photo Source	Defect Description	Defect Location	Crack Orientation	Crack Width (mm)	Crack Length (mm)	Comments	Photo	Severity Category
WW3.3	P1000 896-940	Collapsed plaster on wall, Evidence of vermin, Other	Stairs (adj. Bedroom 319)	n/a	n/a	n/a	Wallpaper on wall to LHS of door (939, 940) Window cill broken with hole (900) 2x Crack to wall of window cill (902) Mould staining on ceiling, wallpaper detached from ceiling (910, 921, 922) Walls appear re-plastered (-) Black stain to wall above light (925, 926) Crack/tear in wall finish to wall at RHS of window (913) Evidence of vermin (928)

Amber Amber Amber

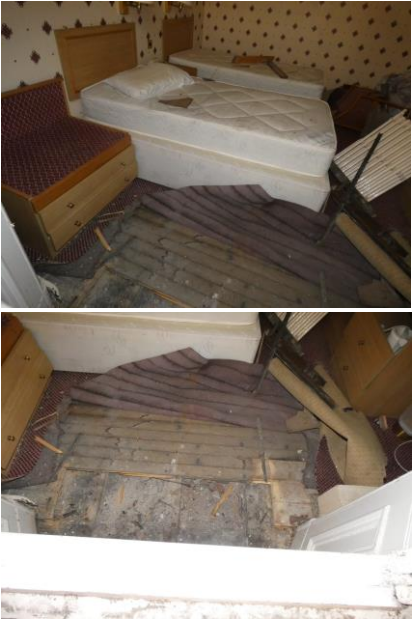
n/a
WW2.4	P1020 231-236	Evidence of water ingress	Bedroom 211	n/a	n/a	n/a	Joists ends connection to wall. Evidence of water ingress. Minimal section loss noted

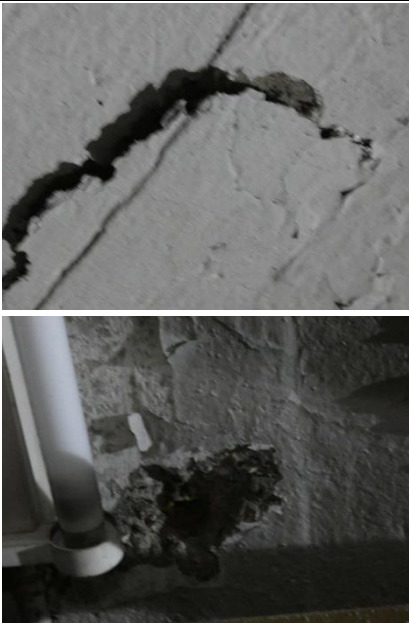
Green
3.2	P1030056-058	Missing/dislodged concrete	Battery Room - ceiling	n/a	n/a	n/a	Missing/dislodged concrete to arched ceiling
