Belleisle Park | Entrance Wall Restoration Works |

Stage C Proposals

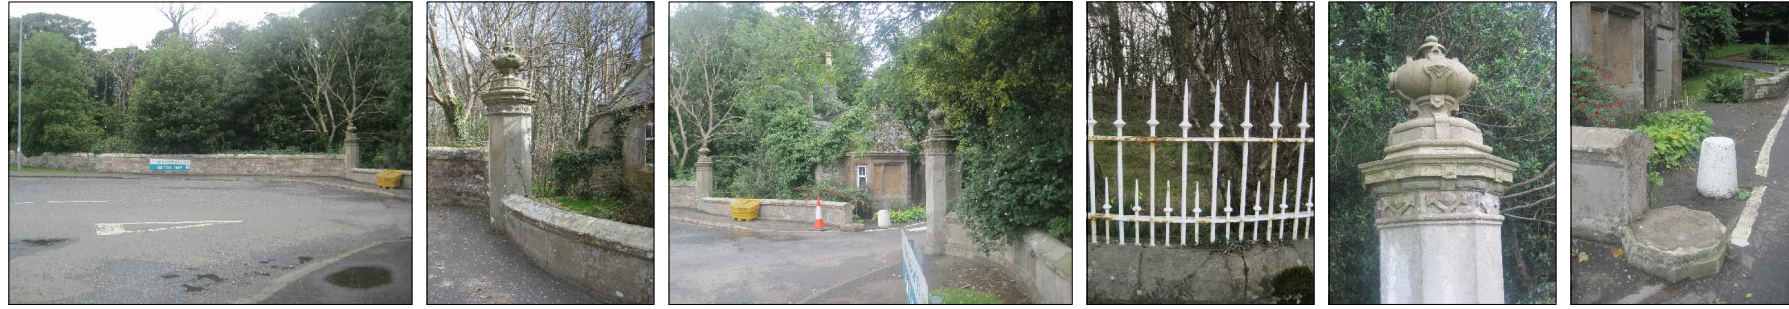
- Entrance Widened to Reduce the Risk of Collision
- Missing Pier Rebuilt
- Historic Railings Reintroduced to Match existing North Lodge Examples
- Inappropriate Signage Replaced
- Uplighting Opportunities Being Explored by the Hotel Developer
- Grit Bin Relocated
