Former Ayr Station Hotel Building Structural Condition

Independent Report

03 October 2019

Document reference: 399316/SNI/GLA/DOC/S2/REP/002

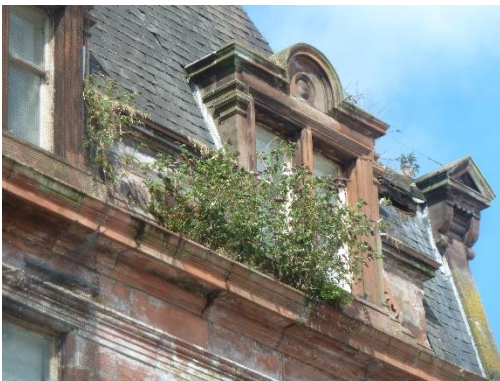
Photo 1: Dormer at east corner of south section

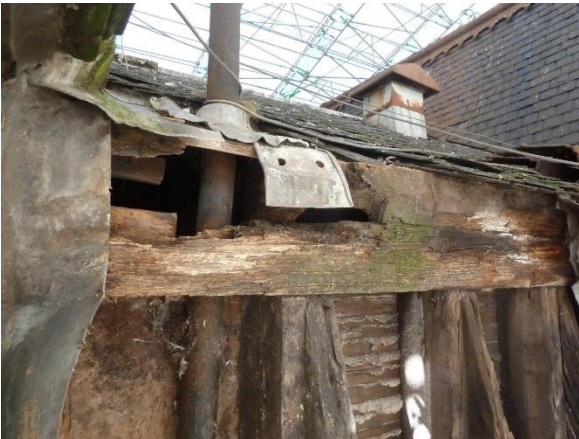
Photo 2: Roof Eaves Beam – East Elevation

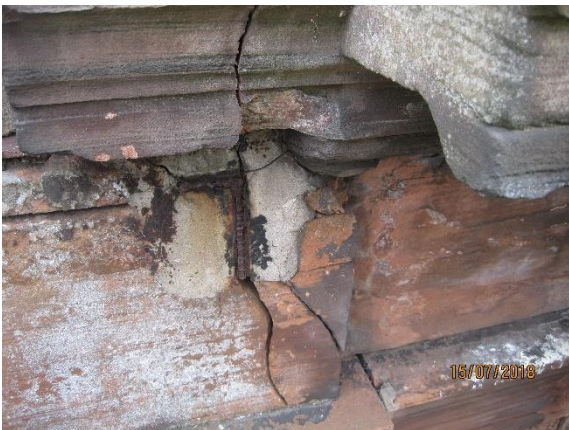
Concentrated structural cracking is apparent around historic metal inserts (likely in wrought iron) at various points on perimeter and cross-walls and chimney stacks. The metal inserts are typically at an advanced stage of decay, with both corrosion and delamination of the metal evident.

Photo 3: Historic Metal Insert - South Gable

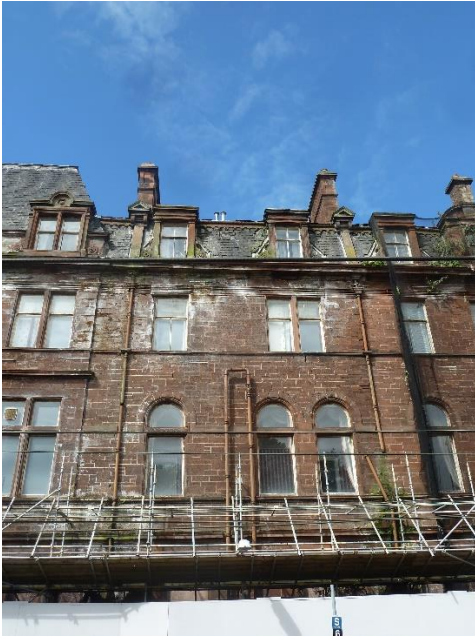
Appearing more developed and extensive on the east elevation the efflorescence is more obvious along the line of the feature cornice at eaves level in two locations adjacent to platforms 1 and 3.

Photo 4: Efflorescence – East Elevation

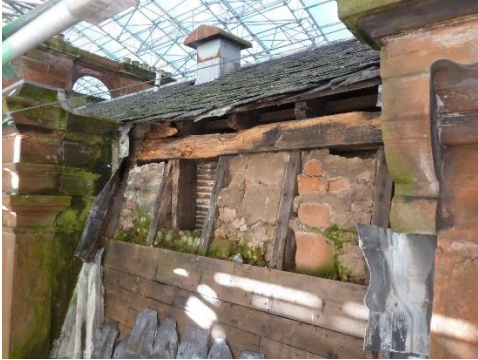
The materials that constitute the external components of the mansard where they were visible appeared, on the east side of the building, to be generally to be in a poor, to very poor condition.

Photo 5: Lower mansard – east elevation

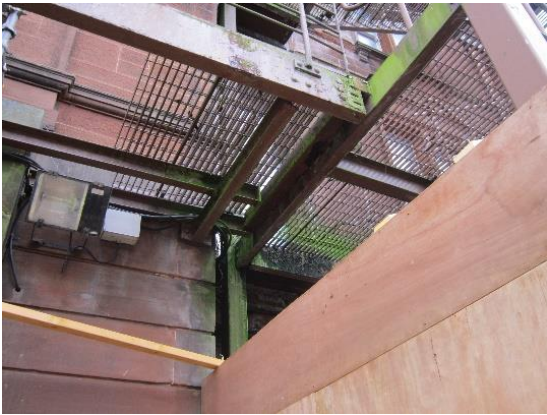
Photo 7: Escape Stair – west elevation

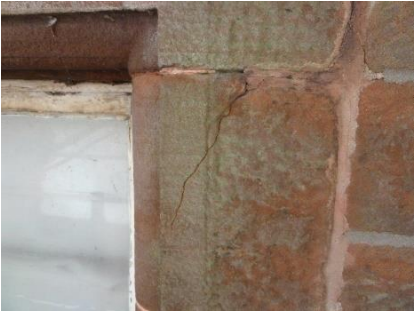
Defect ID	Photo Source	Defect Description	Defect Location	Crack Orientation	Crack Width (mm)	Crack Length (mm)	Comments	Photo	Severity Category
N1.1	P1200200	Missing/damaged pointing	North Elevation N1, Wall	n/a	n/a	n/a	-	 	Amber
N1.2	P1200201	Cracking to sandstone	North Elevation N1, Wall	Diagonal	1	100	Crack on sandstone block adjacent window

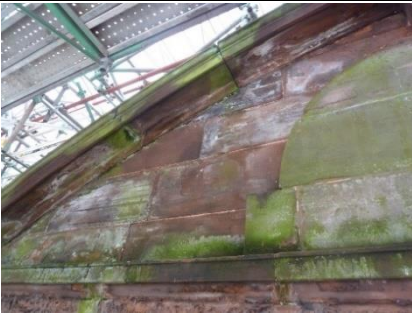
Defect ID	Photo Source	Defect Description	Defect Location	Crack Orientation	Crack Width (mm)	Crack Length (mm)	Comments	Photo	Severity Category
N1.4	P1200203, 204	Water staining efflorescence	North Elevation N1, Wall	n/a	n/a	n/a	General water staining and vegetation growth/staining noted on wall face

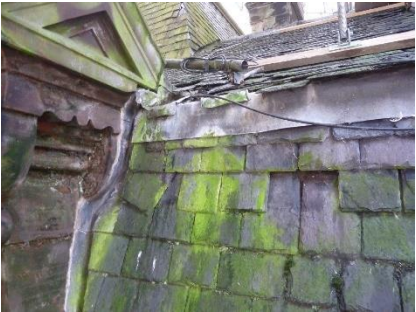
Defect ID	Photo Source	Defect Description	Defect Location	Crack Orientation	Crack Width (mm)	Crack Length (mm)	Comments	Photo	Severity Category
N1.12	P1200221	Missing/damaged tiles/roof	North Elevation N1, Wall	n/a	n/a	n/a	Missing/dislodged roof tiles

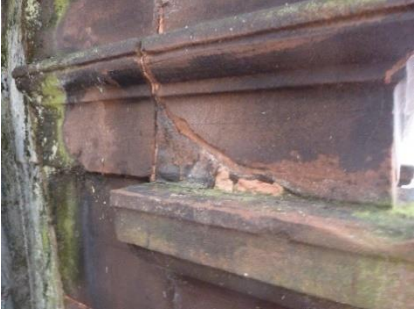
Red
N1.13	P1200222, 0223	Spalled/damaged sandstone, Cracking to sandstone	North Elevation N1, Wall	Diagonal	1	150	Crack on sandstone block, appears to have been repaired/infilled

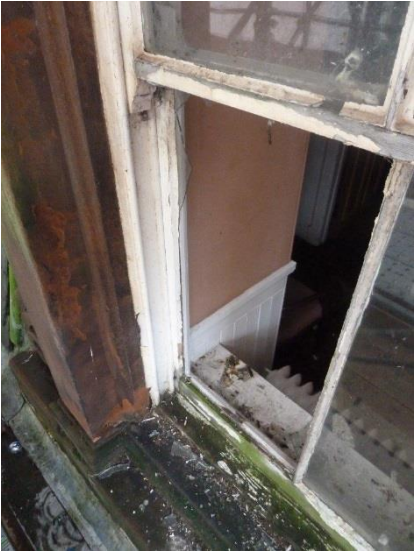
Defect ID	Photo Source	Defect Description	Defect Location	Crack Orientation	Crack Width (mm)	Crack Length (mm)	Comments	Photo	Severity Category
N1.14	P1200224	Other	North Elevation N1, Wall	n/a	n/a	n/a	Missing window pane

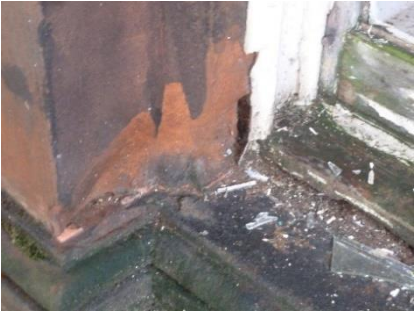
Amber
N1.15	P1200225	Spalled/damaged sandstone	North Elevation N1, Wall	n/a	n/a	n/a	Deterioration of sandstone pilaster at side of window

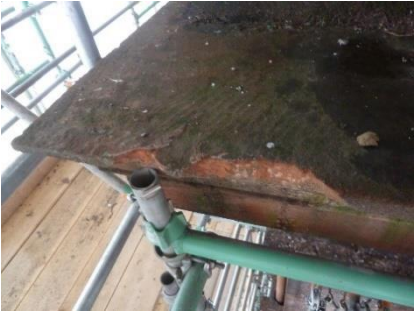
Defect ID	Photo Source	Defect Description	Defect Location	Crack Orientation	Crack Width (mm)	Crack Length (mm)	Comments	Photo	Severity Category
N1.16	P1200226, 227, 231, 232	Spalled/damaged sandstone ledge	North Elevation N1, Wall	n/a	n/a	n/a	Spalled/cracked/broken off sandstone to ledge feature at 5 locations

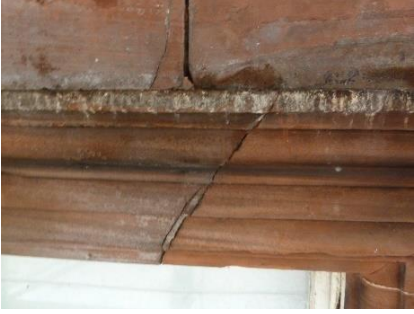
Green
N1.17	P1200228	Cracking to sandstone	North Elevation N1, Wall	Diagonal	2	100	Crack on sandstone block of window lintel

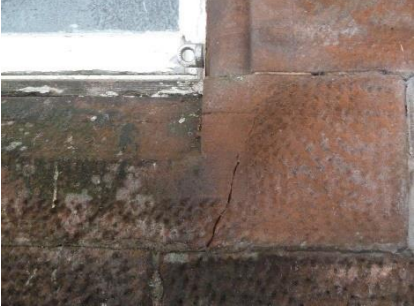
Amber
N1.18	P1200229	Cracking to sandstone	North Elevation N1, Wall	Vertical	2	150	Crack on sandstone block adjacent to window cill

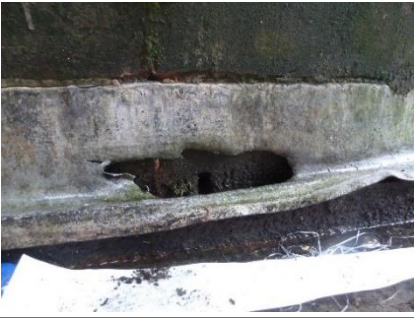
Defect ID	Photo Source	Defect Description	Defect Location	Crack Orientation	Crack Width (mm)	Crack Length (mm)	Comments	Photo	Severity Category
N1.22	P1200236	Other	North Elevation N1, Wall	n/a	n/a	n/a	Damaged flashing below window

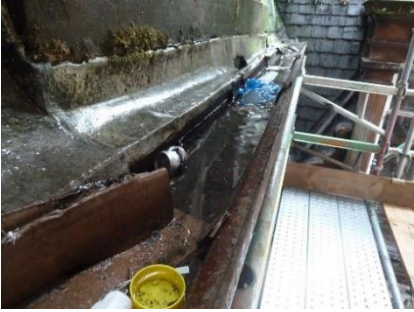
Amber
N1.23	P1200237, 238, 239	Damaged/defective gutter/drainage	North Elevation N1, Wall	n/a	n/a	n/a	Gutter appears to be defective and not draining

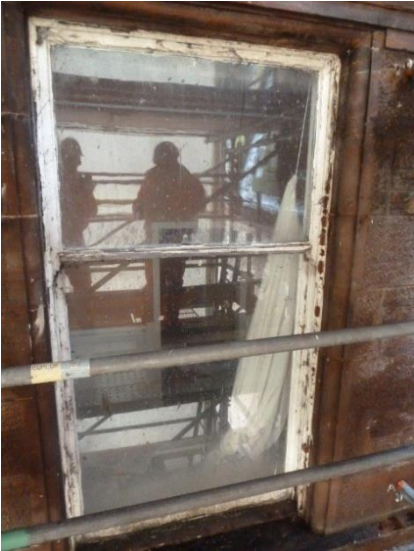
Defect ID	Photo Source	Defect Description	Defect Location	Crack Orientation	Crack Width (mm)	Crack Length (mm)	Comments	Photo	Severity Category
N1.24	P1200313, 315	Other	North Elevation N1, Wall	n/a	n/a	n/a	Deterioration of timber framing to windows

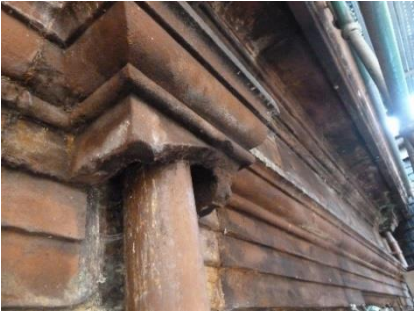
Green
N1.25	P1200314	Spalled/ damaged sandstone	North Elevation N1, Wall	n/a	n/a	n/a	Cracked/broken off sandstone to gutter/downpipe feature

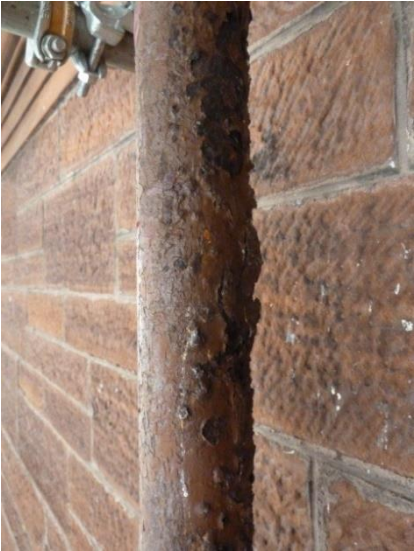
Defect ID	Photo Source	Defect Description	Defect Location	Crack Orientation	Crack Width (mm)	Crack Length (mm)	Comments	Photo	Severity Category
N1.26	P1200316	Damaged/defective gutter/drainage	North Elevation N1, Wall	n/a	n/a	n/a	Surface corrosion to downpipe, appears quite extensive

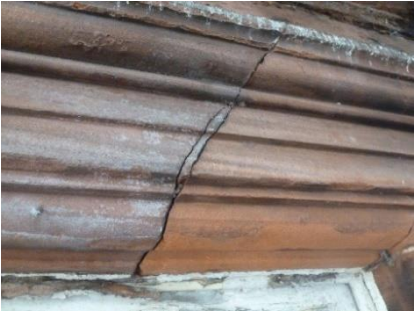
Green
N1.27	P1200317, 318	Cracking to sandstone	North Elevation N1, Wall	Diagonal	4	300	Cracked window lintel, 2no. separate cracks on lintel observed

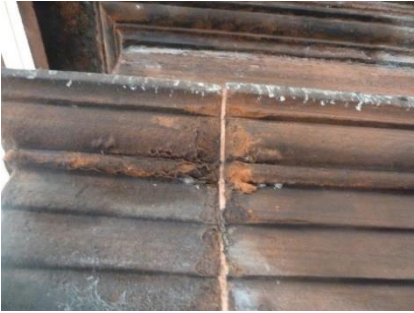
Defect ID	Photo Source	Defect Description	Defect Location	Crack Orientation	Crack Width (mm)	Crack Length (mm)	Comments	Photo	Severity Category
N1.28	P1200319	Spalled/damaged sandstone	North Elevation N1, Wall	n/a	n/a	n/a	Spalling/delamination of sandstone blocks on and adjacent ledge feature

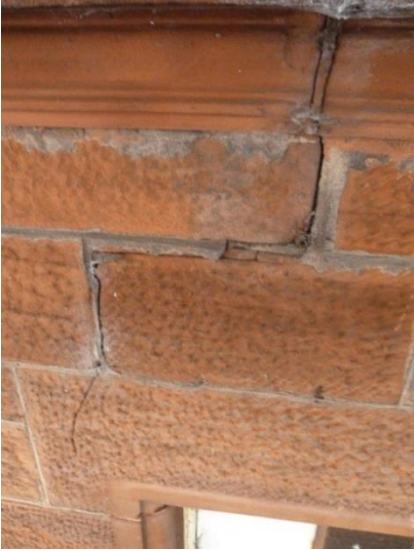
Green
N1.29	P1200428, 430	Missing/damaged pointing, Cracking to sandstone	North Elevation N1, Wall	Stepped / Diagonal	3	2000	Crack between upper and lower windows. Crack travels mostly along mortar joint and extends on a sandstone block

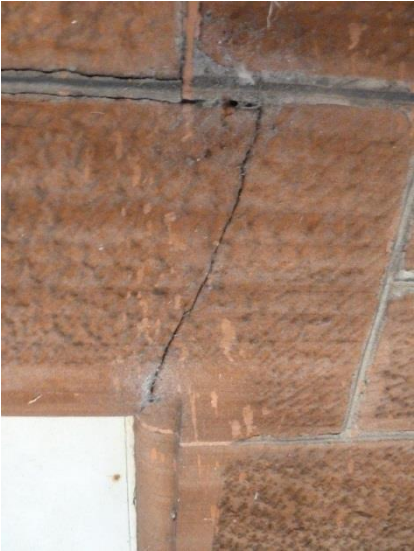
Defect ID	Photo Source	Defect Description	Defect Location	Crack Orientation	Crack Width (mm)	Crack Length (mm)	Comments	Photo	Severity Category
N1.30	P1200429	Cracking to sandstone	North Elevation N1, Wall	Diagonal	1	300	Crack on lintel

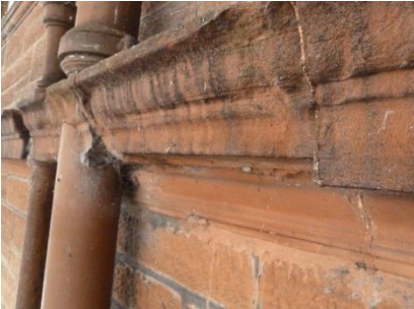
Green
N1.31	P1200431, 432	Spalled/damaged sandstone	North Elevation N1, Wall	n/a	n/a	n/a	Sandstone ledge feature appears to exhibit delamination/erosion with loss of section observed

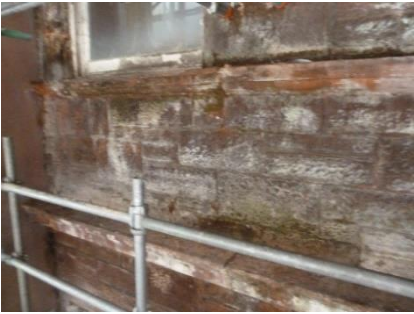
Defect ID	Photo Source	Defect Description	Defect Location	Crack Orientation	Crack Width (mm)	Crack Length (mm)	Comments	Photo	Severity Category
N1.32	P1200433	Water staining efflorescence	North Elevation N1, Wall	n/a	n/a	n/a	-

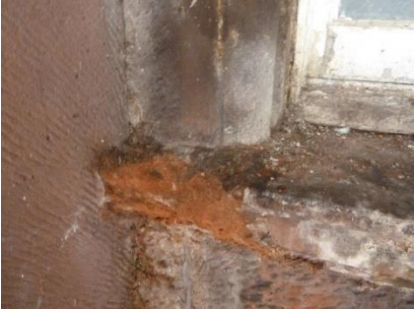
Green
N1.33	P1200434	spalled/damaged sandstone	North Elevation N1, Wall	n/a	n/a	n/a	Deterioration to sandstone block at window cill

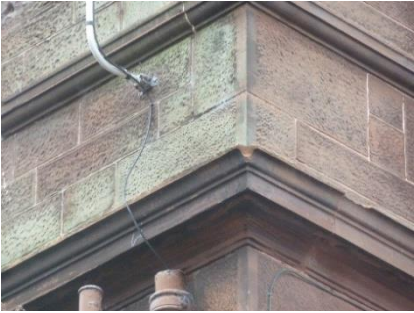
Defect ID	Photo Source	Defect Description	Defect Location	Crack Orientation	Crack Width (mm)	Crack Length (mm)	Comments	Photo	Severity Category
N2.1	P1190486	Spalled/damaged sandstone	Elevation N2, Wall	n/a	n/a	n/a	Cracked/broken off sandstone to ledge feature

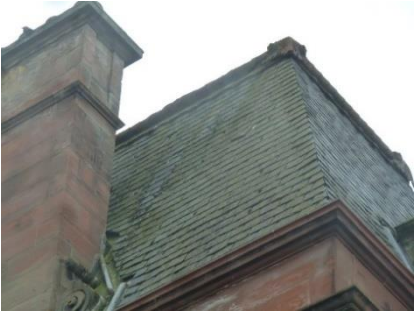
Green
N2.2	P1190488	Missing/damaged tiles/roof	Elevation N2, Roof	n/a	n/a	n/a	-

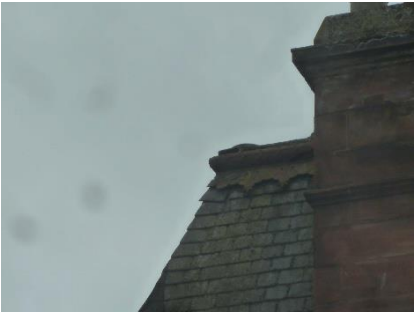
Red
N2.3	P1190492	Other	Elevation N2, Roof	n/a	n/a	n/a	Cast iron feature piece broken/missing

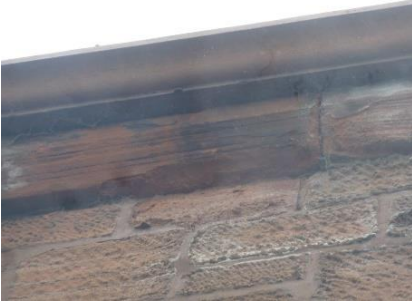
Defect ID	Photo Source	Defect Description	Defect Location	Crack Orientation	Crack Width (mm)	Crack Length (mm)	Comments	Photo	Severity Category
N3.1	P1190481	Spalled/damaged sandstone	Underside gutter support	n/a	n/a	n/a	Sandstone ledge feature appears to exhibit delamination/erosion

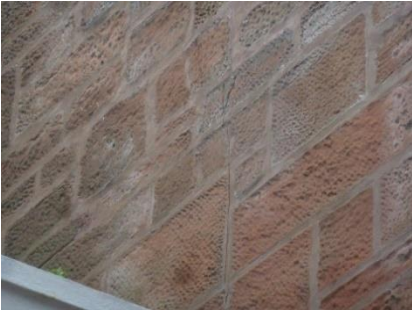
Green
N3.2	P1190482	Cracking to sandstone	Wall	Vertical	1	750	-

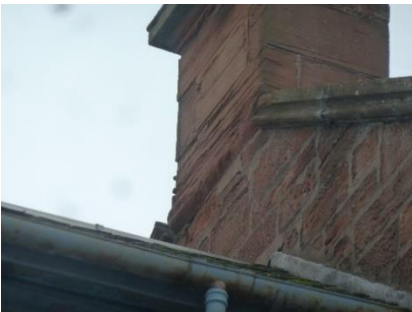
Green
N3.3	P1190483	Spalled/damaged sandstone	Underside chimney	n/a	n/a	n/a	Sandstone blocks appears to exhibit delamination/erosion

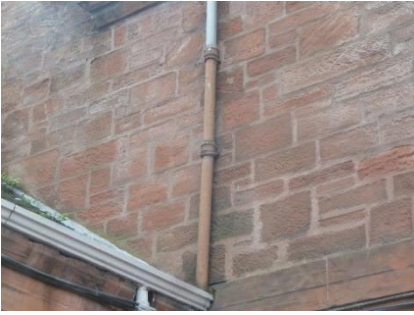
Defect ID	Photo Source	Defect Description	Defect Location	Crack Orientation	Crack Width (mm)	Crack Length (mm)	Comments	Photo	Severity Category
N3.4	P1190484	Spalled/damaged sandstone	Elevation N3, Wall	n/a	n/a	n/a	Sandstone blocks appears to exhibit weathering/erosion

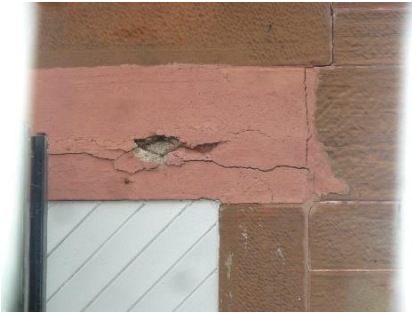
Defect ID	Photo Source	Defect Description	Defect Location	Crack Orientation	Crack Width (mm)	Crack Length (mm)	Comments	Photo	Severity Category
N4.1	P1190472	Cracking to lintel	Door lintel	Horizontal	2	750	Horizontal crack through lintel and vertical through sandstone block joints

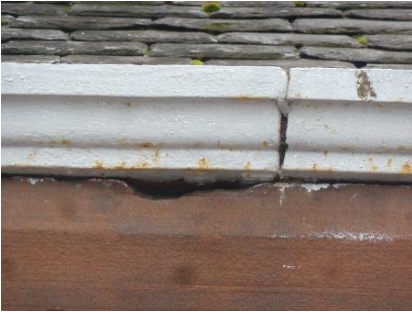
Red
N4.2	P1190473	Spalled/damaged sandstone	Underside of gutter	n/a	n/a	n/a	Cracked/broken off sandstone block forming gap below gutter

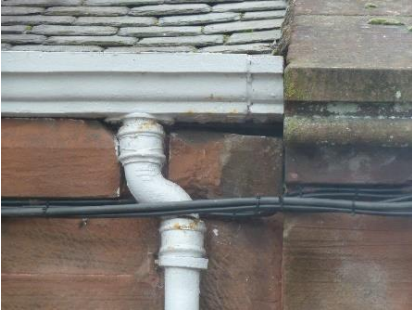
Amber
N4.3	P1190474	Spalled/damaged sandstone	Underside of gutter	n/a	n/a	n/a	Cracked/broken off sandstone block adjacent downpipe

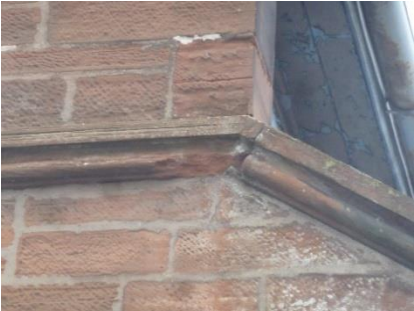
Defect ID	Photo Source	Defect Description	Defect Location	Crack Orientation	Crack Width (mm)	Crack Length (mm)	Comments	Photo	Severity Category
N4.4	P1190476	Spalled/damaged sandstone	Sandstone ledge feature	n/a	n/a	n/a	Cracked/broken off sandstone to ledge feature

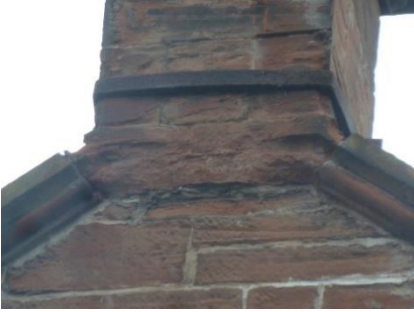
Green
N4.5	P1190477	Spalled/damaged sandstone	Sandstone ledge feature below chimney	n/a	n/a	n/a	Sandstone ledge feature appears to exhibit delamination/ erosion

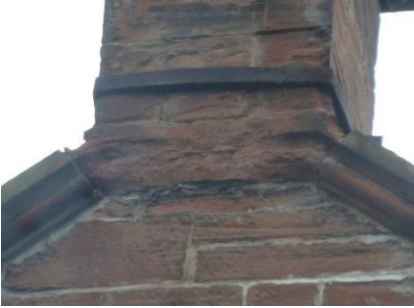
Green
N4.6	P1190477	Other	Chimney	n/a	n/a	n/a	Metal strapping on chimney stack noted. Evidence of possible past movement of stack

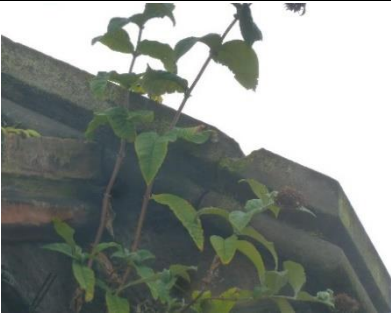
Defect ID	Photo Source	Defect Description	Defect Location	Crack Orientation	Crack Width (mm)	Crack Length (mm)	Comments	Photo	Severity Category
N4.7	P1190478	Spalled/damaged sandstone	Elevation N4, Wall	n/a	n/a	n/a	Cracked/broken off sandstone block

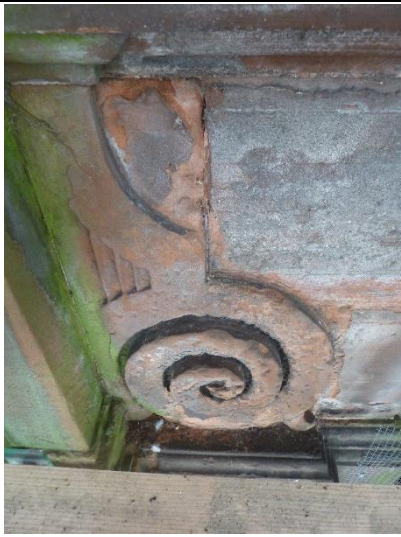
Defect ID	Photo Source	Defect Description	Defect Location	Crack Orientation	Crack Width (mm)	Crack Length (mm)	Comments	Photo	Severity Category
E1.10	P1200117	Spalled/damaged sandstone	Feature stonework	n/a	n/a	n/a	General delamination/erosion to feature sandstone block

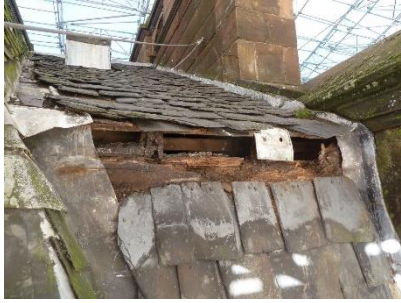
Green
E1.11	P1200118	Other	Mansard roof	n/a	n/a	n/a	Missing/dislodged tiles exposing damaged/rotted timber. Roof void also exposed

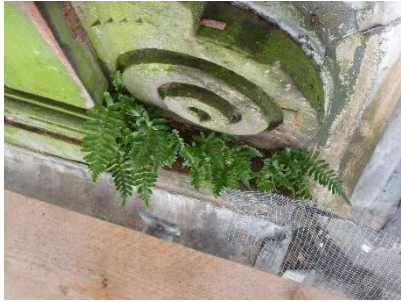
Defect ID	Photo Source	Defect Description	Defect Location	Crack Orientation	Crack Width (mm)	Crack Length (mm)	Comments	Photo	Severity Category
E1.15	P1200125	Vegetation growth	Roof and wall	n/a	n/a	n/a	General vegetation growth observed on elevation E1 building face

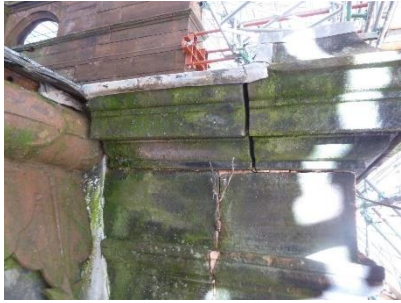
Amber
E1.16	P1200126-128	Spalled/damaged sandstone	Above window	n/a	n/a	n/a	Cracked/broken off sandstone. Missing mortar, possibly loose block

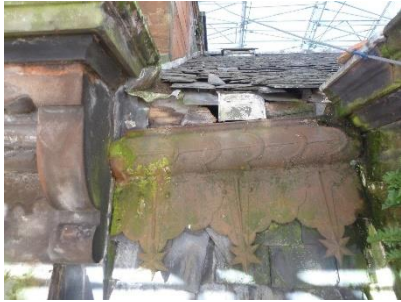
Defect ID	Photo Source	Defect Description	Defect Location	Crack Orientation	Crack Width (mm)	Crack Length (mm)	Comments	Photo	Severity Category
E1.18	P1200133	Other	Mansard roof	n/a	n/a	n/a	Missing tiles exposed and damaged/rotted timber. Roof void exposed. Broken cast iron feature

Red
E1.19	P1200136	Spalled/damaged sandstone	Above roof	n/a	n/a	n/a	Cracked/broken off sandstone. Missing mortar, possibly loose block

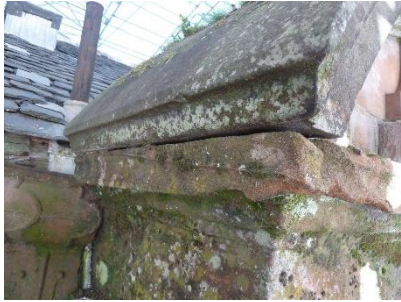
Defect ID	Photo Source	Defect Description	Defect Location	Crack Orientation	Crack Width (mm)	Crack Length (mm)	Comments	Photo	Severity Category
E1.21	P1200139	Spalled/damaged sandstone	Above window	n/a	n/a	n/a	Delamination/erosion of sandstone. Missing mortar, possibly loose block

Red
E1.22	P1200140-141	Cracking to sandstone	Roof	Diagonal	3	200	-	 	Amber
E1.23	P1200142	Other	Window	n/a	n/a	n/a	Smashed window pane	 	Red

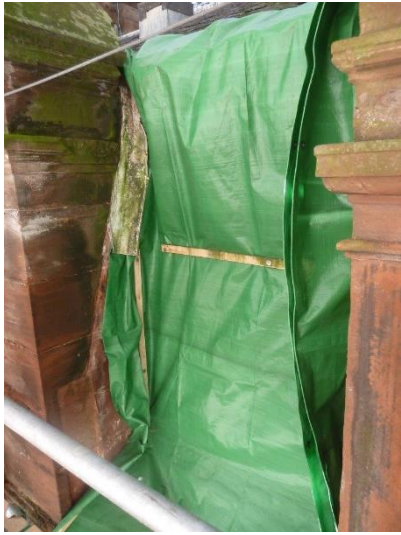
Defect ID	Photo Source	Defect Description	Defect Location	Crack Orientation	Crack Width (mm)	Crack Length (mm)	Comments	Photo	Severity Category
E1.24	P1200143-144	Other	Mansard roof	n/a	n/a	n/a	Full roof section removed (timbers, tiles, etc) and sheeted

Red
E1.25	P1200145	Spalled/damaged sandstone	Above window	n/a	n/a	n/a	Cracked/broken off sandstone. Missing mortar, possibly loose block

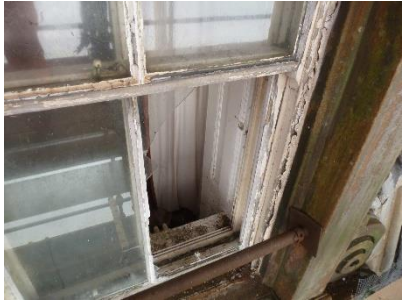
Defect ID	Photo Source	Defect Description	Defect Location	Crack Orientation	Crack Width (mm)	Crack Length (mm)	Comments	Photo	Severity Category
E1.26	P1200146	Other	Window	n/a	n/a	n/a	Smashed window pane

Red
E1.27	P1200147-152	Other	Mansard roof	n/a	n/a	n/a	Missing tiles exposed and damaged/rotted timber. Roof void exposed. Damaged flashing

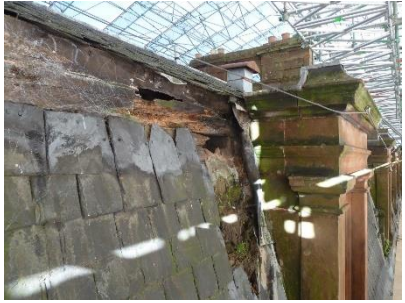
Red
E1.28	P1200153	Spalled/damaged sandstone	Above window	n/a	n/a	n/a	Cracked/broken off sandstone. Missing mortar, possibly loose block

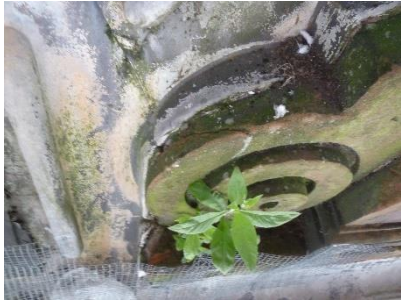
Defect ID	Photo Source	Defect Description	Defect Location	Crack Orientation	Crack Width (mm)	Crack Length (mm)	Comments	Photo	Severity Category
E1.32	P1200159	Cracking to sandstone	Feature stonework	Diagonal	2-3	150	-

Amber
E1.33	P1200160-163	Other	Mansard roof	n/a	n/a	n/a	Missing tiles exposed and damaged/rotted timber. Roof void exposed	 	Red
E1.34	P1200164-166	Other	Mansard roof	n/a	n/a	n/a	Missing tiles exposed and damaged/rotted timber. Roof void exposed

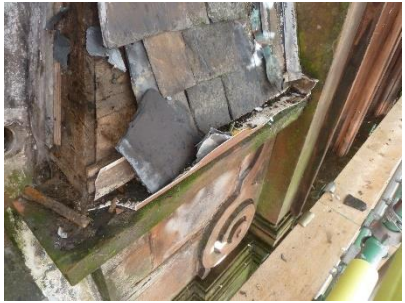
Defect ID	Photo Source	Defect Description	Defect Location	Crack Orientation	Crack Width (mm)	Crack Length (mm)	Comments	Photo	Severity Category
E1.41	P1200182	Damaged/defective gutter/drainage Displaced tiles/slates	Mansard roof	n/a	n/a	n/a	Damaged gutter

Red
E1.42	P1200183	Spalled/damaged sandstone	Mansard roof	n/a	n/a	n/a	Delamination/erosion of sandstone to feature stonework

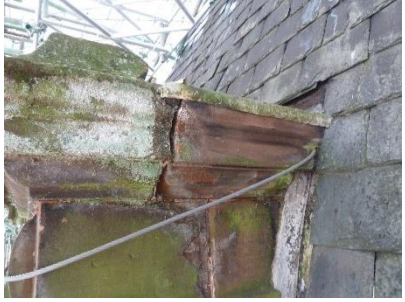
Defect ID	Photo Source	Defect Description	Defect Location	Crack Orientation	Crack Width (mm)	Crack Length (mm)	Comments	Photo	Severity Category
E1.43	P1200186	Missing/damaged tiles/roof	Mansard roof	n/a	n/a	n/a	Missing tiles	 	Red
E1.44	P1200187-188	Damaged cast iron fittings	Roof tower	n/a	n/a	n/a	Missing cast iron feature piece	 	Amber
E1.45	P1200189	Spalled/damaged sandstone	Above roof	n/a	n/a	n/a	Delamination/erosion of sandstone. Missing mortar, possibly loose block

Amber

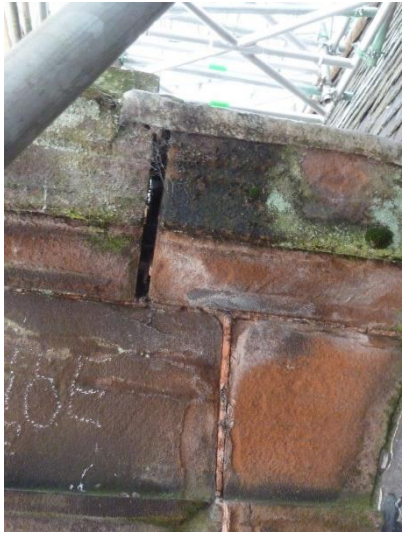
Defect ID	Photo Source	Defect Description	Defect Location	Crack Orientation	Crack Width (mm)	Crack Length (mm)	Comments	Photo	Severity Category
E1.46	P1200190194	Spalled/damaged sandstone	Above roof	n/a	n/a	n/a	Delamination/erosion of sandstone. Missing mortar, possibly loose block

Amber
E1.47	P1200191	Other	Window	n/a	n/a	n/a	Broken window pane

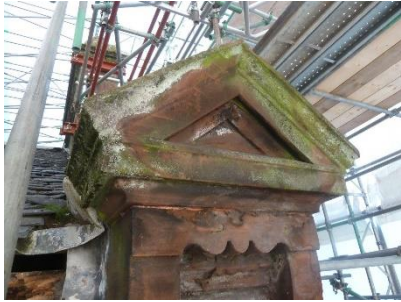
Defect ID	Photo Source	Defect Description	Defect Location	Crack Orientation	Crack Width (mm)	Crack Length (mm)	Comments	Photo	Severity Category
E1.48	P1200193	Other	Mansard roof	n/a	n/a	n/a	Missing tiles exposed and damaged/rotted timber. Roof void exposed	 	Red
E1.49	P1200196	Water staining efflorescence	Sandstone	n/a	n/a	n/a	General defect - water staining to building face

Green
E1.50	P1200240-242	Spalled/damaged sandstone Unattached gutter bracket.	Wall	n/a	n/a	n/a	Cracked/broken off sandstone	 	Amber

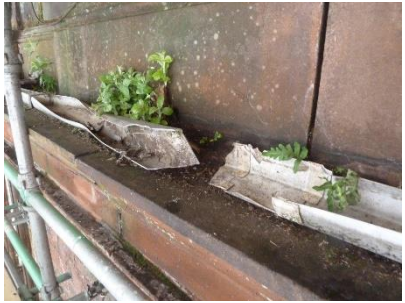
Defect ID	Photo Source	Defect Description	Defect Location	Crack Orientation	Crack Width (mm)	Crack Length (mm)	Comments	Photo	Severity Category
E1.51	P1200243	Other	Gutter	n/a	n/a	n/a	Damage to temporary gutters

Red
E1.52	P1200244-245	Cracking to sandstone	Wall	Diagonal	6	700	Substantial crack to lintel which extends into sandstone wall

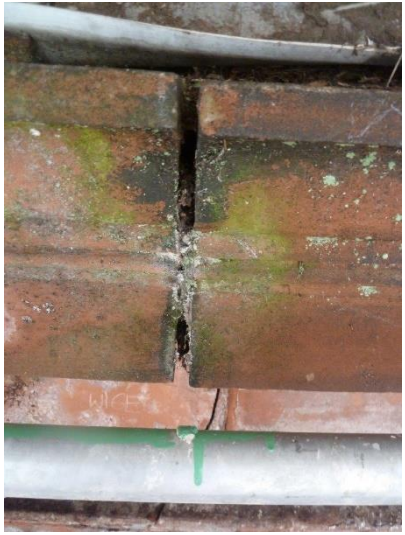
Defect ID	Photo Source	Defect Description	Defect Location	Crack Orientation	Crack Width (mm)	Crack Length (mm)	Comments	Photo	Severity Category
E1.53	P1200246	Other	Wall	n/a	n/a	n/a	Delamination/erosion of sandstone. Missing mortar, possibly loose block

Amber
E1.54	P1200247	Spalled/damaged sandstone	Wall	n/a	n/a	n/a	Cracked/broken off sandstone

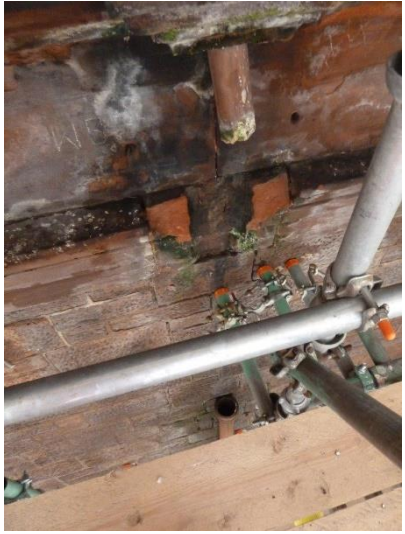
Defect ID	Photo Source	Defect Description	Defect Location	Crack Orientation	Crack Width (mm)	Crack Length (mm)	Comments	Photo	Severity Category
E1.59	P1200257	Spalled/damaged sandstone	Wall	n/a	n/a	n/a	Cracked/broken off sandstone due to broken rainwater pipe

Amber
E1.60	P1200257	Damaged/defective gutter/drainage	Downpipe	n/a	n/a	n/a	Missing section of downpipe

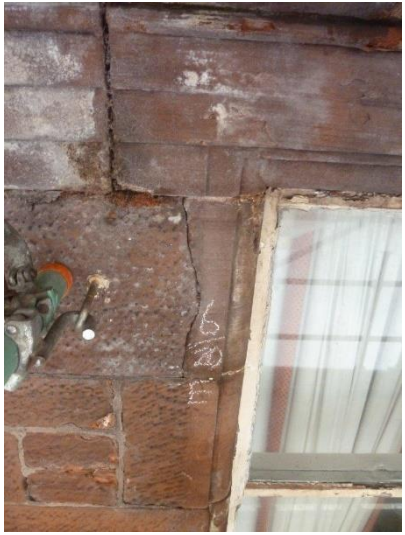
Defect ID	Photo Source	Defect Description	Defect Location	Crack Orientation	Crack Width (mm)	Crack Length (mm)	Comments	Photo	Severity Category
E1.61	P1200258-259	Cracking to sandstone	Wall	Vertical	2	300	Crack to sandstone adjacent to window

Red
E1.62	P1200260	Spalled/damaged sandstone	Wall	n/a	n/a	n/a	Missing mortar, possibly loose block

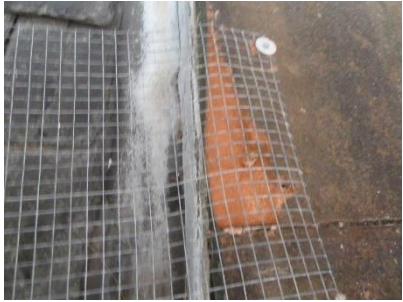
Defect ID	Photo Source	Defect Description	Defect Location	Crack Orientation	Crack Width (mm)	Crack Length (mm)	Comments	Photo	Severity Category
E1.66	P1200267	Spalled/damaged sandstone	Wall	n/a	n/a	n/a	Cracked/broken off sandstone

Green
E1.67	P1200269	Spalled/damaged sandstone	Wall	n/a	n/a	n/a	Cracked/broken off sandstone

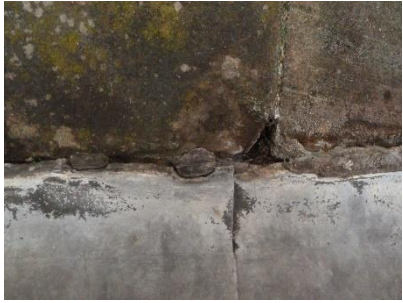
Green
E1.68	P1200270	Other	Flashing	n/a	n/a	n/a	Defective flashing

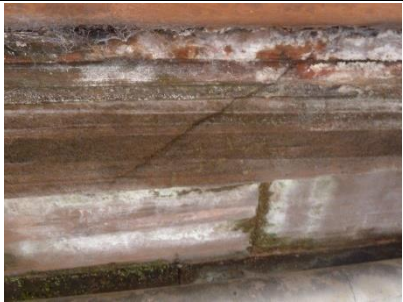
Defect ID	Photo Source	Defect Description	Defect Location	Crack Orientation	Crack Width (mm)	Crack Length (mm)	Comments	Photo	Severity Category
E1.69	P1200271	Cracking to sandstone	Wall	Diagonal	1	100	Crack to sandstone

Green
E1.70	P1200272	Cracking to sandstone	Lintel	Vertical/ Diagonal	2	100	Crack to sandstone at corner of window/lintel	 	Amber
E1.71	P1200273-277	Other	Flashing	n/a	n/a	n/a	Defective flashing, missing mortar	 	Amber

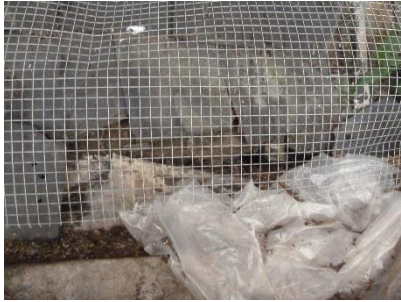
Defect ID	Photo Source	Defect Description	Defect Location	Crack Orientation	Crack Width (mm)	Crack Length (mm)	Comments	Photo	Severity Category
E1.72	P1200278-280	Other	Flashing	n/a	n/a	n/a	Defective flashing

Red
E1.73	P1200281	Damaged/defective gutter/drainage	Downpipe	n/a	n/a	n/a	Damaged downpipe

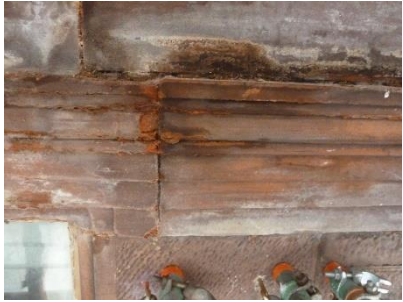
Defect ID	Photo Source	Defect Description	Defect Location	Crack Orientation	Crack Width (mm)	Crack Length (mm)	Comments	Photo	Severity Category
E1.75	P1200284	Spalled/damaged sandstone	wall	n/a	n/a	n/a	Delamination/erosion of sandstone along ledge feature

Green
E1.76	P1200285	Spalled/damaged sandstone	wall	n/a	n/a	n/a	Cracked/broken off sandstone to underside of ledge feature

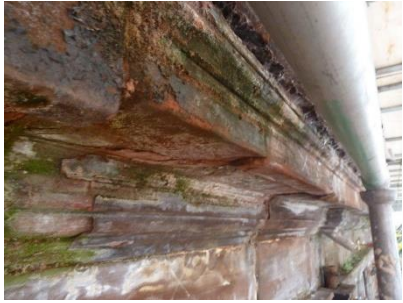
Green
E1.77	P1200286-287	Spalled/damaged sandstone	wall	n/a	n/a	n/a	Cracked/broken off sandstone to underside of ledge feature

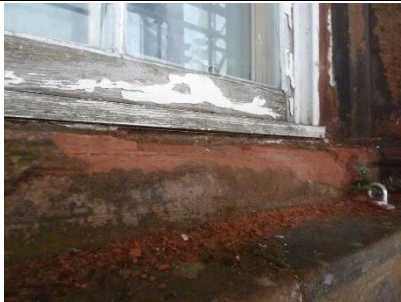
Defect ID	Photo Source	Defect Description	Defect Location	Crack Orientation	Crack Width (mm)	Crack Length (mm)	Comments	Photo	Severity Category
E1.81	P1200293	Spalled/damaged sandstone	Cill	n/a	n/a	n/a	Delamination/erosion of sandstone to window cill

Green
E1.82	P1200294-295	Other	Wall	n/a	n/a	n/a	Missing mortar, possibly loose sandstone block. Probable water ingress from defective rainwater downpipe	 	Green
E1.83	P1200296	Cracking to sandstone	Wall	Diagonal	2	100	Crack to sandstone block emanating from possible metal insert

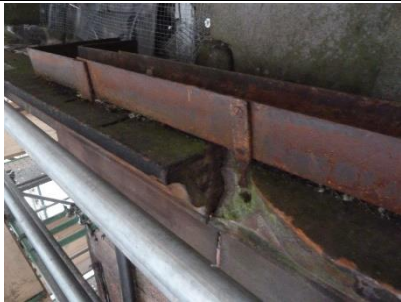
Defect ID	Photo Source	Defect Description	Defect Location	Crack Orientation	Crack Width (mm)	Crack Length (mm)	Comments	Photo	Severity Category
E1.93	P1200312	Spalled/damaged sandstone	Sandstone ledge feature	n/a	n/a	n/a	Cracked/broken off sandstone to sandstone ledge feature

Red
E1.94	Not used	Not used	Not used	Not used	Not used	Not used	Not used	Not used	Not used
E1.95	P1200322	Spalled/damaged sandstone	Sandstone ledge feature	n/a	n/a	n/a	Cracked/broken off sandstone to sandstone ledge feature

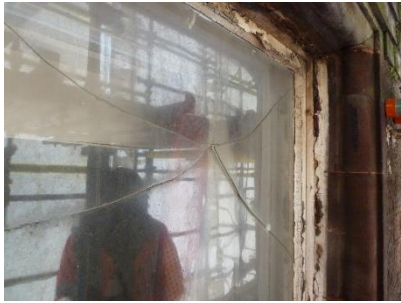
Defect ID	Photo Source	Defect Description	Defect Location	Crack Orientation	Crack Width (mm)	Crack Length (mm)	Comments	Photo	Severity Category
E1.101	P1200328	Other	Window	n/a	n/a	n/a	Crack to window pane

Amber
E1.102	P1200329	Other	Window	n/a	n/a	n/a	Deterioration of timber framing to windows - Common defect visible in majority of windows

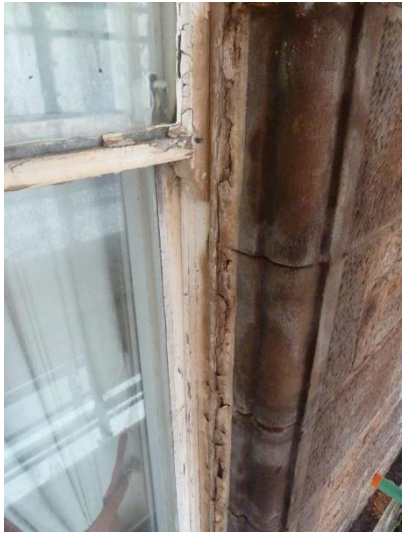
Defect ID	Photo Source	Defect Description	Defect Location	Crack Orientation	Crack Width (mm)	Crack Length (mm)	Comments	Photo	Severity Category
E1.105	P1200332	Other	Window	n/a	n/a	n/a	Deterioration of timber framing to windows - Common defect visible in majority of windows

Green
E1.106	P1200333	Other	Window	n/a	n/a	n/a	Missing window pane

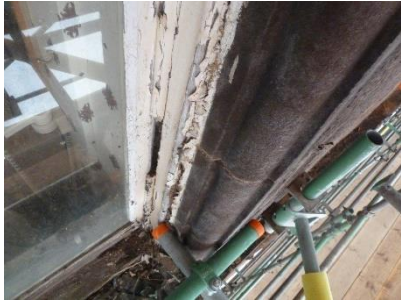
Defect ID	Photo Source	Defect Description	Defect Location	Crack Orientation	Crack Width (mm)	Crack Length (mm)	Comments	Photo	Severity Category
E1.107	P1200334	Cracking to sandstone	Lintel	Diagonal	6	100	Crack to window lintel	 	Amber
E1.108	P1200335	Other	Window	n/a	n/a	n/a	Deterioration of timber framing to windows - Common defect visible in majority of windows

Green
E1.109	P1200336	Water staining efflorescence	Wall	n/a	n/a	n/a	Water staining to building face

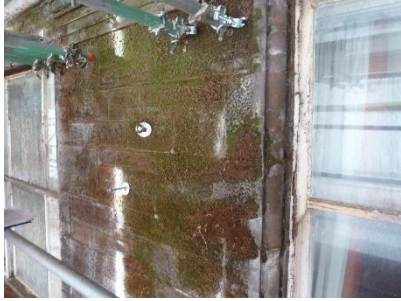
Defect ID	Photo Source	Defect Description	Defect Location	Crack Orientation	Crack Width (mm)	Crack Length (mm)	Comments	Photo	Severity Category
E1.110	P1200337	Damaged/defective gutter/drainage	Gutter	n/a	n/a	n/a	Missing gutter fixing	 	Amber
E1.111	P1200338	Spalled/damaged sandstone	Lintel	n/a	n/a	n/a	Delamination/erosion of sandstone to underside of window lintel	 	Green
E1.112	P1200339	Water staining efflorescence	Sandstone	n/a	n/a	n/a	Water staining to building face

Green

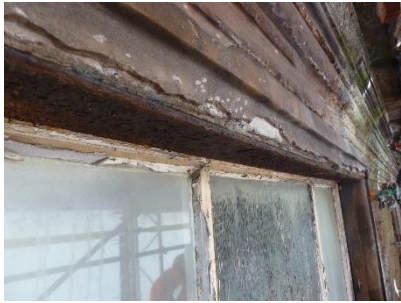
Defect ID	Photo Source	Defect Description	Defect Location	Crack Orientation	Crack Width (mm)	Crack Length (mm)	Comments	Photo	Severity Category
E1.113	P1200341, 342	Other	Lintel	n/a	n/a	n/a	Corroded steel lintel

Green
E1.114	P1200343	Spalled/damaged sandstone	Lintel	n/a	n/a	n/a	Sections of sandstone appear to have cracked/broken off the window lintel

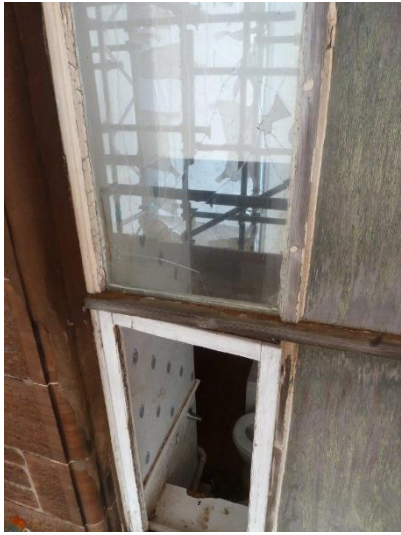
Defect ID	Photo Source	Defect Description	Defect Location	Crack Orientation	Crack Width (mm)	Crack Length (mm)	Comments	Photo	Severity Category
E1.115	P1200344	Other	Window	n/a	n/a	n/a	Crack to window pane

Green
E1.116	P1200345	Spalled/damaged sandstone	Window	n/a	n/a	n/a	Cracked/broken off sandstone

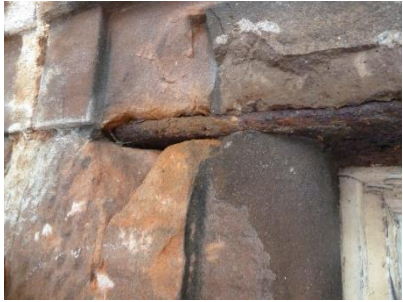
Defect ID	Photo Source	Defect Description	Defect Location	Crack Orientation	Crack Width (mm)	Crack Length (mm)	Comments	Photo	Severity Category
E1.117	P1200347	Cracking to sandstone	Window	Diagonal	2	50	Cracked/broken off sandstone at bearing location of steel lintel, which is exhibiting surface corrosion

Amber
E1.118	P1200348	Cracking to sandstone	Wall	Vertical	1	400	Cracked sandstone block

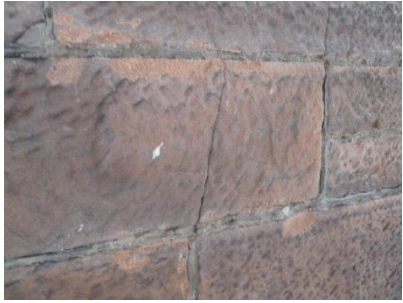
Green
E1.119	P1200349	Cracking to sandstone	Wall	Diagonal	2	75	Cracked sandstone block

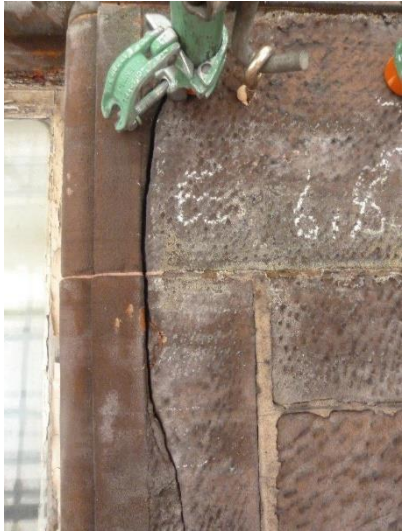
Defect ID	Photo Source	Defect Description	Defect Location	Crack Orientation	Crack Width (mm)	Crack Length (mm)	Comments	Photo	Severity Category
E1.120	P1200350	Cracking to sandstone	Window	Vertical	8	500	Crack to sandstone blocks at vertical window surround

Amber
E1.121	P1200351	Other	Window	n/a	n/a	n/a	Deterioration of timber framing to windows - Common defect visible in majority of window frames

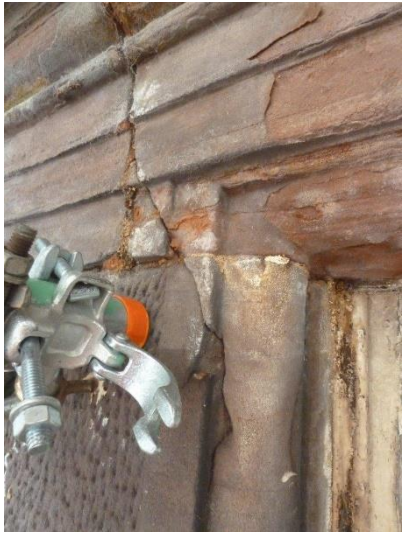
Defect ID	Photo Source	Defect Description	Defect Location	Crack Orientation	Crack Width (mm)	Crack Length (mm)	Comments	Photo	Severity Category
E1.122	P1200352	Cracking to sandstone	Window	Diagonal	3	200	Crack to sandstone window vertical framing

Amber
E1.123	P1200353	Water staining efflorescence	Wall	n/a	n/a	n/a	Water staining to building face

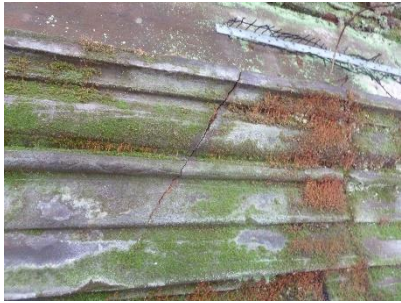
Defect ID	Photo Source	Defect Description	Defect Location	Crack Orientation	Crack Width (mm)	Crack Length (mm)	Comments	Photo	Severity Category
E1.124	P1200354	Cracking to sandstone	Lintel	Diagonal	2	200	Crack to lintel, likely due to lost lintel support (see below E1.125)

Green
E1.125	P1200355-357	Spalled/damaged sandstone	Wall	n/a	n/a	n/a	Cracked/broken off sandstone to vertical window framing/support to lintel. Evidence of lintel movement. Danger of lintel failure if left untreated

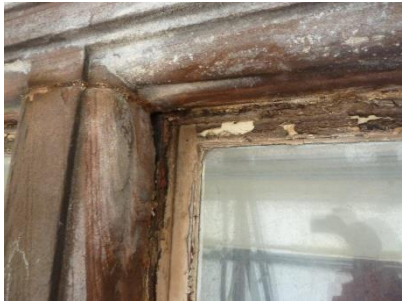
Defect ID	Photo Source	Defect Description	Defect Location	Crack Orientation	Crack Width (mm)	Crack Length (mm)	Comments	Photo	Severity Category
E1.128	P1200361	Other	Window	n/a	n/a	n/a	Deterioration of timber framing to windows - Common defect visible in majority of windows

Green
E1.129	P1200362	Cracking to sandstone	Wall	Diagonal	1	100	Crack in sandstone to window frame

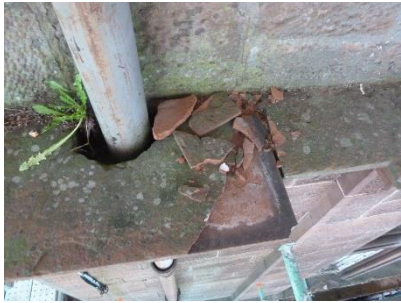
Defect ID	Photo Source	Defect Description	Defect Location	Crack Orientation	Crack Width (mm)	Crack Length (mm)	Comments	Photo	Severity Category
E1.133	P1200366	Spalled/damaged sandstone	Wall	n/a	n/a	n/a	Cracked/broken off sandstone to ledge feature

Green
E1.134	P1200367	Cracking to sandstone	Wall	Diagonal	3	200	Cracked sandstone to cill

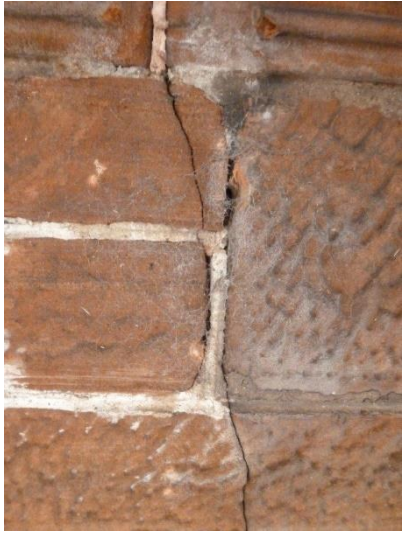
Defect ID	Photo Source	Defect Description	Defect Location	Crack Orientation	Crack Width (mm)	Crack Length (mm)	Comments	Photo	Severity Category
E1.137	P1200372	Cracking to sandstone	Wall	Vertical	1	1000	Crack to sandstone block adjacent to window

Amber
E1.138	P1200373	Spalled/damaged sandstone	Wall	n/a	n/a	n/a	Cracked/broken off sandstone to underside of ledge feature

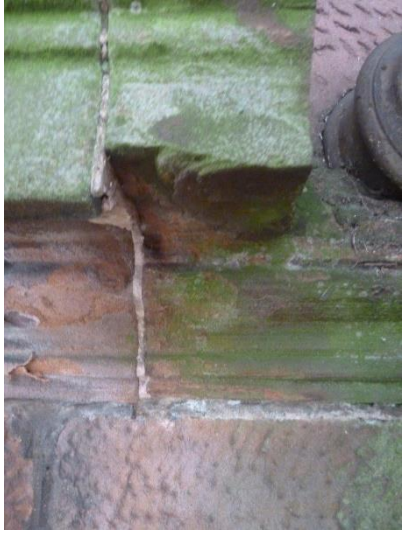
Green

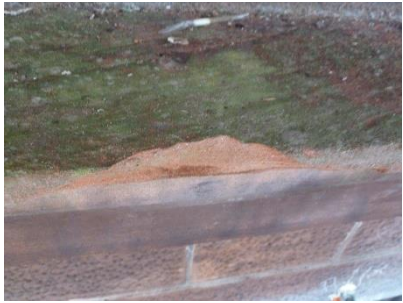
Defect ID	Photo Source	Defect Description	Defect Location	Crack Orientation	Crack Width (mm)	Crack Length (mm)	Comments	Photo	Severity Category
E1.139	P1200375	Spalled/damaged sandstone	Wall	n/a	n/a	n/a	Cracked/broken off sandstone to top of sandstone ledge feature

Green
E1.140	P1200376	Spalled/damaged sandstone	Wall	n/a	n/a	n/a	Delamination/erosion of sandstone to gutter framing – Common defect throughout

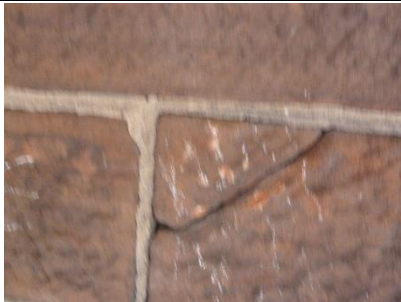
Defect ID	Photo Source	Defect Description	Defect Location	Crack Orientation	Crack Width (mm)	Crack Length (mm)	Comments	Photo	Severity Category
E1.147	P1200389	Cracking to sandstone	Wall	Diagonal	1	100	Crack to corner of sandstone block

Green
E1.148	P1200390	Other	Wall	n/a	n/a	n/a	Corroded downpipe

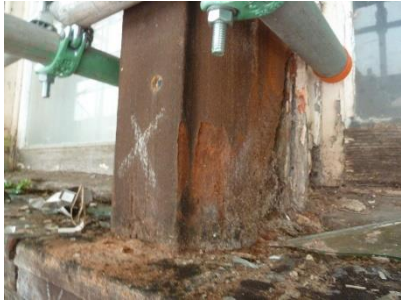
Defect ID	Photo Source	Defect Description	Defect Location	Crack Orientation	Crack Width (mm)	Crack Length (mm)	Comments	Photo	Severity Category
E1.152	P1200394	Cracking to sandstone	Wall	Vertical	5	100	Crack to sandstone cill	 	Amber
E1.153	P1200395	Spalled/damaged sandstone	Window mullion	n/a	n/a	n/a	Delamination/erosion of sandstone to mullion

Green
E1.154	P1200396	Cracking to sandstone	Wall	Diagonal	1	100	Crack to sandstone block	 	Green

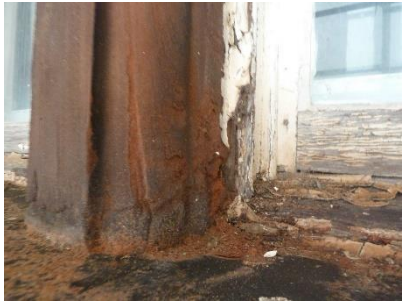
Defect ID	Photo Source	Defect Description	Defect Location	Crack Orientation	Crack Width (mm)	Crack Length (mm)	Comments	Photo	Severity Category
E1.155	P1200397	Spalled/damaged sandstone	Window mullion	n/a	n/a	n/a	Delamination/erosion of sandstone to mullion

Green
E1.156	P1200398	Water staining efflorescence	Wall	n/a	n/a	n/a	Water staining to building face

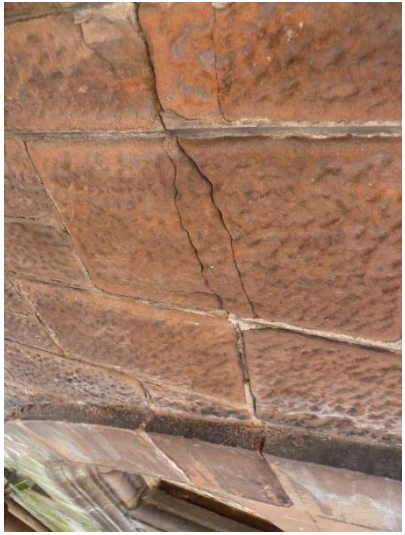
Defect ID	Photo Source	Defect Description	Defect Location	Crack Orientation	Crack Width (mm)	Crack Length (mm)	Comments	Photo	Severity Category
E1.157	P1200399-404	Cracking to sandstone	Wall	Vertical	10	3000	Large crack running vertically between window frames

Amber
E1.158	P1200405	Spalled/damaged sandstone	Window mullion	n/a	n/a	n/a	Delamination/erosion of sandstone to mullion	 	Green

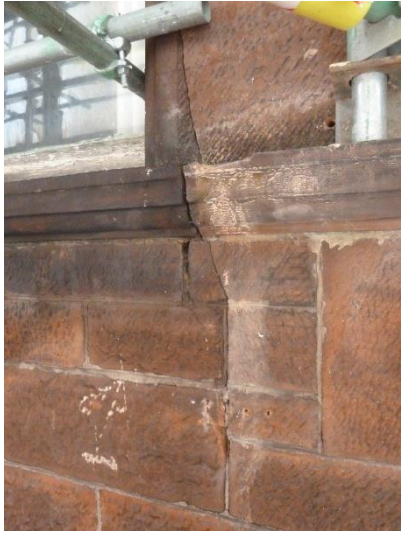
Defect ID	Photo Source	Defect Description	Defect Location	Crack Orientation	Crack Width (mm)	Crack Length (mm)	Comments	Photo	Severity Category
E1.162	P1200409-411	Cracking to sandstone	Window	Vertical	2	500	Crack to sandstone to side of window framing, crack extends below cill level

Amber
E1.163	P1200412-413	Cracking to sandstone	Wall	Vertical	1	1000	Crack to sandstone block. Crack appears to emanate from metal/anchor insert

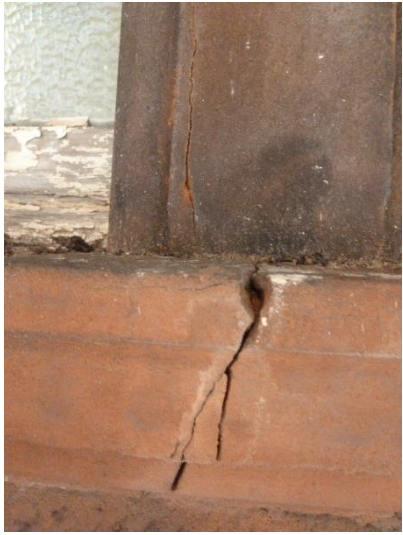
Defect ID	Photo Source	Defect Description	Defect Location	Crack Orientation	Crack Width (mm)	Crack Length (mm)	Comments	Photo	Severity Category
E1.164	P1200416	Cracking to sandstone	Sandstone	Diagonal	5	100	Crack to sandstone block at cill

Amber
E1.165	P1200417	Spalled/damaged sandstone	Sandstone ledge feature	n/a	n/a	n/a	Cracked/broken off sandstone to underside of ledge feature

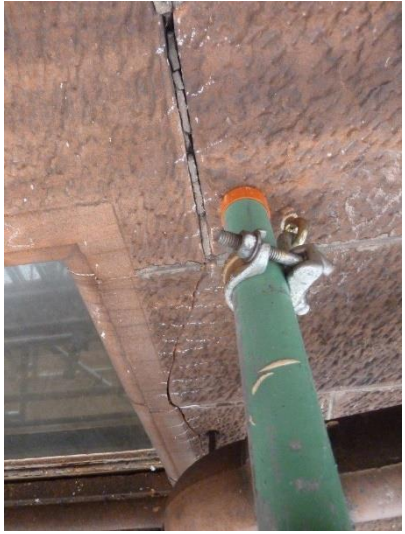
Defect ID	Photo Source	Defect Description	Defect Location	Crack Orientation	Crack Width (mm)	Crack Length (mm)	Comments	Photo	Severity Category
E1.166	P1200418-419	Cracking to sandstone	Sandstone	Vertical	1-3	1000	Crack spans vertically from sandstone ledge feature above to side of window framing. Crack travels through mortar joint and blocks. Deterioration of mortar joint noted

Amber
E1.167	P1200422	Other	Downpipe	n/a	n/a	n/a	Crack to downpipe

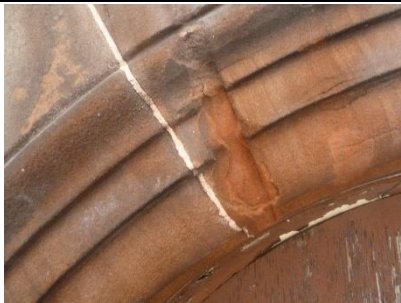
Defect ID	Photo Source	Defect Description	Defect Location	Crack Orientation	Crack Width (mm)	Crack Length (mm)	Comments	Photo	Severity Category
E1.173	P1200441	Spalled/damaged sandstone	Arch	n/a	n/a	n/a	Spalled/delamination/erosion of sandstone to arch

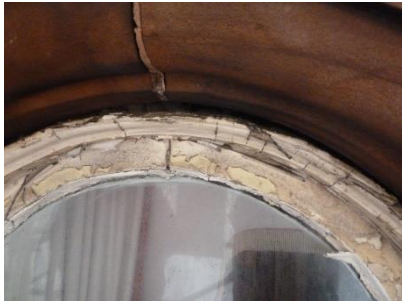
Defect ID	Photo Source	Defect Description	Defect Location	Crack Orientation	Crack Width (mm)	Crack Length (mm)	Comments	Photo	Severity Category
E1.175	P1200443	Other	Window	n/a	n/a	n/a	Timber window frame debonding from sandstone surround and showing signs of deterioration

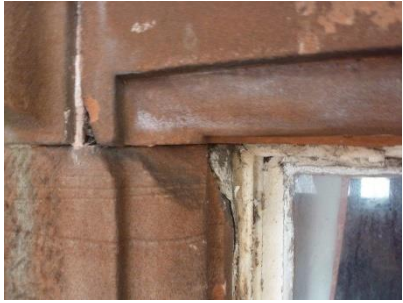
Amber
E1.176	P1200445	Spalled/damaged sandstone	Window	n/a	n/a	n/a	Delamination/erosion of sandstone to vertical window frame

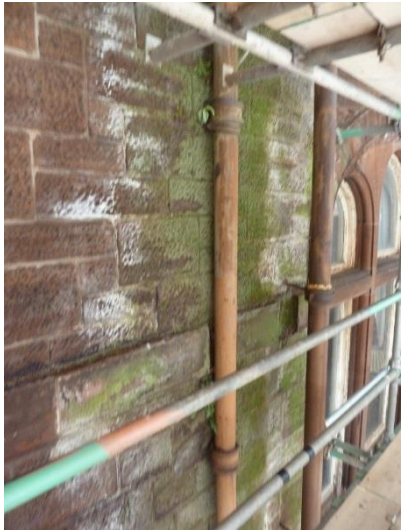
Defect ID	Photo Source	Defect Description	Defect Location	Crack Orientation	Crack Width (mm)	Crack Length (mm)	Comments	Photo	Severity Category
E1.177	P1200444	Other	Wall	n/a	n/a	n/a	Water staining to building face

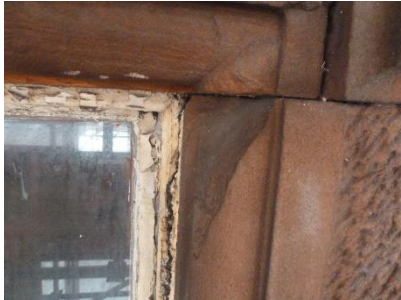
Green
E1.178	P1200446	Spalled/damaged sandstone	Window	n/a	n/a	n/a	Cracked/broken off sandstone to vertical window frame

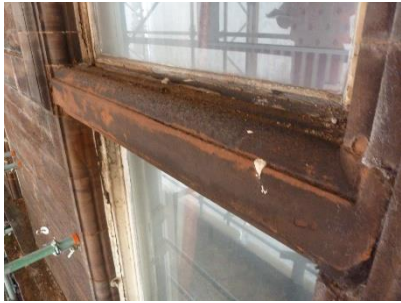
Defect ID	Photo Source	Defect Description	Defect Location	Crack Orientation	Crack Width (mm)	Crack Length (mm)	Comments	Photo	Severity Category
E1.181	P1200449-451	Spalled/damaged sandstone	Window	n/a	n/a	n/a	Delamination/erosion of sandstone to window transom

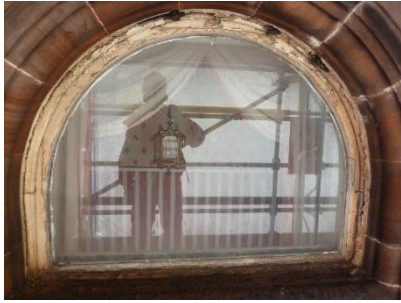
Amber
E1.182	P1200452	Other	Window	n/a	n/a	n/a	Deterioration of timber framing to arch window

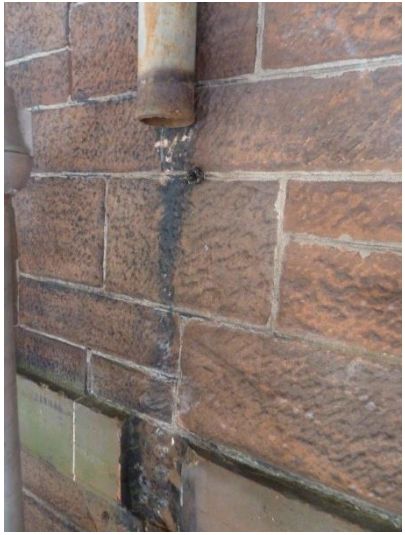
Defect ID	Photo Source	Defect Description	Defect Location	Crack Orientation	Crack Width (mm)	Crack Length (mm)	Comments	Photo	Severity Category
E1.183	P1200454-455	Damaged/defective gutter/drainage	Downpipe	n/a	n/a	n/a	Missing downpipe
