Former Ayr Station Hotel Building Structural Condition

Independent Report

03 October 2019

Document reference: 399316/SNI/GLA/DOC/S2/REP/002

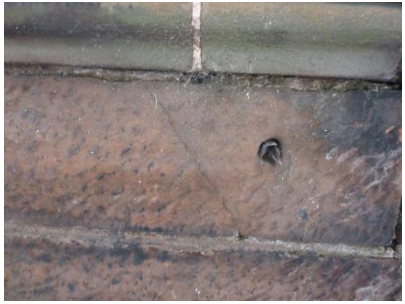
Red
E1.184	P1200456	Cracking to sandstone	Wall	Diagonal	1	300	Crack to sandstone block

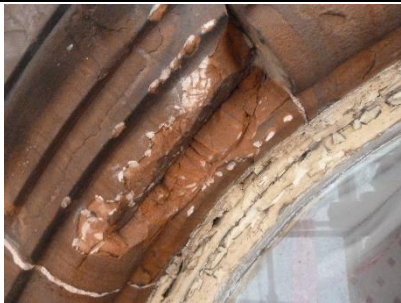
Defect ID	Photo Source	Defect Description	Defect Location	Crack Orientation	Crack Width (mm)	Crack Length (mm)	Comments	Photo	Severity Category
E1.185	P1200457-458	Spalled/damaged sandstone	Arch lintel	n/a	n/a	n/a	Cracked/broken off sandstone to arch lintel

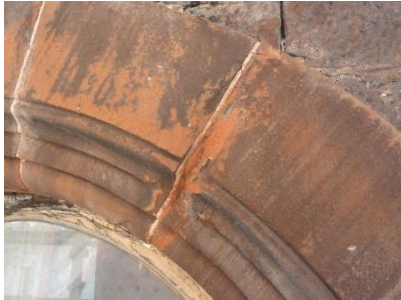
Amber
E1.186	P1200459-460	Spalled/damaged sandstone	Arch lintel	n/a	n/a	n/a	Delamination/erosion of/cracked/broken off sandstone to arch lintel

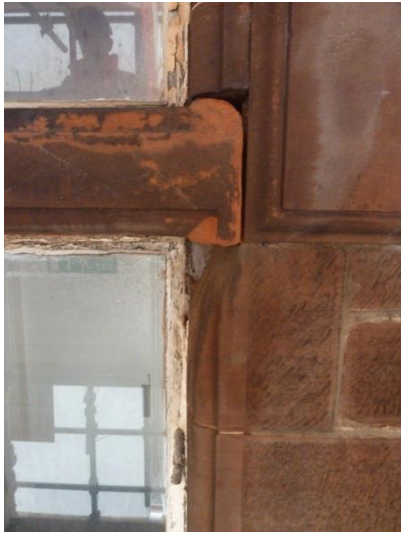
Defect ID	Photo Source	Defect Description	Defect Location	Crack Orientation	Crack Width (mm)	Crack Length (mm)	Comments	Photo	Severity Category
E1.187	P1200461-464	Spalled/damaged sandstone	Window	n/a	n/a	n/a	Delamination/erosion of sandstone to window transom. Evidence of movement to transom, risk of failure

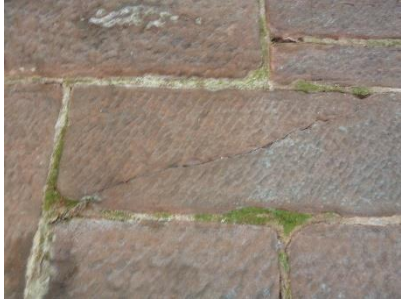
Red
E1.188	P1200465, 466	Cracking to sandstone	Wall	Diagonal	1	400	Crack to sandstone block adjacent arch lintel

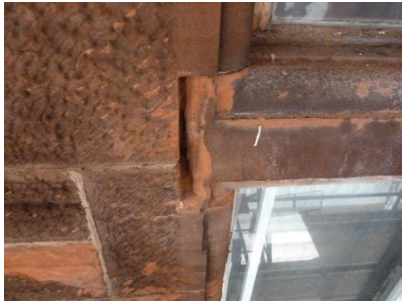
Defect ID	Photo Source	Defect Description	Defect Location	Crack Orientation	Crack Width (mm)	Crack Length (mm)	Comments	Photo	Severity Category
E1.189	P1200468	Spalled/damaged sandstone	Window	n/a	n/a	n/a	Delamination/erosion of/cracked/broken off sandstone to window transom. Visible gap/loss of mortar between transom and vertical frame, risk of movement to transom

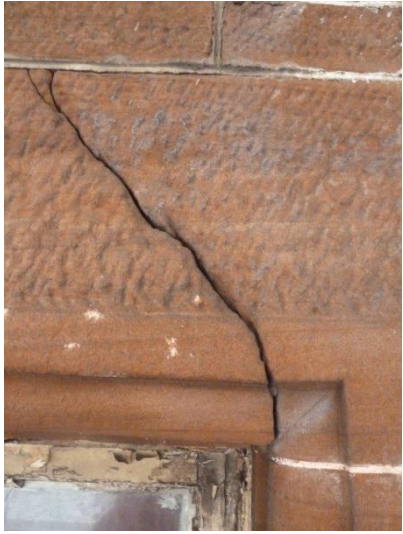
Red
E1.190	P1200469	Cracking to sandstone	Window	Diagonal	5	200	Crack to sandstone window lintel

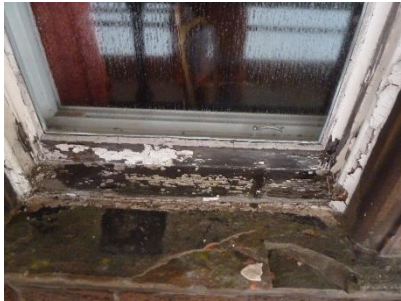
Defect ID	Photo Source	Defect Description	Defect Location	Crack Orientation	Crack Width (mm)	Crack Length (mm)	Comments	Photo	Severity Category
E1.194	P1200478	Other	Window	n/a	n/a	n/a	Deterioration of timber framing to windows - Common defect visible in majority of window frames

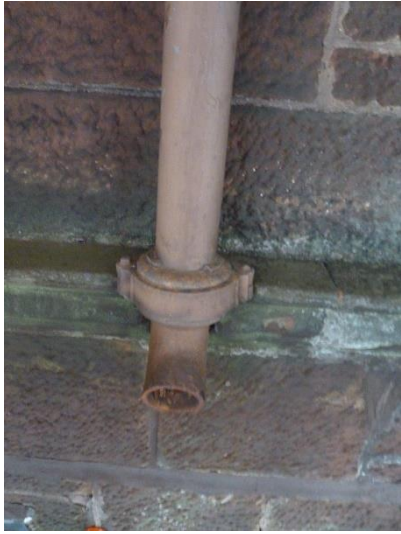
Green
E1.195	P1200479-480	Damaged/defective gutter/drainage	Downpipe	n/a	n/a	n/a	Missing downpipe section

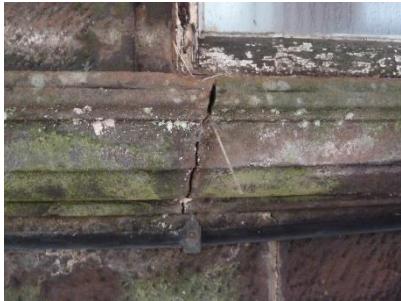
Defect ID	Photo Source	Defect Description	Defect Location	Crack Orientation	Crack Width (mm)	Crack Length (mm)	Comments	Photo	Severity Category
E1.199	P1200485-486	Cracking to sandstone	Window	Vertical	1	200	Crack to sandstone at window cill

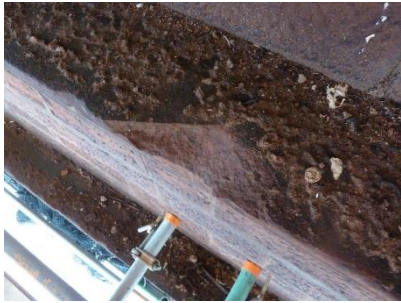
Defect ID	Photo Source	Defect Description	Defect Location	Crack Orientation	Crack Width (mm)	Crack Length (mm)	Comments	Photo	Severity Category
E1.205	P1200496	Spalled/damaged sandstone	Sandstone ledge feature	n/a	n/a	n/a	Cracked/broken off sandstone to sandstone ledge feature

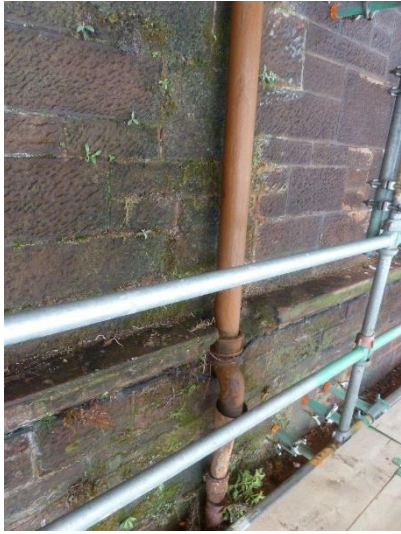
Green
E1.206	P1200497	Damaged/defective gutter/drainage	Downpipe	n/a	n/a	n/a	Defective downpipe

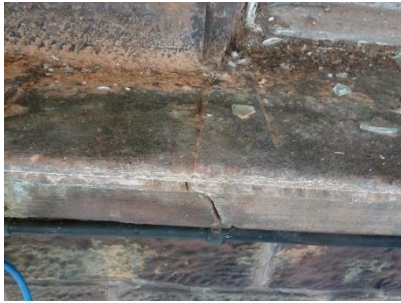
Defect ID	Photo Source	Defect Description	Defect Location	Crack Orientation	Crack Width (mm)	Crack Length (mm)	Comments	Photo	Severity Category
E1.207	P1200498	Cracking to sandstone	Window	Vertical	2	100	Crack to sandstone at window cill ledge

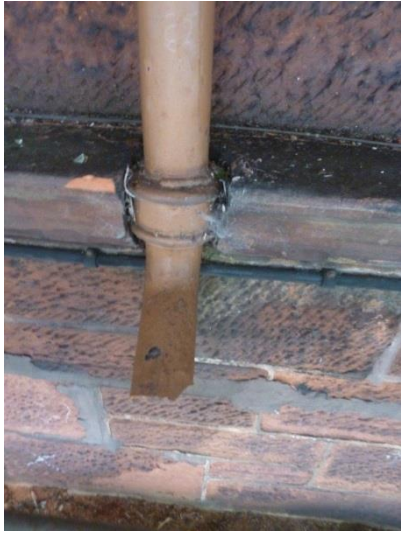
Green
E1.208	P1200499	Damaged/defective gutter/drainage	Downpipe	n/a	n/a	n/a	Missing downpipe section

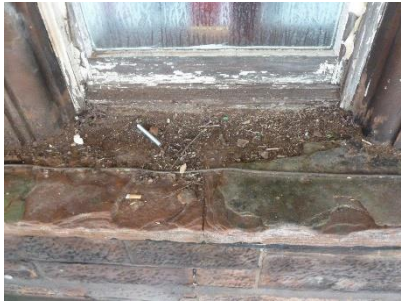
Defect ID	Photo Source	Defect Description	Defect Location	Crack Orientation	Crack Width (mm)	Crack Length (mm)	Comments	Photo	Severity Category
E1.211	P1200502	Spalled/damaged sandstone	Cill	n/a	n/a	n/a	Delamination/erosion of sandstone to window cill

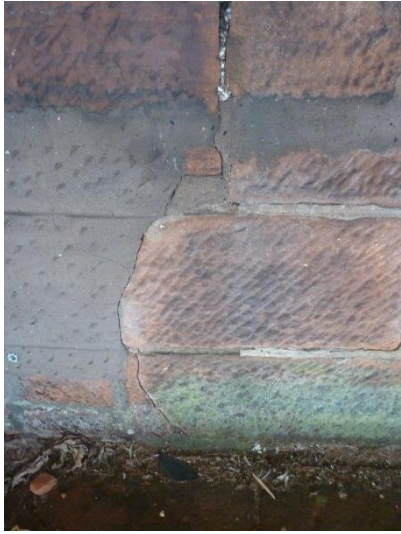
Amber
E1.212	P1200503	Cracking to sandstone	Wall	Vertical	1	450	Crack to sandstone block

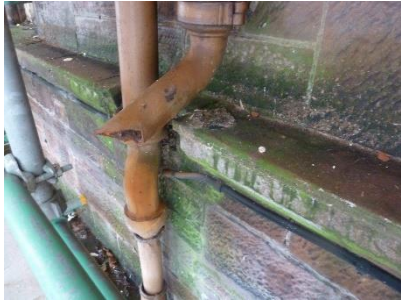
Defect ID	Photo Source	Defect Description	Defect Location	Crack Orientation	Crack Width (mm)	Crack Length (mm)	Comments	Photo	Severity Category
E1.213	P1200504	Damaged/defective gutter/drainage	Downpipe	n/a	n/a	n/a	Missing downpipe section

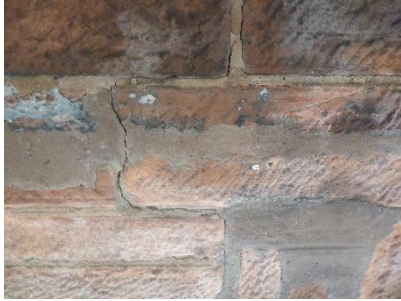
Red
E1.214	P1200505	Cracking to sandstone	Wall	Vertical	1	300	Crack to sandstone block

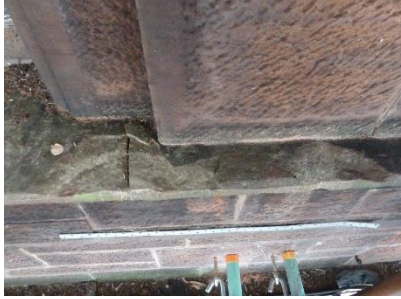
Amber
E1.215	P1200506	Spalled/damaged sandstone	Cill	n/a	n/a	n/a	Delamination/erosion of sandstone to window cill

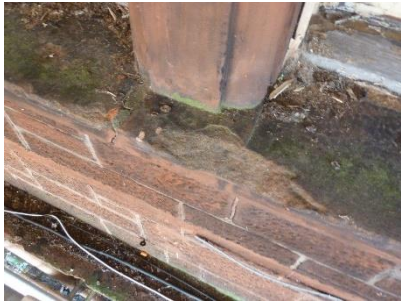
Defect ID	Photo Source	Defect Description	Defect Location	Crack Orientation	Crack Width (mm)	Crack Length (mm)	Comments	Photo	Severity Category
E1.216	P1200507	Spalled/damaged sandstone	Cill	n/a	n/a	n/a	Delamination/erosion of sandstone to window cill

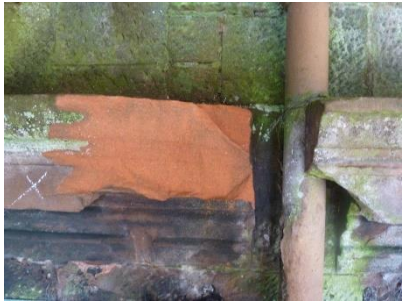
Defect ID	Photo Source	Defect Description	Defect Location	Crack Orientation	Crack Width (mm)	Crack Length (mm)	Comments	Photo	Severity Category
E1.218	P1200509	Spalled/damaged sandstone	Sandstone ledge feature	n/a	n/a	n/a	Cracked/broken off sandstone to ledge feature adjacent downpipe

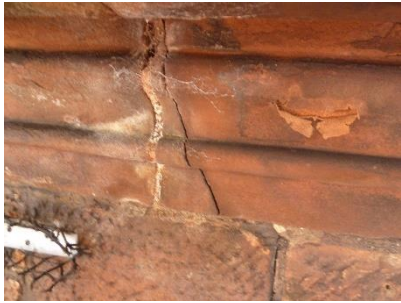
Defect ID	Photo Source	Defect Description	Defect Location	Crack Orientation	Crack Width (mm)	Crack Length (mm)	Comments	Photo	Severity Category
E1.224	P1200519	Cracking to sandstone	Sandstone ledge feature	Vertical	1	150	Crack to sandstone ledge feature. Delamination of sandstone also noted

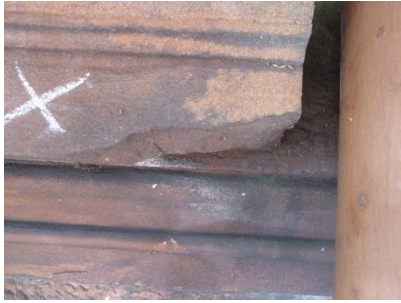
Amber
E1.225	P1200520	Spalled/damaged sandstone	Sandstone ledge feature	n/a	n/a	n/a	Cracked/broken off sandstone to underside of ledge feature adjacent to downpipe

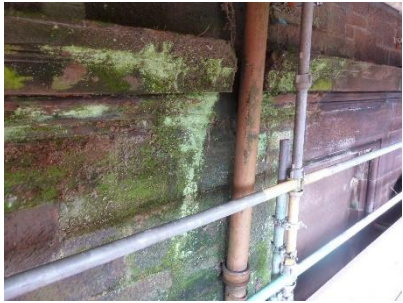
Defect ID	Photo Source	Defect Description	Defect Location	Crack Orientation	Crack Width (mm)	Crack Length (mm)	Comments	Photo	Severity Category
E1.228	P1200524	Water staining efflorescence	Wall	n/a	n/a	n/a	Water staining and vegetation growth/staining to building face

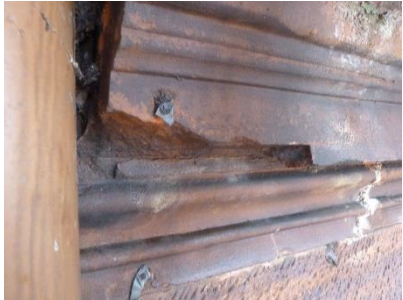
Green
E1.229	P1200525	Spalled/damaged sandstone	Downpipe	n/a	n/a	n/a	Cracked/broken off sandstone to underside of sandstone ledge feature adjacent downpipe

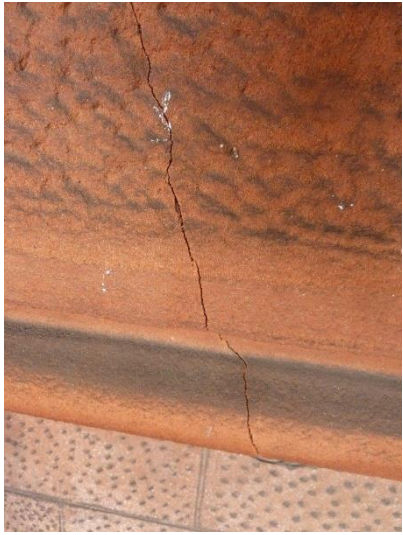
Defect ID	Photo Source	Defect Description	Defect Location	Crack Orientation	Crack Width (mm)	Crack Length (mm)	Comments	Photo	Severity Category
E1.234	P1200531	Cracking to sandstone	Lintel	Vertical	1	300	Crack to sandstone at window lintel

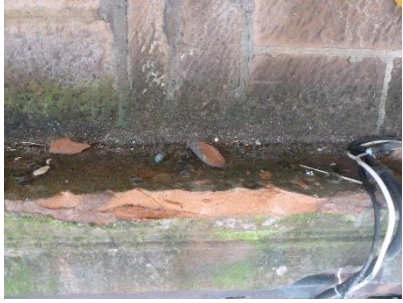
Amber
E1.235	P1200532	Spalled/damaged sandstone	Sandstone ledge feature	n/a	n/a	n/a	Cracked/broken off sandstone to sandstone ledge feature

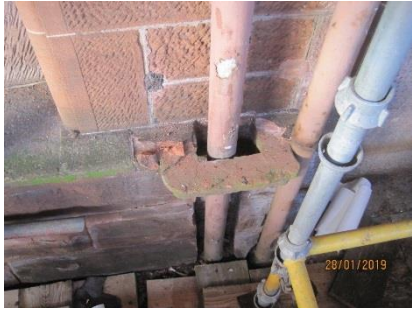
Defect ID	Photo Source	Defect Description	Defect Location	Crack Orientation	Crack Width (mm)	Crack Length (mm)	Comments	Photo	Severity Category
E1.251	P1200899	Spalled/damaged sandstone	Downpipe	n/a	n/a	n/a	Delamination/erosion of/cracked/broken off sandstone at downpipe

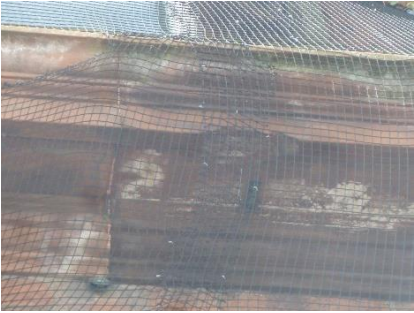
Defect ID	Photo Source	Defect Description	Defect Location	Crack Orientation	Crack Width (mm)	Crack Length (mm)	Comments	Photo	Severity Category
E2.1	P1190455	Spalled/damaged sandstone	Elevation E2, Wall	n/a	n/a	n/a	General defect to East and North elevations – minor delamination/erosion of/cracked/broken off sandstone to sandstone faces, generally to ledge features and other sandstone features

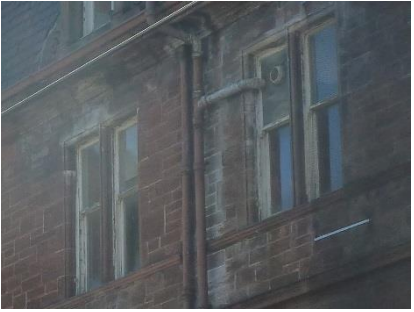
Amber
E2.2	P1190455	Water staining efflorescence	Elevation E2, Wall	n/a	n/a	n/a	General defect to East and North elevations – water staining/efflorescence to sandstone faces

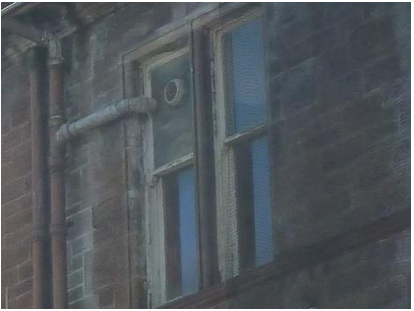
Green
E2.3	P1190455	Other	Elevation E2, Wall	n/a	n/a	n/a	General defect to East and North elevations - deteriorated timber framing to windows

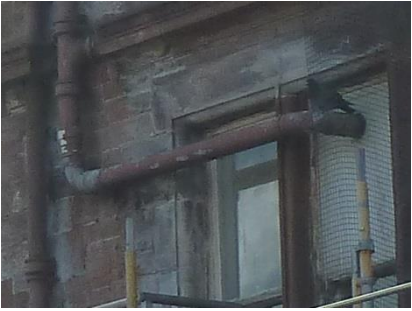
Defect ID	Photo Source	Defect Description	Defect Location	Crack Orientation	Crack Width (mm)	Crack Length (mm)	Comments	Photo	Severity Category
E2.4	P1190455	Damaged/defective gutter/drainage	Elevation E2, Wall	n/a	n/a	n/a	General defect to East and North elevations - gutters/downpipes showing signs of degradation/corrosion

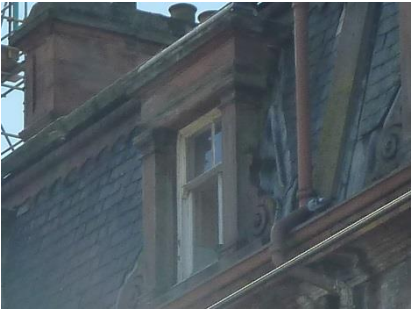
Red
E2.5	P1190456	Other	Elevation E2, Wall	n/a	n/a	n/a	General defect to East and North elevations - weathered flashing

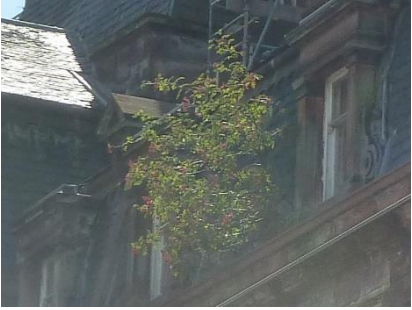
Red
E2.6	P1190456	Vegetation growth	Elevation E2, Wall	n/a	n/a	n/a	General defect to East and North elevations – vegetation growth to building elevation

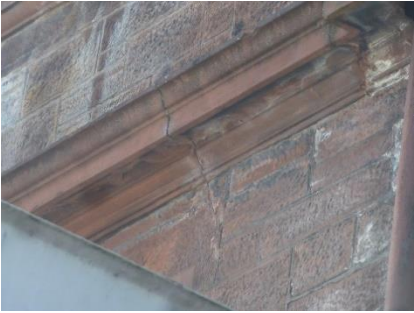
Defect ID	Photo Source	Defect Description	Defect Location	Crack Orientation	Crack Width (mm)	Crack Length (mm)	Comments	Photo	Severity Category
E2.7	P1190448	Cracking to sandstone	Elevation E2, Wall	Vertical	2	300	-

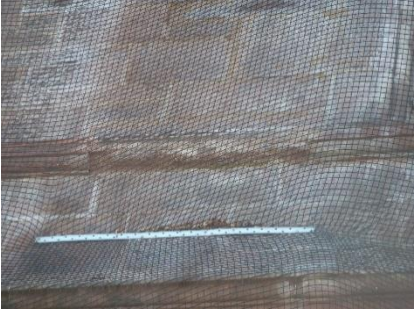
Red
E2.8	P1190447	Spalled/damaged sandstone	Elevation E2, Wall	n/a	n/a	n/a	Cracked/broken off sandstone to sandstone ledge feature section face

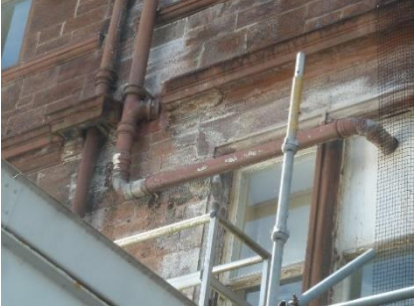
Amber
E2.9	P1190446	Spalled/damaged sandstone	Elevation E2, Wall	n/a	n/a	n/a	Cracked/broken off sandstone to sandstone ledge feature section edge

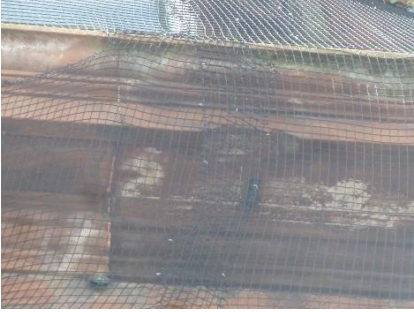
Defect ID	Photo Source	Defect Description	Defect Location	Crack Orientation	Crack Width (mm)	Crack Length (mm)	Comments	Photo	Severity Category
E2.10	P1190450	Missing/damaged tiles/roof	Elevation E2, Wall	n/a	n/a	n/a	Displaced slates to tower roof, sides & vertical face	 	Red
E2.11	P1190444	Spalled/damaged sandstone	Elevation E2, Wall	n/a	n/a	n/a	Cracked/broken off sandstone to underside of Sandstone ledge feature

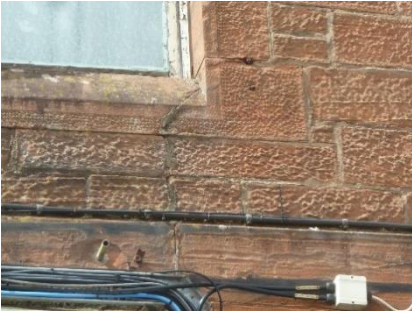
Defect ID	Photo Source	Defect Description	Defect Location	Crack Orientation	Crack Width (mm)	Crack Length (mm)	Comments	Photo	Severity Category
E2.13	P1190442	Cracking to sandstone	Elevation E2, Wall	Vertical	2	500	Crack to sandstone block, appears to have been repaired at some point in past

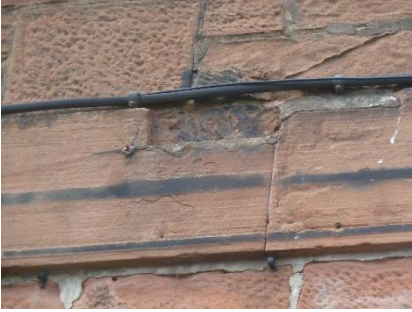
Amber
E2.14	P1190460	Spalled/damaged sandstone	Elevation E2, Wall	n/a	n/a	n/a	Delamination/cracked/broken off sandstone to face of block

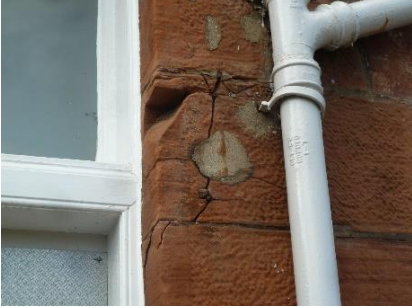
Amber
E2.15	P1190459	Spalled/damaged sandstone	Elevation E2, Wall	n/a	n/a	n/a	Cracked/broken off sandstone to side of door frame. appears to have been exacerbated by sandstone fixings

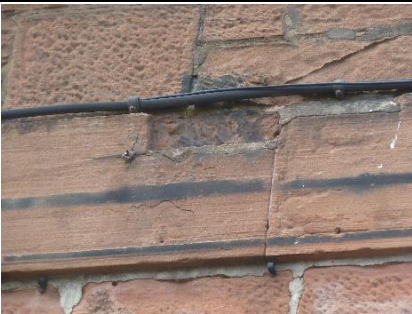
Defect ID	Photo Source	Defect Description	Defect Location	Crack Orientation	Crack Width (mm)	Crack Length (mm)	Comments	Photo	Severity Category
E2.16	P1190460	Spalled/damaged sandstone	Elevation E2, Wall	n/a	n/a	n/a	Cracked sandstone & vertical through render

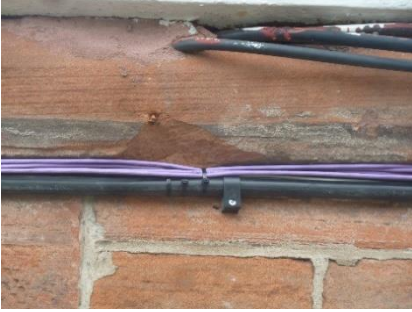
Green
E2.17	P1190461	Spalled/damaged sandstone	Elevation E2, Wall	n/a	n/a	n/a	-

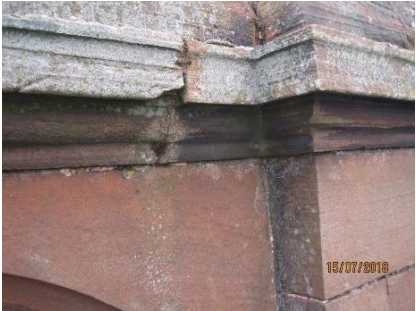
Defect ID	Photo Source	Defect Description	Defect Location	Crack Orientation	Crack Width (mm)	Crack Length (mm)	Comments	Photo	Severity Category
S1.7	IMG_9573	Fractured, detached sandstone element of block	Above featured arched aperture, at Chimney Top.	n/a	n/a	n/a	-

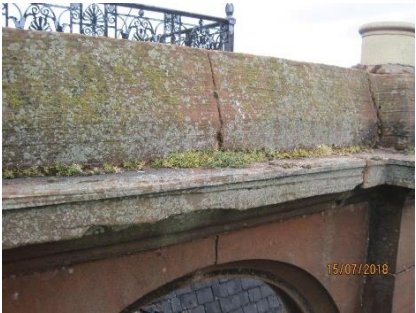
Amber
S1.8	IMG_9574, IMG_9575	Vegetation growth	On top of promontory stone, at Chimney Top.	n/a	n/a	n/a	Vegetation growth all over promontory stone at U/S of chimney pots.

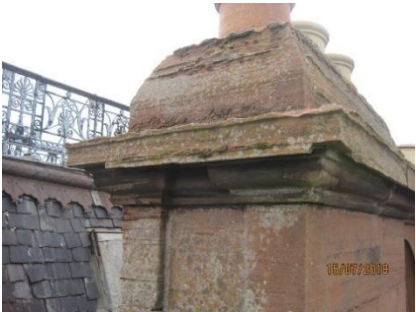
Green
S1.9	IMG_9576-IMG_9578	Fractured, detached element of sandstone block.	Drip check feature to U/S of capping stone, at Chimney Top.	n/a	n/a	n/a	-

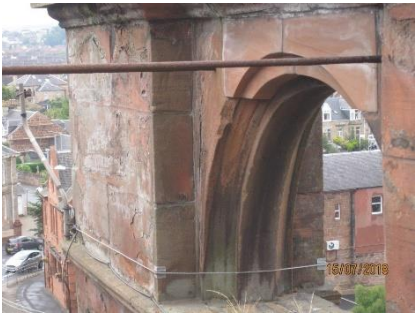
Defect ID	Photo Source	Defect Description	Defect Location	Crack Orientation	Crack Width (mm)	Crack Length (mm)	Comments	Photo	Severity Category
S1.10	IMG_9579	Fractured, detached element of sandstone block.	On the edge of arched feature, at Chimney Top (rear face).	n/a	n/a	n/a	-	 	Green
S1.11	IMG_9579	In general, to the rear face, surface layer peeling and detaching.	On the edge of arched feature, at Chimney Top (rear face).	n/a	n/a	n/a	-

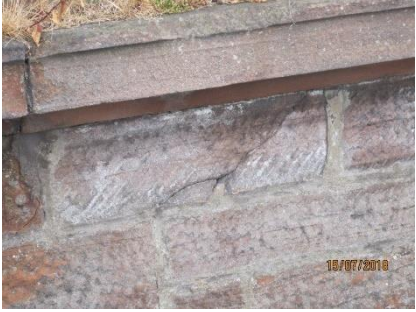
Defect ID	Photo Source	Defect Description	Defect Location	Crack Orientation	Crack Width (mm)	Crack Length (mm)	Comments	Photo	Severity Category
S1.19	IMG_9591	Fractured, detached element of sandstone block.	RHS of triangular feature panel adjacent RWP, at Upper Eaves Level.	n/a	n/a	n/a	-	 	Amber
S1.20	IMG_9594- IMG_9595	Fractured and cracked sandstone	RHS Chimney wall below curved capping stone.	Diagonal	1-3	400	-

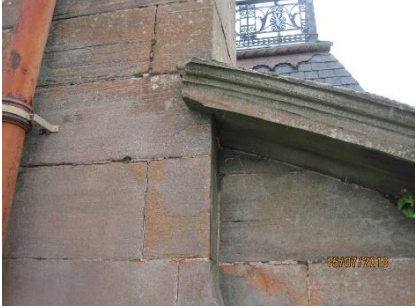
Amber
S1.21	IMG_9595	Fractured, detached element of sandstone block.	RHS arched capping stone, above Upper Eaves Level.	n/a	n/a	n/a	-

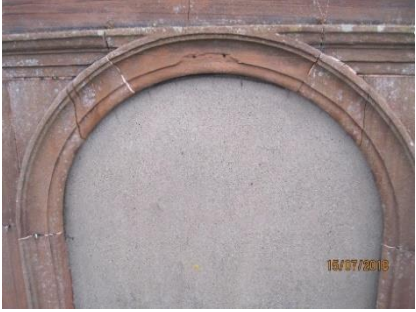
Defect ID	Photo Source	Defect Description	Defect Location	Crack Orientation	Crack Width (mm)	Crack Length (mm)	Comments	Photo	Severity Category
S1.32	IMG_9609- IMG_9610	3no. Cracks	LHS insert to lintel, below Upper Eaves Level.	Radial	<1-3	75-150	Cracks propagating from cast/ wrought iron insert	 	Amber
S1.33	IMG_9611- IMG_9614	Crack	LHS to arch, below Upper Eaves Level.	Vertical	3-5	200	-

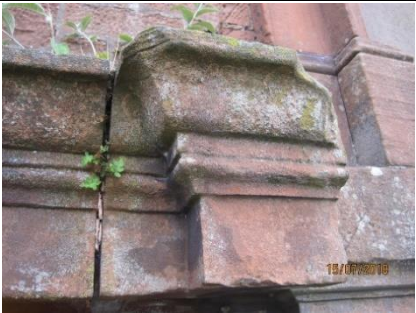
Defect ID	Photo Source	Defect Description	Defect Location	Crack Orientation	Crack Width (mm)	Crack Length (mm)	Comments	Photo	Severity Category
S1.38	IMG_9627	Detached element of sandstone block	LHS mullion at feature panel, at Eaves Level.	n/a	n/a	n/a	-

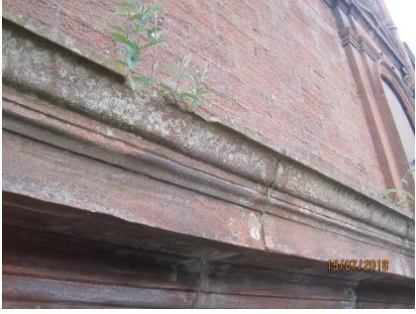
Red
S1.39	IMG_9628- IMG_9629	Fractured, detached and broken sandstone block.	Edge to Sandstone ledge feature, at LHS of feature panel, at Eaves Level.	n/a	n/a	n/a	-

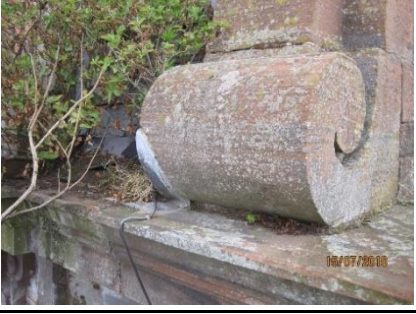
Green
S1.40	IMG_9630- IMG_9632	Repair to curled stone feature.	LHS of gable, at Eaves Level.	n/a	n/a	n/a	-

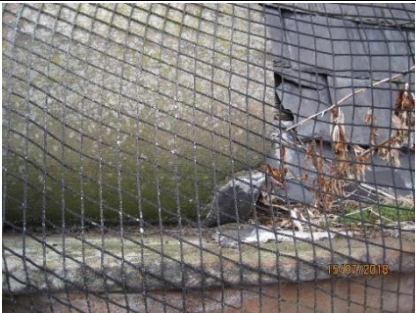
Defect ID	Photo Source	Defect Description	Defect Location	Crack Orientation	Crack Width (mm)	Crack Length (mm)	Comments	Photo	Severity Category
S1.41	IMG_9633- IMG_9634	Repair to curled stone feature.	RHS of gable, at Eaves Level.	n/a	n/a	n/a	-

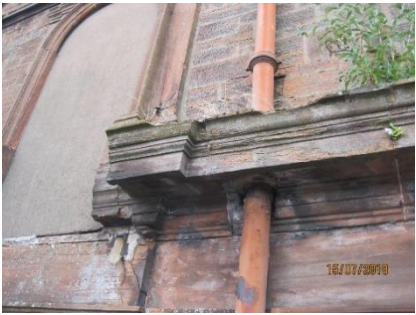
Green
S1.42	IMG_9635	Fractured and detached element of sandstone.	Edge to Sandstone ledge feature, at RHS of feature panel, at Eaves Level.	n/a	n/a	n/a	-

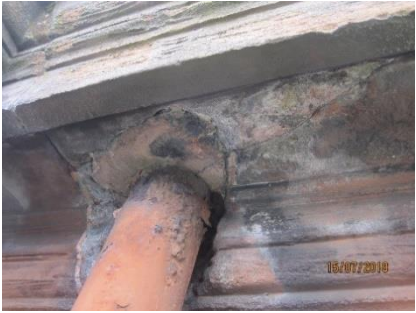
Amber
S1.43	IMG_9636- IMG_9638	2no. Cracks	Soffit of Sandstone ledge feature at RWP, at RHS of feature panel, at Eaves Level.	Radial	<1-2	400	-

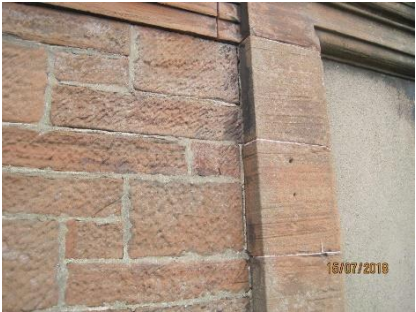
Defect ID	Photo Source	Defect Description	Defect Location	Crack Orientation	Crack Width (mm)	Crack Length (mm)	Comments	Photo	Severity Category
S1.44	IMG_9642	Crack	LHS of feature panel, below Eaves Level.	n/a	<1-2	150	-

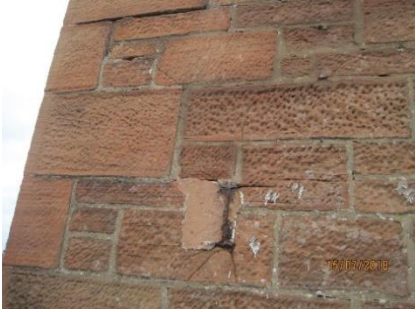
Amber
S1.45	IMG_9643	5no. Cracks	LHS of feature panel, below Upper Eaves Level.	Radial	<1-3	550	Cracks propagating from wrought iron insert

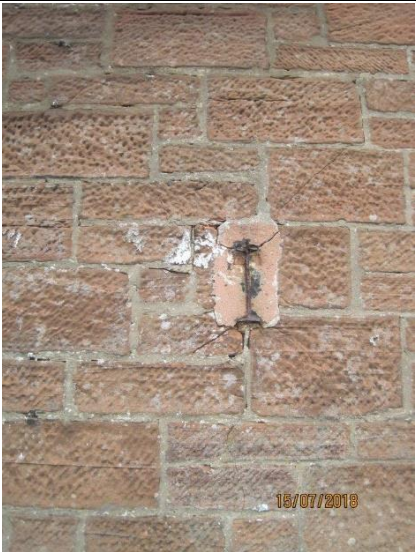
Defect ID	Photo Source	Defect Description	Defect Location	Crack Orientation	Crack Width (mm)	Crack Length (mm)	Comments	Photo	Severity Category
S1.46	IMG_9644- IMG_9645	5no. Cracks	LHS of feature panel, below Upper Eaves Level.	Radial	<1-3	700	Cracks propagating from wrought iron insert

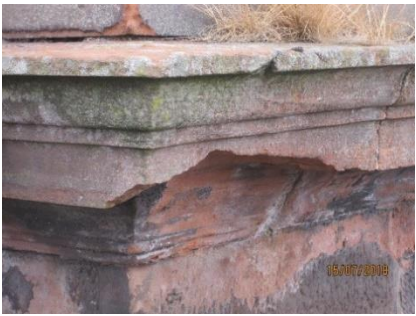
Amber
S1.47	IMG_9646, IMG_9649	Fractured, detached and broken sandstone block.	Side of gable next to RWP, at 2nd Floor Level.	n/a	n/a	n/a	-

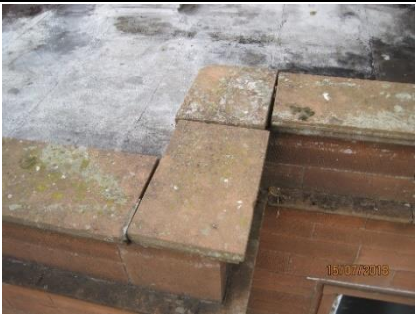
Defect ID	Photo Source	Defect Description	Defect Location	Crack Orientation	Crack Width (mm)	Crack Length (mm)	Comments	Photo	Severity Category
S1.48	IMG_9647- IMG_9648	Dislodged capping stones.	Roof of 2 storey extension building at LHS of gable.	n/a	n/a	n/a	3no. Capping stones dislodged at 2no. Locations.

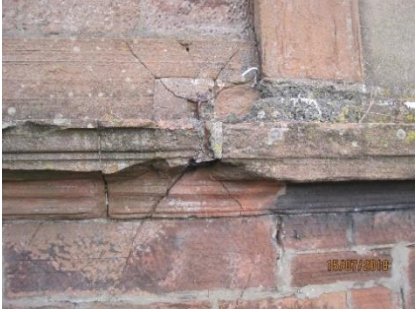
Red
S1.49	IMG_9651	5no. Cracks & Damage to Sandstone ledge feature	LHS of rectangular panel, at 2nd Floor Level.	Radial	<1-4	900 (longest)	Cracks propagating from wrought iron insert. Damage to U/S of Sandstone ledge feature - fractured and broken with elements detached

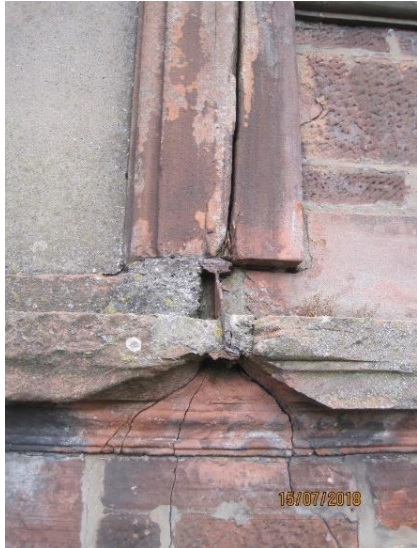
Defect ID	Photo Source	Defect Description	Defect Location	Crack Orientation	Crack Width (mm)	Crack Length (mm)	Comments	Photo	Severity Category
S1.50	IMG_9652- IMG_9659, IMG_9671	Multiple cracks	RHS corner of rectangular panel, at 2nd Floor Level.	Vertical and diagonal	<1-10	1000 (longest)	Cracks propagating from wrought iron insert

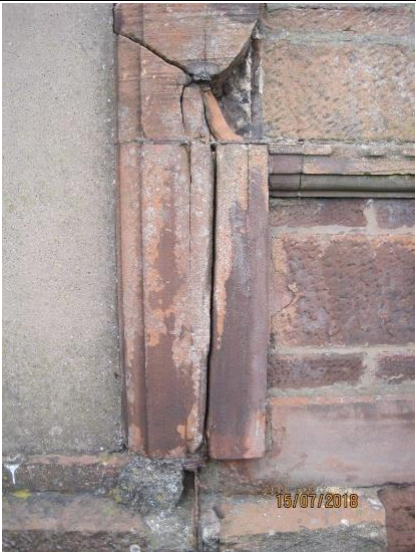
Defect ID	Photo Source	Defect Description	Defect Location	Crack Orientation	Crack Width (mm)	Crack Length (mm)	Comments	Photo	Severity Category
S1.51	IMG_9660- IMG_9667, IMG_9671	4no. Cracks & loss of section	RHS of rectangular panel, above 2nd Floor Level.	Radial and vertical	10-20	1300 (vertical)	Cracks propagating from wrought iron insert. Loss of section - fractured, broken and loose

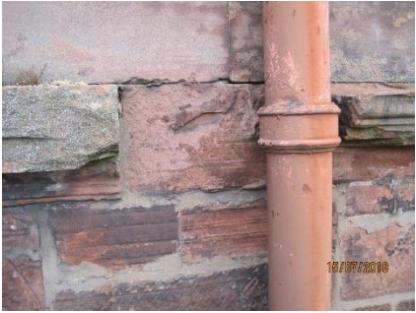
Red
S1.52	IMG_9668- IMG_9669, IMG_9671	Fractured, detached and broken sandstone block.	Adjacent RWP, at 2nd Floor Level.	n/a	n/a	n/a	Approx. 300mm section of sandstone missing on LHS of RWP.

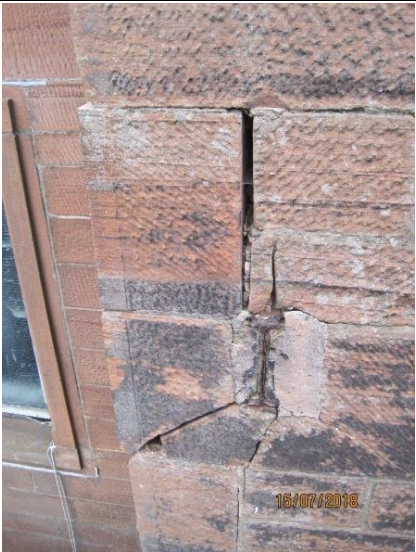
Defect ID	Photo Source	Defect Description	Defect Location	Crack Orientation	Crack Width (mm)	Crack Length (mm)	Comments	Photo	Severity Category
S1.56	IMG_9685- IMG_9687	4no. Cracks	LHS of gable, below First Floor Level.	Radial	<1-12	125-300	Cracks propagating from wrought iron insert

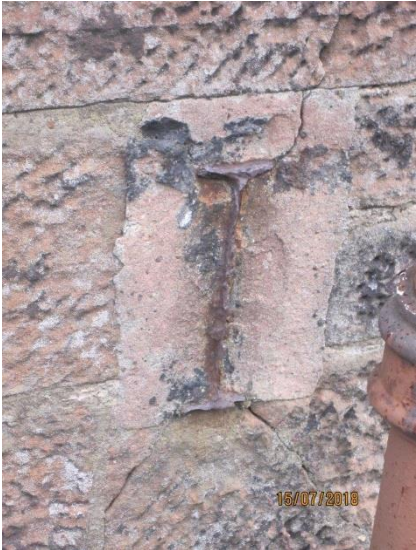
Defect ID	Photo Source	Defect Description	Defect Location	Crack Orientation	Crack Width (mm)	Crack Length (mm)	Comments	Photo	Severity Category
S1.57	IMG_9688- IMG_9689	3no. Cracks	LHS of 2no. openings, below First Floor Level.	Radial	<1-2	200	Cracks propagating from wrought iron insert

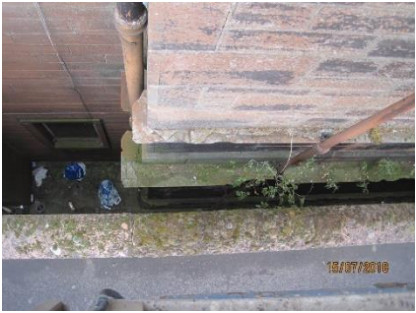
Amber
S1.58	IMG_9690- IMG_9691	Multiple broken and detached elements of sandstone.	Along the edges of the 2no. Sandstone ledge feature lines, below First Floor Level.	n/a	n/a	n/a	Multiple points of erosion and likely damage from debris falling from above.

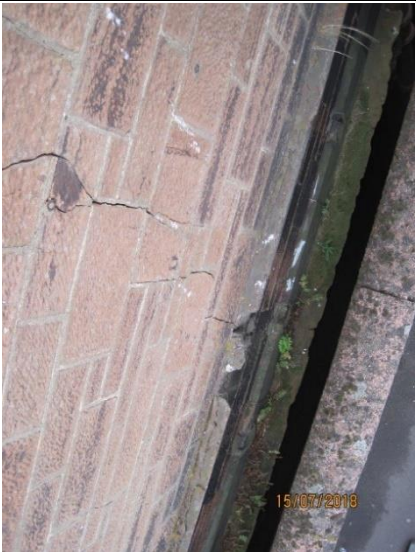
Defect ID	Photo Source	Defect Description	Defect Location	Crack Orientation	Crack Width (mm)	Crack Length (mm)	Comments	Photo	Severity Category
S1.59	IMG_9679- IMG_9680	2no. Cracks	Between Ground Level and First Floor Level.	Vertical	1-10	4000	Visibility limited by the bridge parapet wall. However, cracks appear to propagate from foundation level.

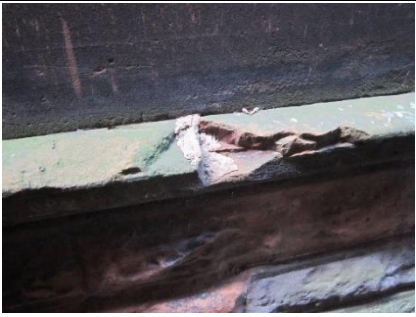
Defect ID	Photo Source	Defect Description	Defect Location	Crack Orientation	Crack Width (mm)	Crack Length (mm)	Comments	Photo	Severity Category
S1.62	IMG_2028	Spalled/damaged sandstone	Elevation S1, Wall	n/a	n/a	n/a	Delamination/erosion of/cracked/broken off sandstone to ledge feature

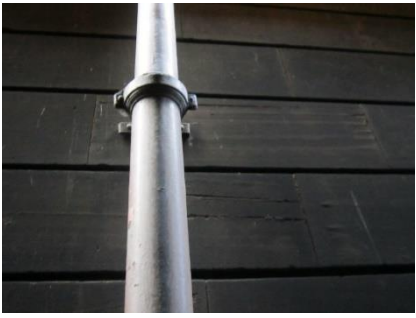
Green
S1.63	IMG_2023	Crack	Elevation S1, Wall	Horizontal	1-5	800	Behind down pipe near tracks

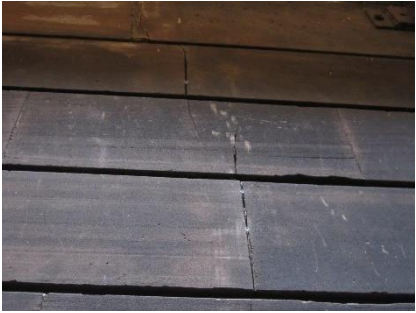
Green
S1.64	IMG_2017	Crack	Elevation S1, Wall	Vertical	1-3	600	Ten blocks up from wall base

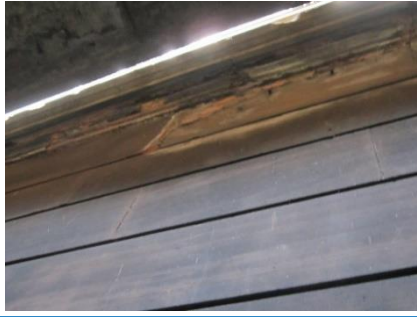
Defect ID	Photo Source	Defect Description	Defect Location	Crack Orientation	Crack Width (mm)	Crack Length (mm)	Comments	Photo	Severity Category
S1.65	IMG_2011	Staining	Elevation S1, Wall	n/a	n/a	n/a	-

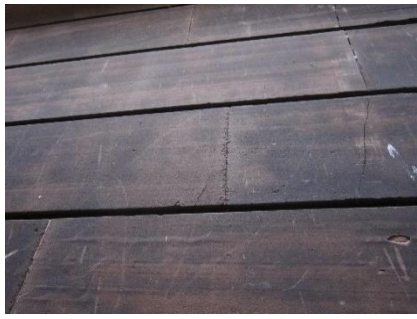
Green
S1.66	IMG_2010	Crack	Elevation S1, Wall	Diagonal	1-3	200	Crack through block

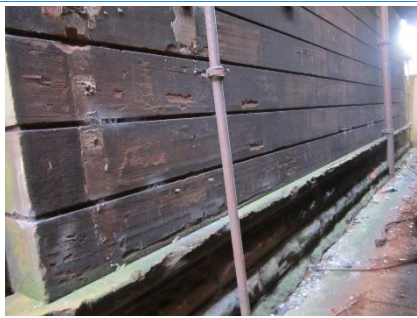
Green
S1.67	IMG_2000	Spalled/damaged sandstone	Elevation S1, Wall	n/a	n/a	n/a	Delamination/erosion of and minor spalling occurring at multiple locations

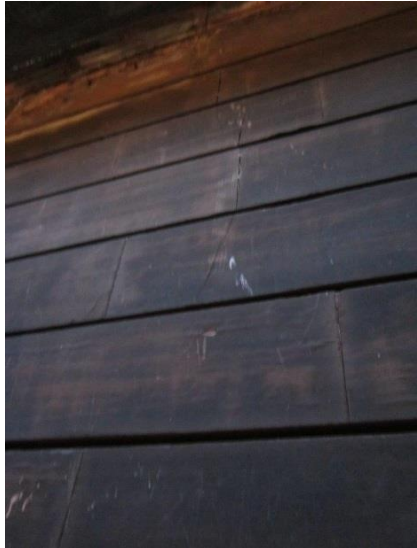
Defect ID	Photo Source	Defect Description	Defect Location	Crack Orientation	Crack Width (mm)	Crack Length (mm)	Comments	Photo	Severity Category
S1.68	IMG_1998	Crack	Elevation S1, Wall	Vertical	3-5	1500	From block 8 to ledge projection. It is likely that the crack extends upwards above bridge parapet

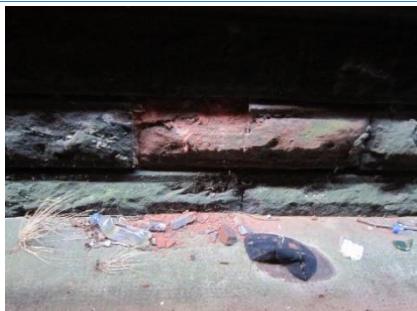
Amber
S1.69	IMG_1994	Spalled/damaged sandstone	Elevation S1, Wall	n/a	n/a	n/a	Deterioration of sandstone blocks with delamination/erosion of/cracked/broken off sandstone noted. Surface of blocks crumble on light contact

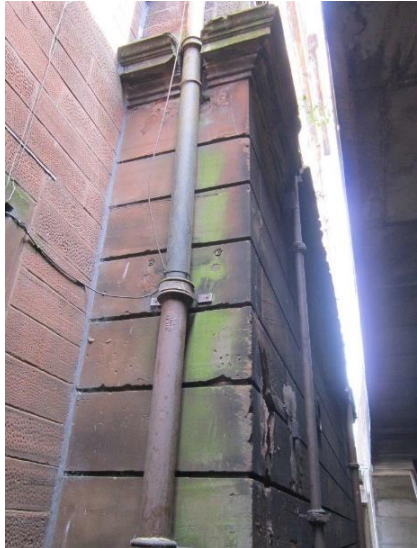
Defect ID	Photo Source	Defect Description	Defect Location	Crack Orientation	Crack Width (mm)	Crack Length (mm)	Comments	Photo	Severity Category
S1.75	IMG_1972	Spalled/damaged sandstone	Elevation S1, Wall	n/a	n/a	n/a	Delamination/spalling to sandstone near down pipe and corners

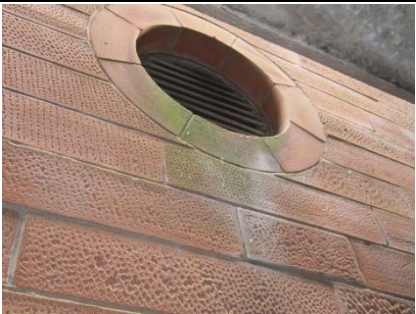
Defect ID	Photo Source	Defect Description	Defect Location	Crack Orientation	Crack Width (mm)	Crack Length (mm)	Comments	Photo	Severity Category
S1.80	IMG_1949	Vegetation staining	Elevation S1, Wall	n/a	n/a	n/a	-

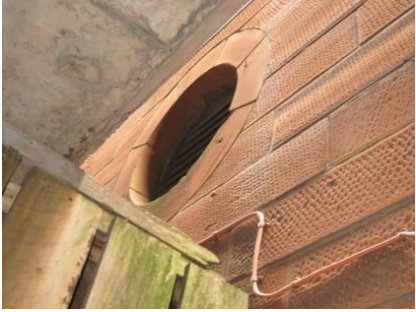
Green
S1.81	IMG_1947	Loss of section	Elevation S1, Wall	n/a	n/a	n/a	-

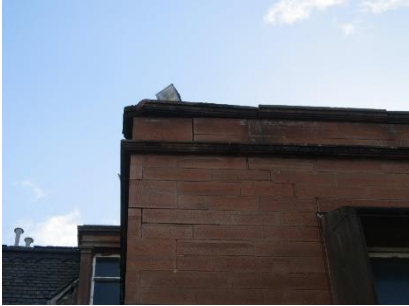
Defect ID	Photo Source	Defect Description	Defect Location	Crack Orientation	Crack Width (mm)	Crack Length (mm)	Comments	Photo	Severity Category
W2.4	IMG_1847	Loss of pointing	Elevation W2, Wall	n/a	n/a	n/a	-

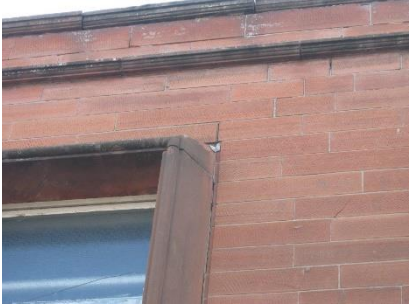
Amber
W2.5	IMG_1849	Cracking to sandstone	Elevation W2, Wall	Vertical	1.0-5.0	300	-

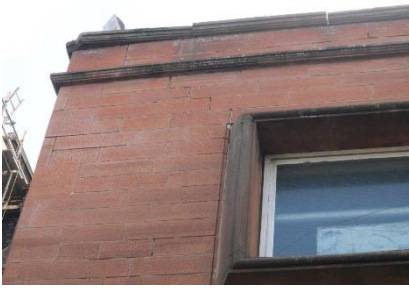
Amber
W2.6	IMG_1851	Cracking to sandstone	Elevation W2, Wall	Diagonal	1.0-5.0	800	Stepped crack

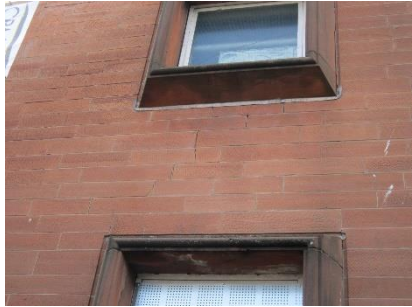
Defect ID	Photo Source	Defect Description	Defect Location	Crack Orientation	Crack Width (mm)	Crack Length (mm)	Comments	Photo	Severity Category
W2.7	IMG_1856	Cracking to sandstone	Elevation W2, Wall	Diagonal	1.0-3.0	1500	Stepped crack

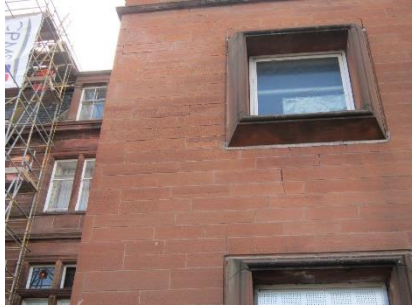
Amber
W2.8	IMG_1859	Loss of pointing	Elevation W2, Wall	n/a	n/a	n/a	-

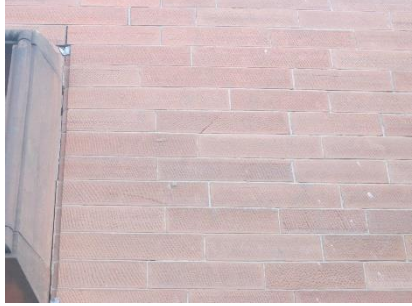
Green
W2.9	IMG_1861	Cracking to sandstone	Elevation W2, Wall	Diagonal	1.0-3.0	300	-

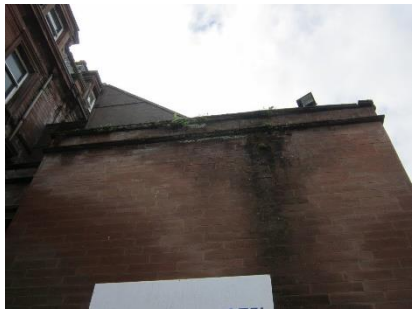
Defect ID	Photo Source	Defect Description	Defect Location	Crack Orientation	Crack Width (mm)	Crack Length (mm)	Comments	Photo	Severity Category
W3.1	IMG_1865	Vegetation growth/staining	Elevation W3, Wall	n/a	n/a	n/a	-

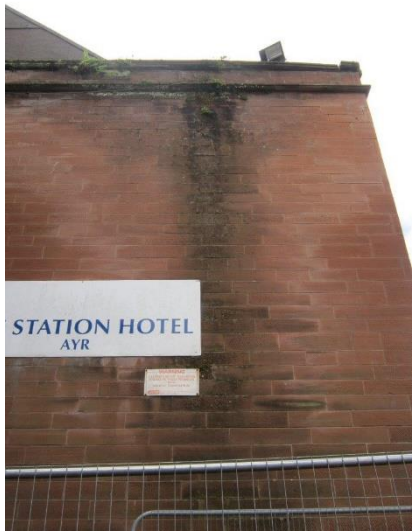
Red
W3.2	IMG_1866	Vegetation growth/staining	Elevation W3, Wall	n/a	n/a	n/a	-

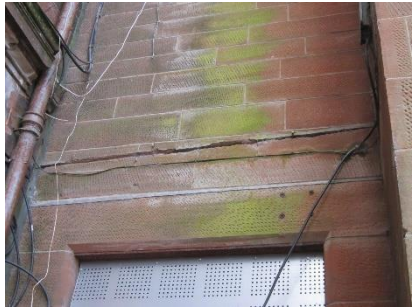
Defect ID	Photo Source	Defect Description	Defect Location	Crack Orientation	Crack Width (mm)	Crack Length (mm)	Comments	Photo	Severity Category
W3.5	IMG_1873	Cracking to sandstone	Elevation W3, Wall	Horizontal	20-30	1500-2000	-

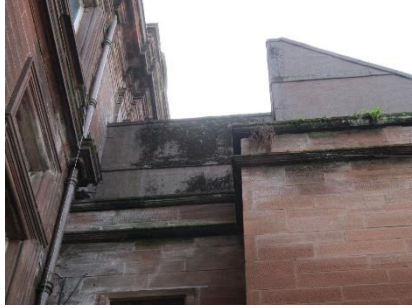
Red
W3.6	IMG_1876	Vegetation growth/staining	Elevation W3, Wall	n/a	n/a	n/a	-

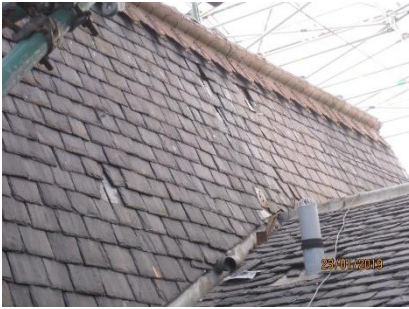
Defect ID	Photo Source	Defect Description	Defect Location	Crack Orientation	Crack Width (mm)	Crack Length (mm)	Comments	Photo	Severity Category
W4.1	IMG_0133	Missing / Dislodged / damaged tiles	Elevation W4, Roof	n/a	n/a	n/a	-

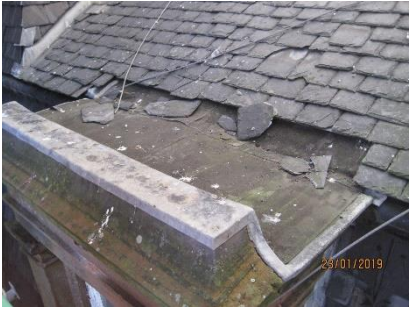
Red
W4.2	IMG_0132, 0135, 0136	Missing / Dislodged / damaged tiles	Elevation W4, Roof	n/a	n/a	n/a	-

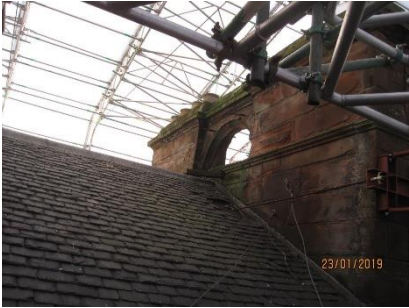
Red
W4.3	IMG_0137	Spalled/damaged sandstone	Elevation W4, Roof Cross wall	n/a	n/a	n/a	Delamination/erosion of sandstone blocks to chimney stack

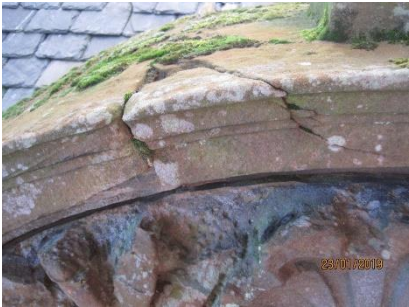
Defect ID	Photo Source	Defect Description	Defect Location	Crack Orientation	Crack Width (mm)	Crack Length (mm)	Comments	Photo	Severity Category
W4.16	IMG_0164	Cracking to sandstone	Elevation W4, Roof Cross wall	Diagonal	1-3	200-300	Chimney stack	 	Red
W4.17	IMG_0167	Cracking to sandstone	Elevation W4, Roof Arch feature	Vertical / Diagonal	1	-	Arch feature capping stone

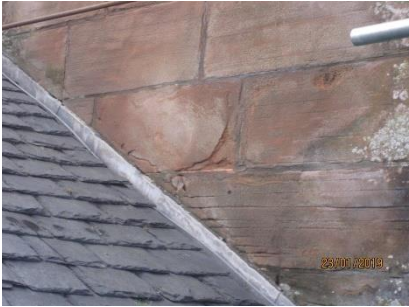
Defect ID	Photo Source	Defect Description	Defect Location	Crack Orientation	Crack Width (mm)	Crack Length (mm)	Comments	Photo	Severity Category
W4.19	IMG_0171	Spalled/damaged sandstone	Elevation W4, Roof	n/a	n/a	n/a	Chimney stack

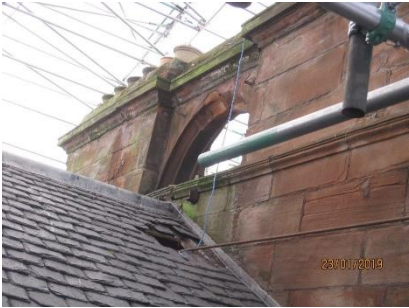
Amber
W4.20	IMG_0173	Vegetation growth	Elevation W4, Roof Cross wall	n/a	n/a	n/a	-

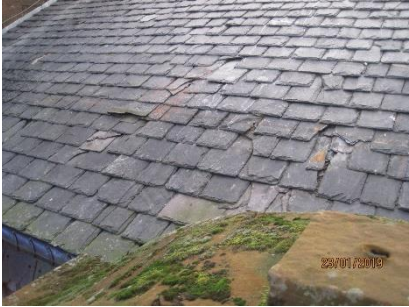
Green
W4.21	IMG_0174-0176	Missing / Dislodged / damaged tiles	Elevation W4, Roof Arch feature	n/a	n/a	n/a	General dislodged / missing roof tiles

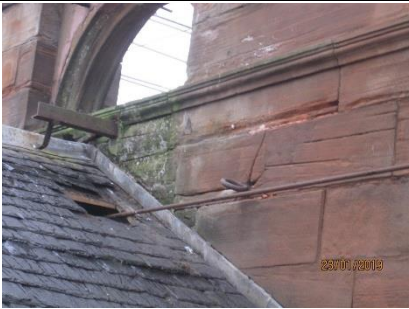
Defect ID	Photo Source	Defect Description	Defect Location	Crack Orientation	Crack Width (mm)	Crack Length (mm)	Comments	Photo	Severity Category
W4.25	IMG_0186	Cracking to sandstone	Elevation W4, Roof Cross wall	Vertical	3-5	300	Chimney stack

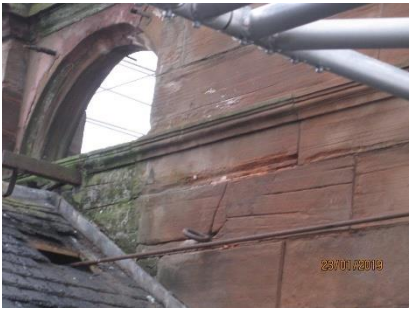
Red
W4.26	IMG_0187	Spalled/damaged sandstone	Elevation W4, Roof Cross wall	n/a	n/a	n/a	Delamination/erosion of sandstone to chimney

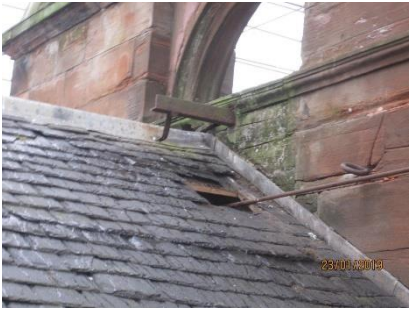
Red
W4.27	IMG_0188	Vegetation growth	Elevation W4, Roof Cross wall	n/a	n/a	n/a	Staining and vegetation growth on chimney stack

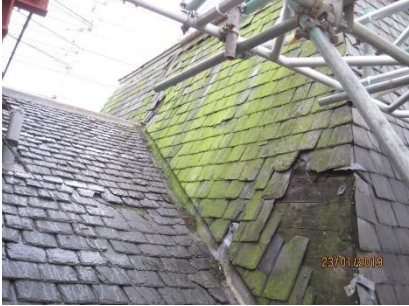
Defect ID	Photo Source	Defect Description	Defect Location	Crack Orientation	Crack Width (mm)	Crack Length (mm)	Comments	Photo	Severity Category
W4.28	IMG_0191, 0192	Vegetation growth	Elevation W4, Roof	n/a	n/a	n/a	-

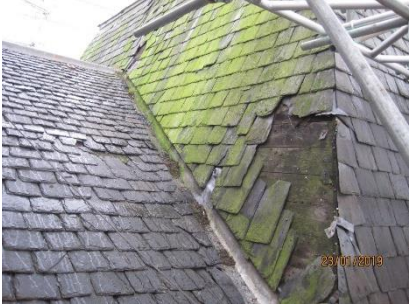
Green
W4.29	IMG_0191, 0192	Missing / Dislodged / damaged tiles	Elevation W4, Roof	n/a	n/a	n/a	-

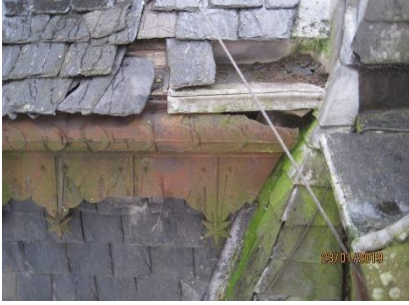
Red
W4.30	IMG_0197	Damaged cast iron fittings	Elevation W4, Roof	n/a	n/a	n/a	Damage to cast iron/metal feature

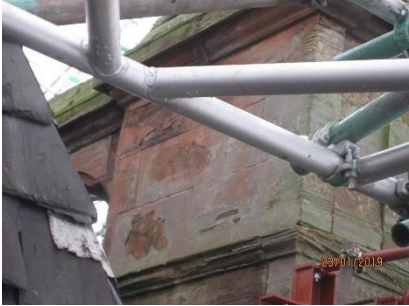
Defect ID	Photo Source	Defect Description	Defect Location	Crack Orientation	Crack Width (mm)	Crack Length (mm)	Comments	Photo	Severity Category
W4.33	IMG_0206, 0207	Spalled/damaged sandstone	Elevation W4, Roof South gable wall	n/a	n/a	n/a	-

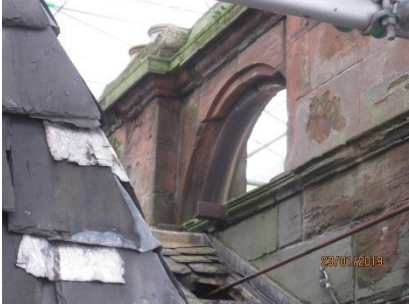
Amber
W4.34	IMG_0208, 0209	Spalled/damaged sandstone	Elevation W4, Roof South gable wall	n/a	n/a	n/a	Cracked/broken off sandstone to arch feature

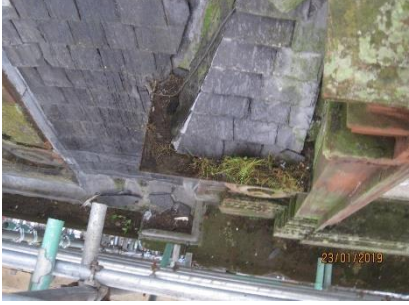
Amber
W4.35	IMG_0210, 0211	Vegetation growth	Elevation W4, Roof	n/a	n/a	n/a	Vegetation growth blocking gutters

Red

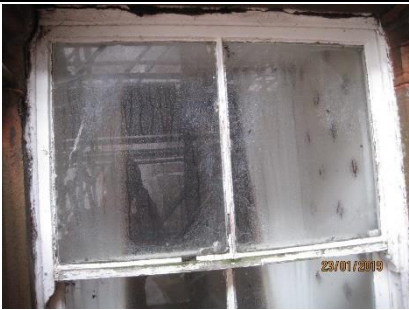
Defect ID	Photo Source	Defect Description	Defect Location	Crack Orientation	Crack Width (mm)	Crack Length (mm)	Comments	Photo	Severity Category
W4.36	IMG_0219-0221	Vegetation growth	Elevation W4, Wall	n/a	n/a	n/a	Window frame damaged and poor condition

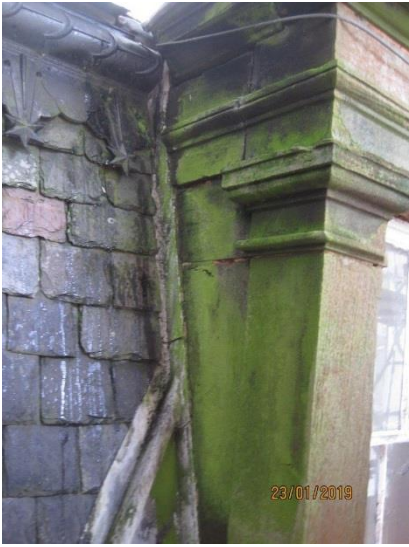
Green
W4.37	IMG_0222	Vegetation growth/staining	Elevation W4, Wall	n/a	n/a	n/a	-

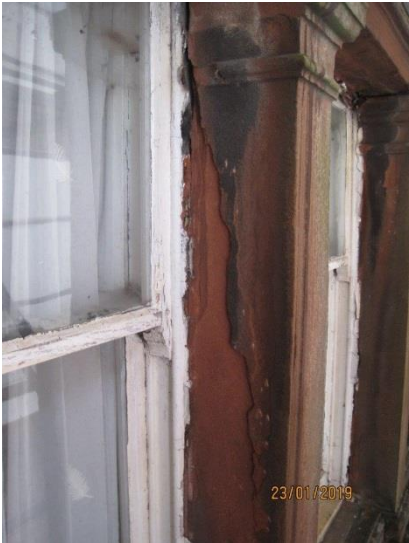
Defect ID	Photo Source	Defect Description	Defect Location	Crack Orientation	Crack Width (mm)	Crack Length (mm)	Comments	Photo	Severity Category
W4.40	IMG_0230-0232	Spalled/damaged sandstone	Elevation W4, Wall Dormer window	n/a	n/a	n/a	Surface of sandstone crumbles on light contact

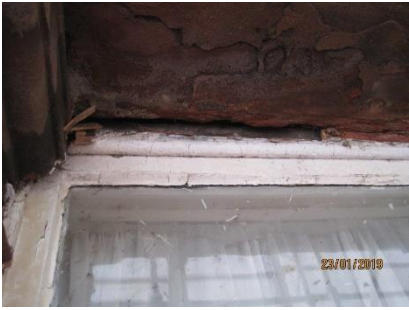
Red
W4.41	IMG_0233	Other	Elevation W4, Wall Dormer window	n/a	n/a	n/a	Visible gap between window frame and stonework circa 10-20mm

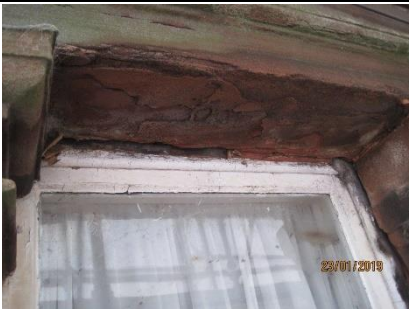
Defect ID	Photo Source	Defect Description	Defect Location	Crack Orientation	Crack Width (mm)	Crack Length (mm)	Comments	Photo	Severity Category
W4.42	IMG_0235	Spalled/damaged sandstone	Elevation W4, Wall Dormer window	n/a	n/a	n/a	Delamination/erosion of sandstone to soffit of window lintel, surface of sandstone crumbles on light contact

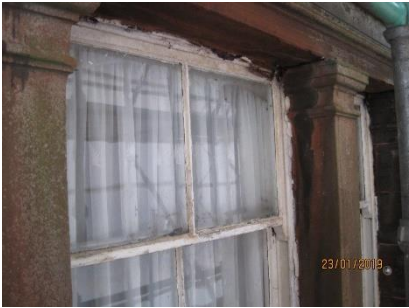
Defect ID	Photo Source	Defect Description	Defect Location	Crack Orientation	Crack Width (mm)	Crack Length (mm)	Comments	Photo	Severity Category
W4.44	IMG_0238-0239	Other	Elevation W4, Wall Dormer window	n/a	n/a	n/a	Timber frame in poor condition - surface finish crumbles on light contact

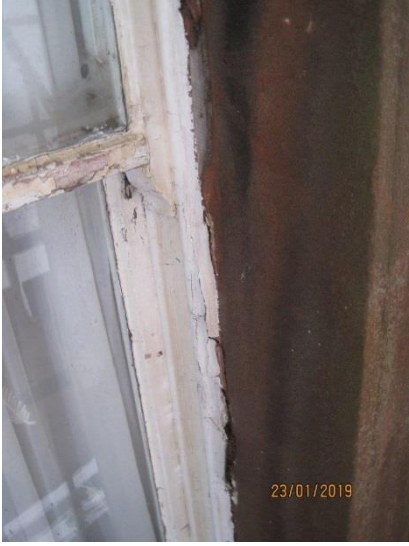
Red
W4.45	IMG_0241-0243	Spalled/damaged sandstone	Elevation W4, Wall Dormer window	n/a	n/a	n/a	-
