Former Ayr Station Hotel Building Structural Condition

Independent Report

03 October 2019

Document reference: 399316/SNI/GLA/DOC/S2/REP/002

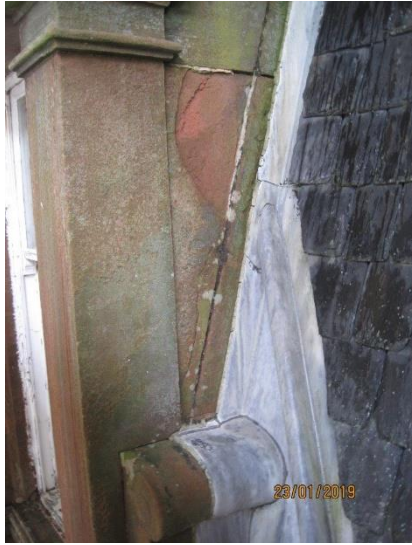
Defect ID	Photo Source	Defect Description	Defect Location	Crack Orientation	Crack Width (mm)	Crack Length (mm)	Comments	Photo	Severity Category
W4.49	IMG_0256-0257	Spalled/damaged sandstone	Elevation W4, Wall Dormer window	n/a	n/a	n/a	Sandstone appears to be delaminating

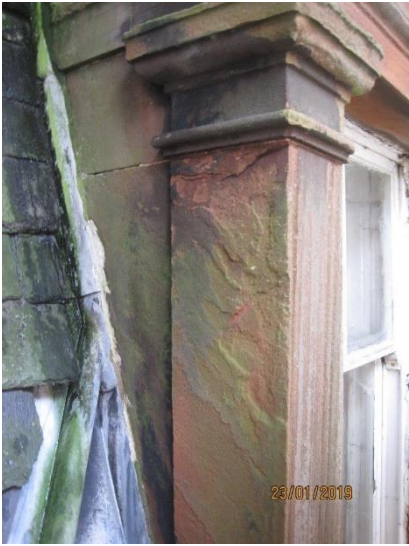
Defect ID	Photo Source	Defect Description	Defect Location	Crack Orientation	Crack Width (mm)	Crack Length (mm)	Comments	Photo	Severity Category
W4.54	IMG_0270	Spalled/damaged sandstone	Elevation W4, Wall Dormer window	n/a	n/a	n/a	Sandstone pilaster appears to be delaminating

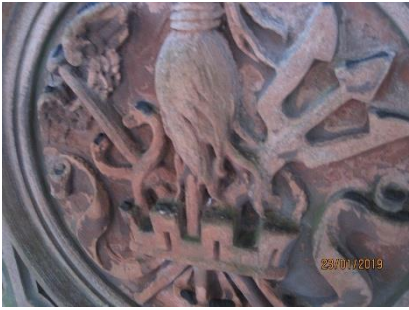
Defect ID	Photo Source	Defect Description	Defect Location	Crack Orientation	Crack Width (mm)	Crack Length (mm)	Comments	Photo	Severity Category
W4.56	IMG_0272-0273	Spalled/damaged sandstone	Elevation W4, Wall Dormer window	n/a	n/a	n/a	-	 	Amber
W4.57	IMG_0274-0277	Spalled/damaged sandstone	Elevation W4, Wall	n/a	n/a	n/a	Mild delamination/erosion of sandstone to circular architectural feature

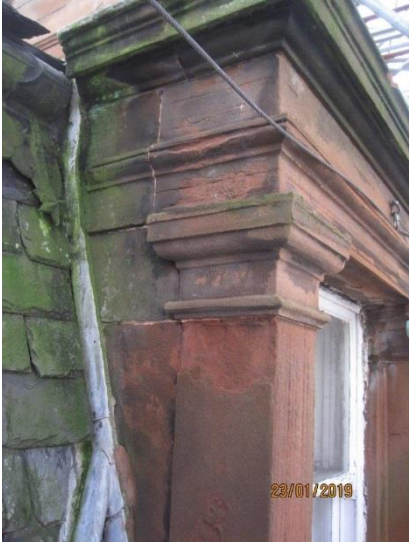
Defect ID	Photo Source	Defect Description	Defect Location	Crack Orientation	Crack Width (mm)	Crack Length (mm)	Comments	Photo	Severity Category
W4.58	IMG_0278-0279	Spalled/damaged sandstone	Elevation W4, Wall Dormer window	n/a	n/a	n/a	-

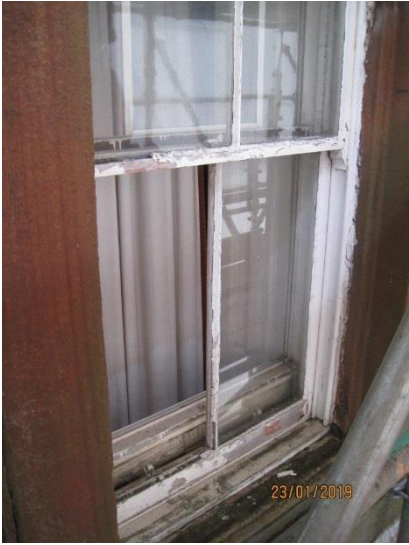
Defect ID	Photo Source	Defect Description	Defect Location	Crack Orientation	Crack Width (mm)	Crack Length (mm)	Comments	Photo	Severity Category
W4.59	IMG_0280-0281	Other	Elevation W4, Wall Dormer window	n/a	n/a	n/a	Timber window frame in poor condition. Missing window pane

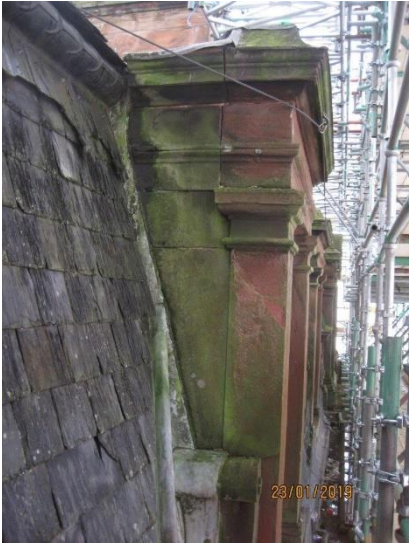
Defect ID	Photo Source	Defect Description	Defect Location	Crack Orientation	Crack Width (mm)	Crack Length (mm)	Comments	Photo	Severity Category
W4.60	IMG_0282-0284	Other	Elevation W4, Wall Dormer window	n/a	n/a	n/a	Vertical joint/gap between sandstone blocks, gap appears to be widening towards the top end

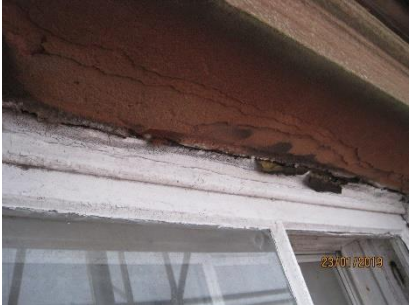
Red
W4.61	IMG_0288-0289	Spalled/damaged sandstone	Elevation W4, Wall Dormer window	n/a	n/a	n/a	Soffit of sandstone window lintel appears to be delaminating

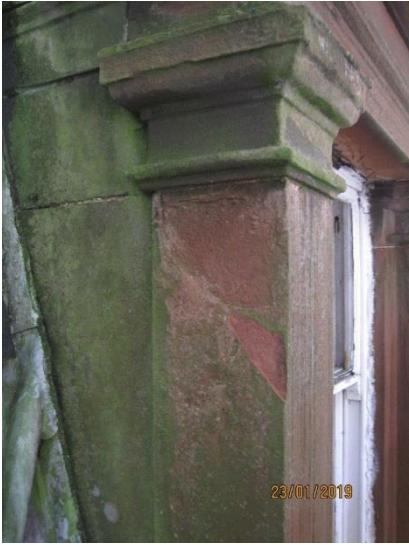
Defect ID	Photo Source	Defect Description	Defect Location	Crack Orientation	Crack Width (mm)	Crack Length (mm)	Comments	Photo	Severity Category
W4.62	IMG_0285-0286	Spalled/damaged sandstone	Elevation W4, Wall Dormer window	n/a	n/a	n/a	Sandstone pilaster appears to be delaminating

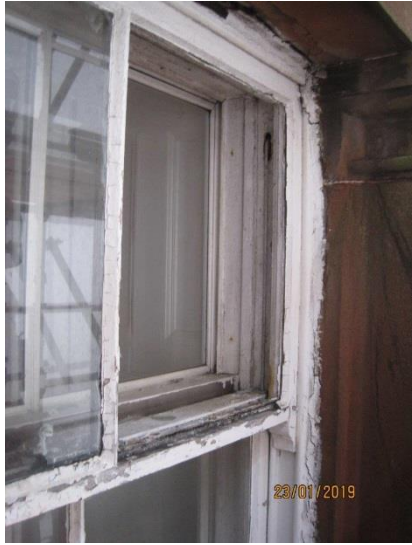
Defect ID	Photo Source	Defect Description	Defect Location	Crack Orientation	Crack Width (mm)	Crack Length (mm)	Comments	Photo	Severity Category
W4.63	IMG_0290	Other	Elevation W4, Wall Dormer window	n/a	n/a	n/a	Timber window frame in poor condition. Missing window pane

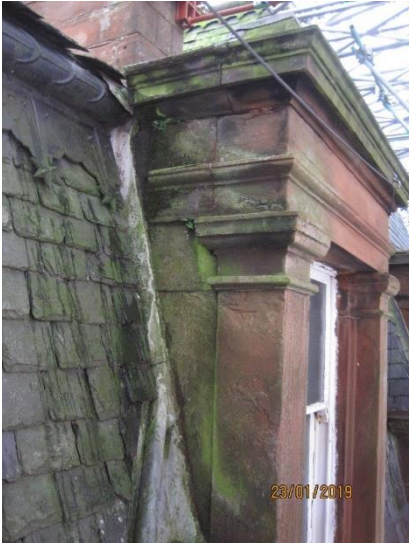
Defect ID	Photo Source	Defect Description	Defect Location	Crack Orientation	Crack Width (mm)	Crack Length (mm)	Comments	Photo	Severity Category
W4.64	IMG_0292-0293	Vegetation stain	Elevation W4, Wall Dormer window	n/a	n/a	n/a	Vegetation stain and dampness

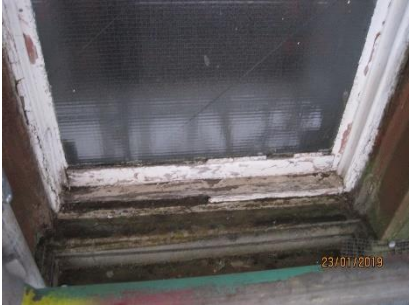
Green
W4.65	IMG_0296-0297	Other	Elevation W4, Wall Dormer window	n/a	n/a	n/a	Timber window frame damaged

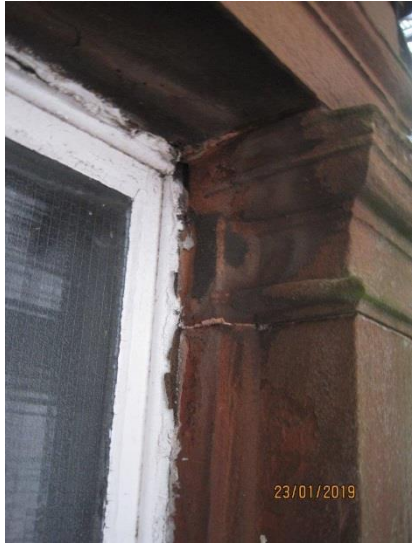
Defect ID	Photo Source	Defect Description	Defect Location	Crack Orientation	Crack Width (mm)	Crack Length (mm)	Comments	Photo	Severity Category
W4.66	IMG_0298-0299	Spalled/damaged sandstone	Elevation W4, Wall Dormer window	n/a	n/a	n/a	-

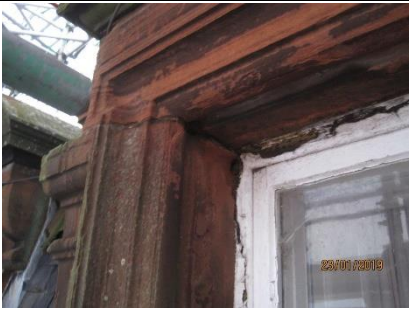
Defect ID	Photo Source	Defect Description	Defect Location	Crack Orientation	Crack Width (mm)	Crack Length (mm)	Comments	Photo	Severity Category
W4.69	IMG_0308-0310	Spalled/damaged sandstone	Elevation W4, Wall Dormer window	n/a	n/a	n/a	Sandstone pilaster at side of window appears to be delaminating. Surface layer of sandstone crumbles on light contact.

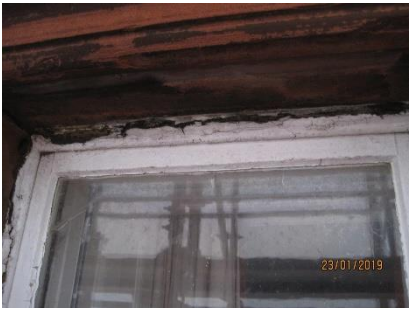
Red
W4.70	IMG_0311-0314	Other	Elevation W4, Wall Dormer window	n/a	n/a	n/a	Timber window frame in poor condition. Peeling paintwork

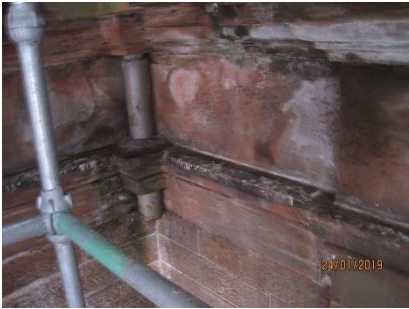
Green
W4.71	IMG_0323	Water staining efflorescence	Elevation W4, Wall	n/a	n/a	n/a	Staining and dampness

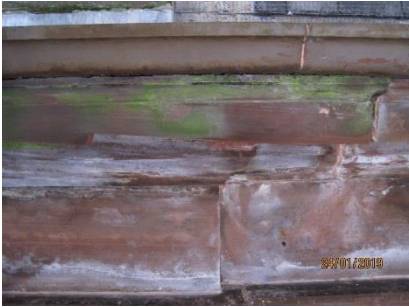
Defect ID	Photo Source	Defect Description	Defect Location	Crack Orientation	Crack Width (mm)	Crack Length (mm)	Comments	Photo	Severity Category
W4.75	IMG_0338-0339	Loss of section	Elevation W4, Wall	n/a	n/a	n/a	-

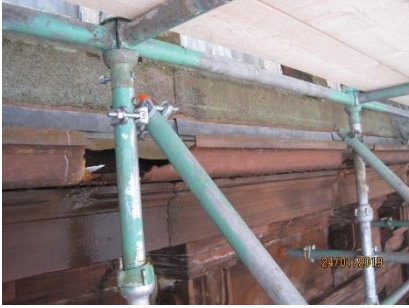
Amber
W4.76	IMG_0340-0341	Damaged/defective gutter/drainage	Elevation W4, Wall	n/a	n/a	n/a	Section of gutter removed for installed scaffold

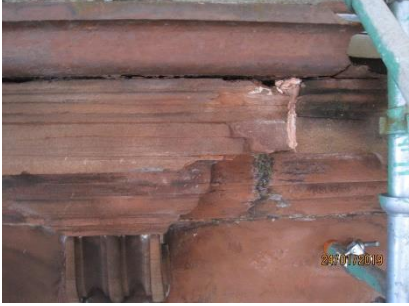
Red
W4.77	IMG_0342-0343	Loss of section	Elevation W4, Wall	n/a	n/a	n/a	-

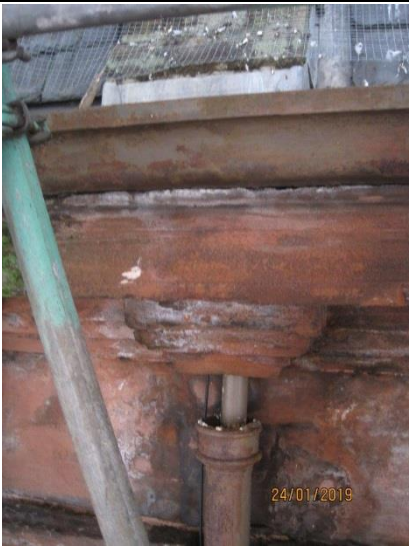
Defect ID	Photo Source	Defect Description	Defect Location	Crack Orientation	Crack Width (mm)	Crack Length (mm)	Comments	Photo	Severity Category
W4.78	IMG_0345-0346	Damaged/ defective gutter/drainage	Elevation W4, Wall	n/a	n/a	n/a	Downpipe with poor fitting narrower section attachment

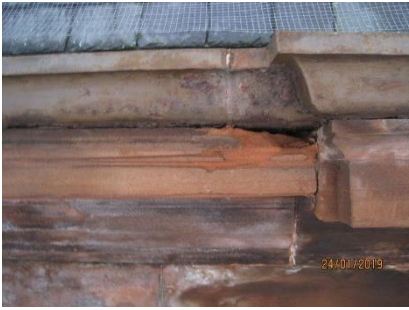
Red
W4.79	IMG_0347-0348	Spalled/ damaged sandstone	Elevation W4, Wall	n/a	n/a	n/a	Loss of section/broken off section to sandstone roof cornice feature

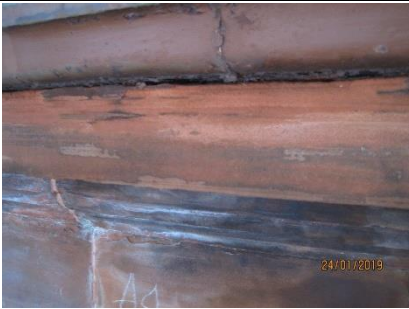
Defect ID	Photo Source	Defect Description	Defect Location	Crack Orientation	Crack Width (mm)	Crack Length (mm)	Comments	Photo	Severity Category
W4.86	IMG_0368, 0370	Spalled/damaged sandstone	Elevation W4, Wall	n/a	n/a	n/a	Delamination/erosion along sandstone ledge feature with loss of section/broken off sections noted

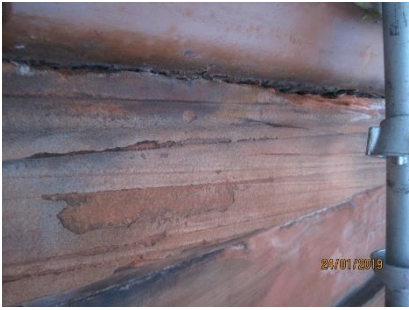
Amber
W4.87	IMG_0372, 0374	Spalled/damaged sandstone	Elevation W4, Wall	n/a	n/a	n/a	Delamination/erosion along sandstone ledge feature

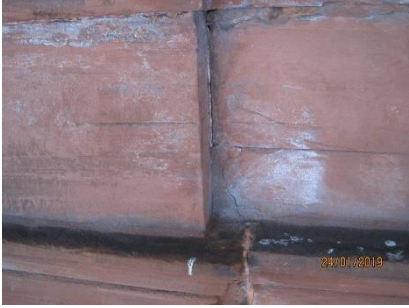
Amber
W4.88	IMG_0375, 0377	Cracking to sandstone	Elevation W4, Wall	Horizontal	1-2	400-500	-

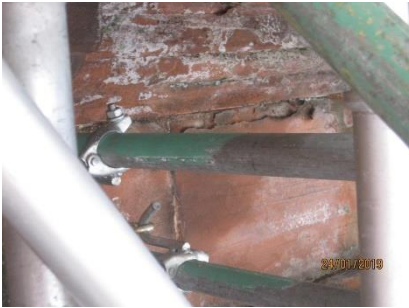
Defect ID	Photo Source	Defect Description	Defect Location	Crack Orientation	Crack Width (mm)	Crack Length (mm)	Comments	Photo	Severity Category
W4.91	IMG_0382, 0385	Spalled/damaged sandstone	Elevation W4, Wall	n/a	n/a	n/a	-

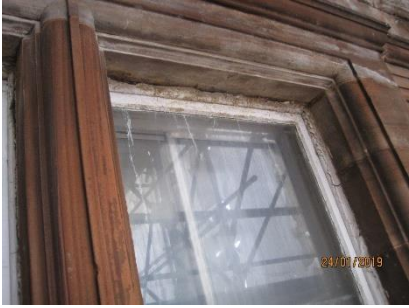
Amber
W4.92	IMG_0399, 0403	Other	Elevation W4, Wall	n/a	n/a	n/a	Timber window frame in poor condition. Peeling paintwork

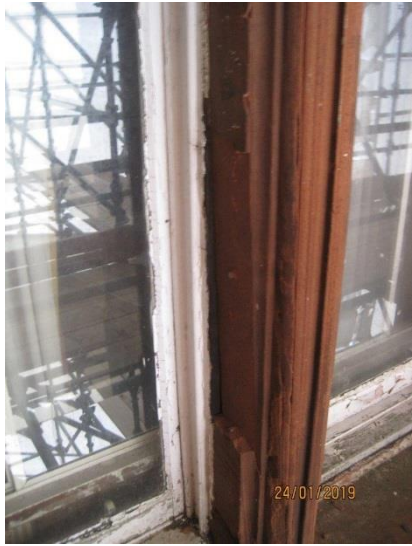
Defect ID	Photo Source	Defect Description	Defect Location	Crack Orientation	Crack Width (mm)	Crack Length (mm)	Comments	Photo	Severity Category
W4.93	IMG_0404, 0406	Loss of section	Elevation W4, Wall	n/a	n/a	n/a	-

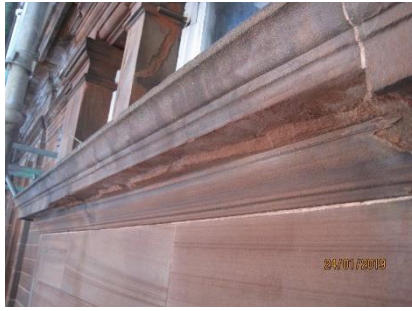
Green
W4.94	IMG_0409, 0411	Loss of section	Elevation W4, Wall	n/a	n/a	n/a	-

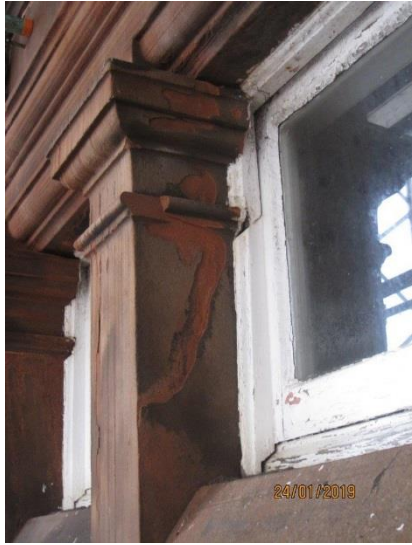
Defect ID	Photo Source	Defect Description	Defect Location	Crack Orientation	Crack Width (mm)	Crack Length (mm)	Comments	Photo	Severity Category
W4.95	IMG_0413, 0414	Spalled/damaged sandstone	Elevation W4, Wall	n/a	n/a	n/a	Sandstone mullion appears to be delaminating

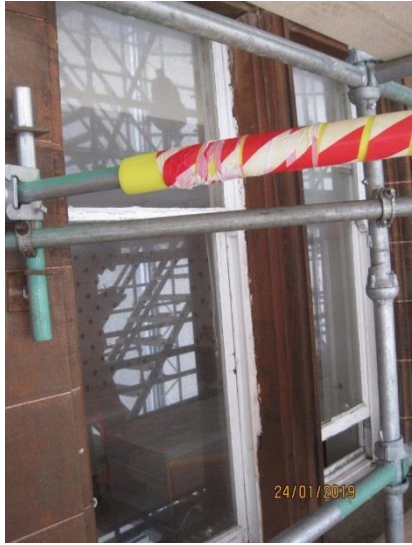
Defect ID	Photo Source	Defect Description	Defect Location	Crack Orientation	Crack Width (mm)	Crack Length (mm)	Comments	Photo	Severity Category
W4.98	IMG_0425, 0436	Other	Elevation W4, Wall	n/a	n/a	n/a	Timber window frame in poor condition. Gaps between sandstone blocks and timber window frame

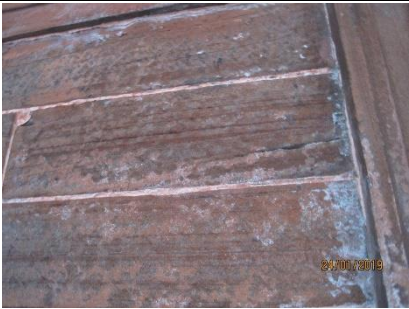
Defect ID	Photo Source	Defect Description	Defect Location	Crack Orientation	Crack Width (mm)	Crack Length (mm)	Comments	Photo	Severity Category
W4.101	IMG_0442, 0443	Cracking to sandstone	Elevation W4, Wall	Horizontal	1-2	100	-

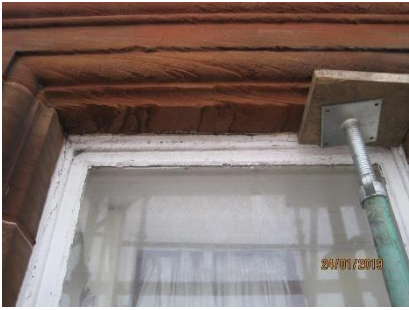
Amber
W4.102	IMG_0444, 0445	Other	Elevation W4, Wall	n/a	n/a	n/a	Delamination/erosion of sandstone. Vertical scaffold leg fitted within window opening

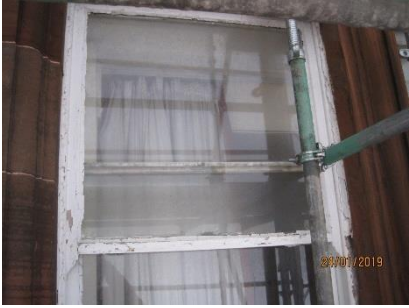
Amber
W4.103	IMG_0446, 0453	Spalled/damaged sandstone	Elevation W4, Wall	n/a	n/a	n/a	Delamination/erosion of sandstone. Notable gap between sandstone blocks and timber window frame

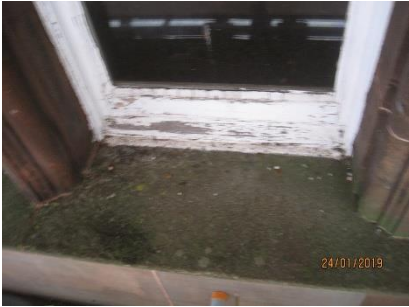
Defect ID	Photo Source	Defect Description	Defect Location	Crack Orientation	Crack Width (mm)	Crack Length (mm)	Comments	Photo	Severity Category
W4.106	IMG_0477-0483	Other	Elevation W4, Wall	n/a	n/a	n/a	Timber window frame in poor condition. Peeling paintwork. Appears damp

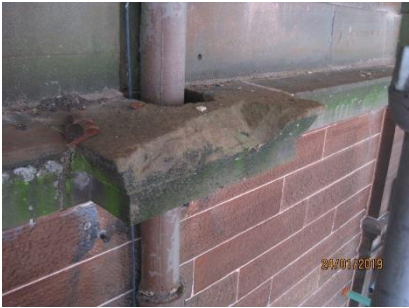
Green
W4.107	IMG_0484-0485	Spalled/damaged sandstone	Elevation W4, Wall	n/a	n/a	n/a	Cracked/broken off Sandstone to ledge architectural feature

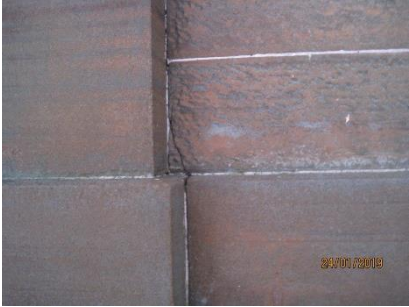
Red
W4.108	IMG_0490-0491	Cracking to sandstone	Elevation W4, Wall	Diagonal	1	50	-

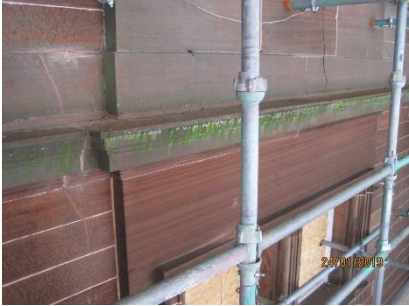
Defect ID	Photo Source	Defect Description	Defect Location	Crack Orientation	Crack Width (mm)	Crack Length (mm)	Comments	Photo	Severity Category
W4.109	IMG_0492-0494, 0498	Vegetation growth/staining	Elevation W4, Wall	n/a	n/a	n/a	Along the length of the ledge architectural feature

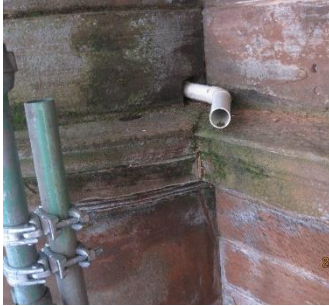
Defect ID	Photo Source	Defect Description	Defect Location	Crack Orientation	Crack Width (mm)	Crack Length (mm)	Comments	Photo	Severity Category
W4.112	IMG_0505	Damaged/ defective gutter/ drainage	Elevation W4, Wall	n/a	n/a	n/a	Possible defective drainage outlet

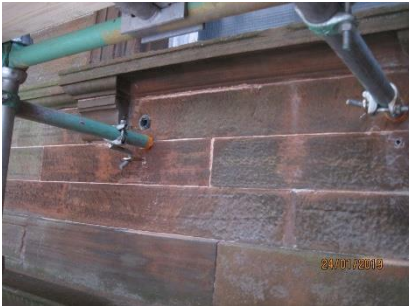
Red
W4.113	IMG_0510-0511	Cracking to sandstone	Elevation W4, Wall	Diagonal	1	50	Crack emanating from metal insert/hole

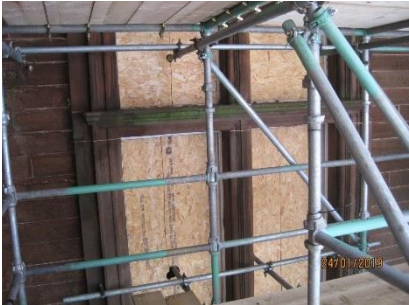
Green
W4.114	IMG_0536	Other	Elevation W4, Wall	n/a	n/a	n/a	Windows boarded up

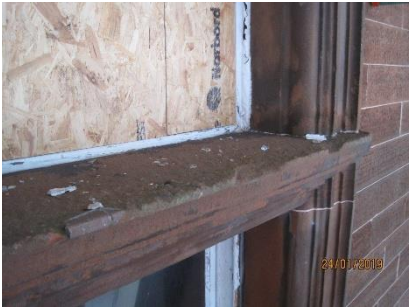
Defect ID	Photo Source	Defect Description	Defect Location	Crack Orientation	Crack Width (mm)	Crack Length (mm)	Comments	Photo	Severity Category
W4.118	IMG_0544	Spalled/damaged sandstone	Elevation W4, Wall	n/a	n/a	n/a	Delamination/cracked/broken off sandstone to window transom

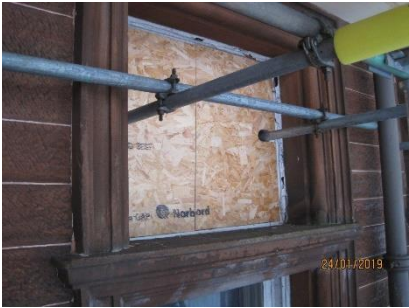
Green
W4.119	IMG_0556	Other	Elevation W4, Wall	n/a	n/a	n/a	Windows partially boarded up

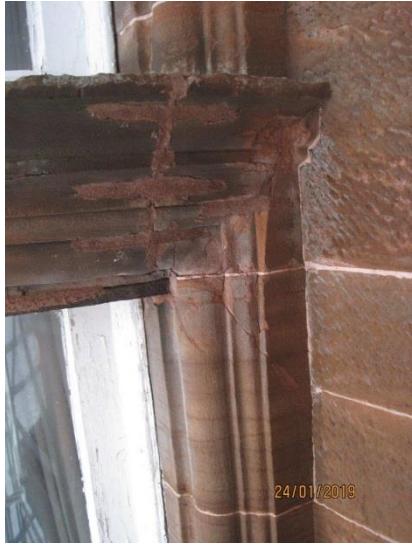
Defect ID	Photo Source	Defect Description	Defect Location	Crack Orientation	Crack Width (mm)	Crack Length (mm)	Comments	Photo	Severity Category
W4.120	IMG_0560, 0561	Cracking to sandstone	Elevation W4, Wall Circular bay window	Diagonal	0-1	200	-

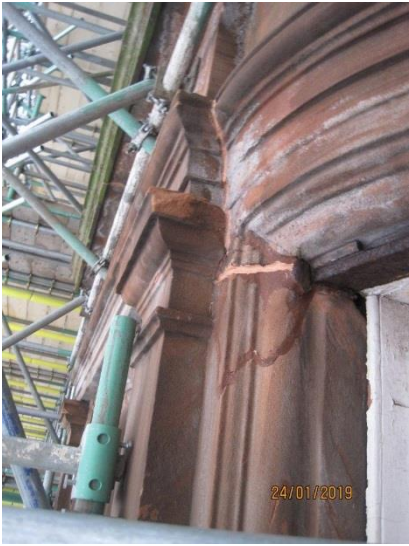
Defect ID	Photo Source	Defect Description	Defect Location	Crack Orientation	Crack Width (mm)	Crack Length (mm)	Comments	Photo	Severity Category
W4.121	IMG_0562-0567	Cracking to sandstone	Elevation W4, Wall Circular bay window	n/a	n/a	n/a	Crack appears to have been repaired/filled in

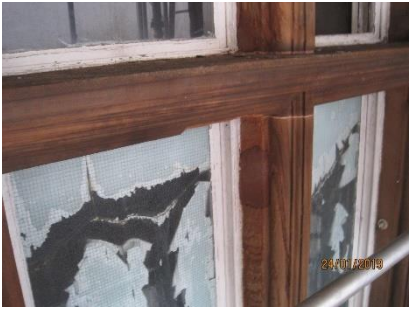
Amber
W4.122	IMG_0568, 0570	Loss of section	Elevation W4, Wall	n/a	n/a	n/a	Loss of section to underside of window ledge

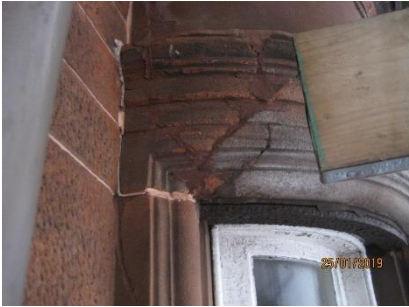
Defect ID	Photo Source	Defect Description	Defect Location	Crack Orientation	Crack Width (mm)	Crack Length (mm)	Comments	Photo	Severity Category
W4.126	IMG_0586, 0588	Cracking to sandstone, Spalled/damaged sandstone	Elevation W4, Wall Circular bay window	Diagonal	n/a	300-400	Crack appears to have been repaired/filled in

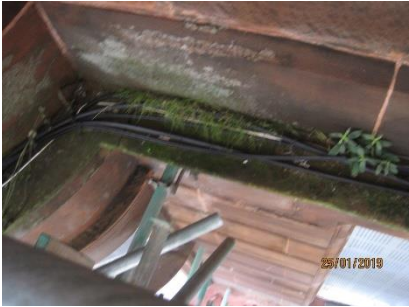
Defect ID	Photo Source	Defect Description	Defect Location	Crack Orientation	Crack Width (mm)	Crack Length (mm)	Comments	Photo	Severity Category
W4.140	IMG_0681, 0682	Vegetation growth	Elevation W4, Wall	n/a	n/a	n/a	Vegetation growth on sandstone ledge feature

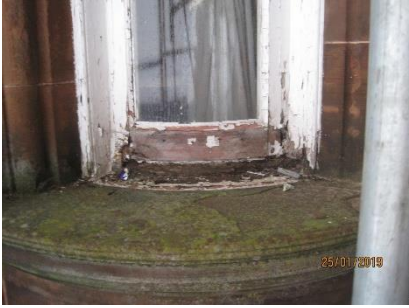
Amber
W4.141	IMG_0683-0690, 0703, 0704	Other	Elevation W4, Wall	n/a	n/a	n/a	Timber frame windows in poor condition

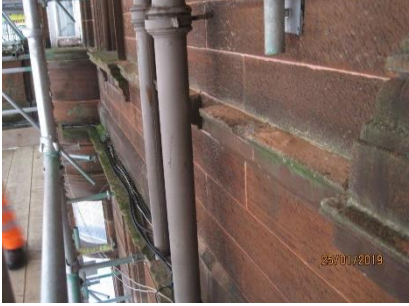
Green
W4.142	IMG_0707, 0711	Spalled/damaged sandstone	Elevation W4, Wall	n/a	n/a	n/a	Minor delamination/cracked/broken off sandstone along sandstone ledge feature

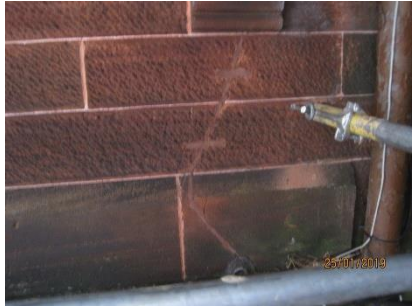
Defect ID	Photo Source	Defect Description	Defect Location	Crack Orientation	Crack Width (mm)	Crack Length (mm)	Comments	Photo	Severity Category
W4.143	IMG_0693, 0694	Cracking to sandstone	Elevation W4, Wall	Diagonal	n/a	600	Crack/defect appears to have been repaired/filled in

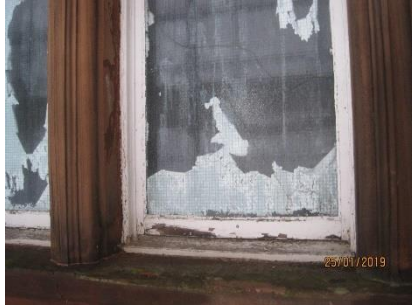
Amber
W4.144	IMG_0705, 0706	Other	Elevation W4, Wall	n/a	n/a	n/a	Cracked window pane

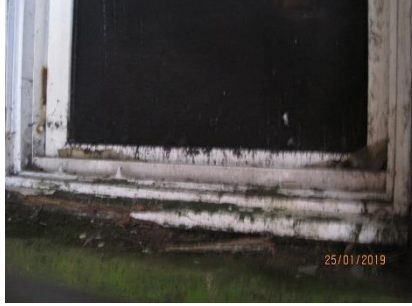
Green
W4.145	IMG_0697, 0707	Other	Elevation W4, Wall	n/a	n/a	n/a	Timber frame windows in poor condition

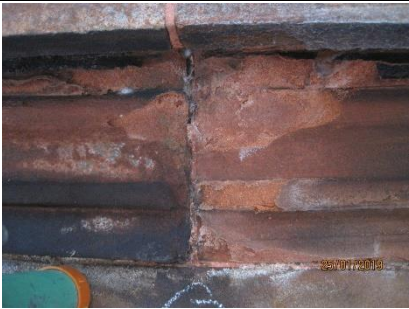
Defect ID	Photo Source	Defect Description	Defect Location	Crack Orientation	Crack Width (mm)	Crack Length (mm)	Comments	Photo	Severity Category
W4.146	IMG_0712, 0715	Spalled/damaged sandstone	Elevation W4, Wall	n/a	n/a	n/a	Delamination/erosion of/cracked/broken off sandstone along sandstone ledge feature. Sandstone surface layer crumbles on light contact.

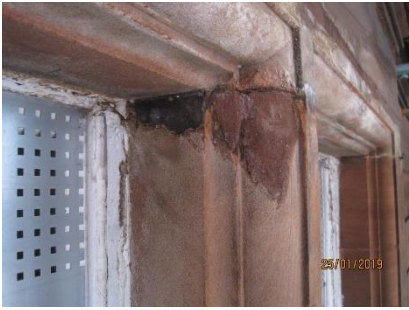
Red
W4.147	IMG_0717-0722	Cracking to sandstone	Elevation W4, Wall	n/a	n/a	n/a	Crack/defect appears to have been repaired/filled in

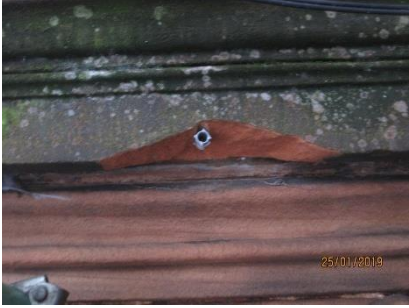
Amber
W4.148	IMG_0723, 0724, 0725, 0730, 0731	Spalled/damaged sandstone	Elevation W4, Wall	n/a	n/a	n/a	Cracked/broken off sandstone to sandstone ledge feature due to anchor fixing

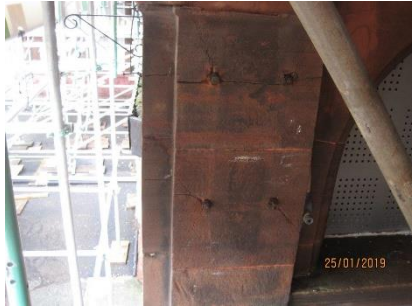
Defect ID	Photo Source	Defect Description	Defect Location	Crack Orientation	Crack Width (mm)	Crack Length (mm)	Comments	Photo	Severity Category
W4.149	IMG_0732-0734	Cracking to sandstone	Elevation W4, Wall	Radial	1-3	100	Cracks emanating from metal inserts

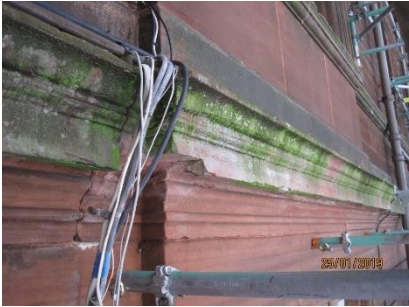
Defect ID	Photo Source	Defect Description	Defect Location	Crack Orientation	Crack Width (mm)	Crack Length (mm)	Comments	Photo	Severity Category
W4.152	IMG_0740-0742	Vegetation growth/staining	Elevation W4, Wall	n/a	n/a	n/a	Vegetation growth/staining along sandstone ledge feature

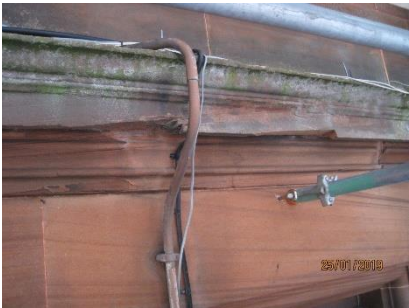
Green
W4.153	IMG_0745-0748	Loss of section	Elevation W4, Wall	n/a	n/a	n/a	Loss of section to underside of sandstone ledge feature above window

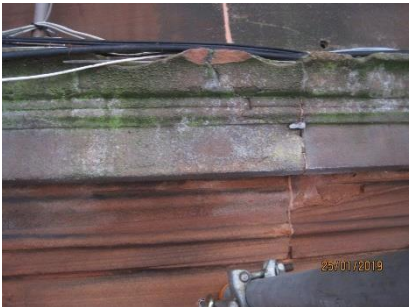
Green
W4.154	IMG_0749-0751	Spalled/damaged sandstone	Elevation W4, Wall	n/a	n/a	n/a	Cracked/broken off sandstone to sandstone ledge feature due to anchor fixing

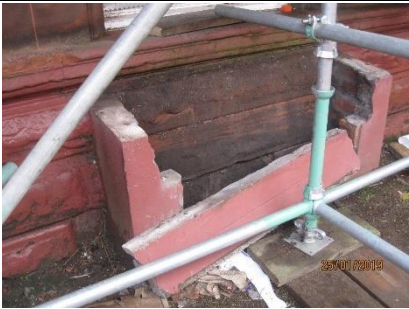
Defect ID	Photo Source	Defect Description	Defect Location	Crack Orientation	Crack Width (mm)	Crack Length (mm)	Comments	Photo	Severity Category
W4.161	IMG_0796, 0799	Spalled/damaged masonry	Elevation W4, Wall	n/a	n/a	n/a	Masonry section detached from external box out/louvre

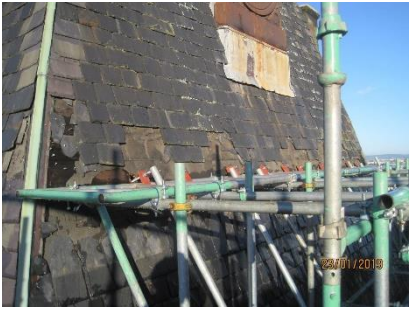
Defect ID	Photo Source	Defect Description	Defect Location	Crack Orientation	Crack Width (mm)	Crack Length (mm)	Comments	Photo	Severity Category
W5.1	IMG_0108	Other	Elevation W5, Roof	n/a	n/a	n/a	Roof tiles removed to allow for scaffold tie connection

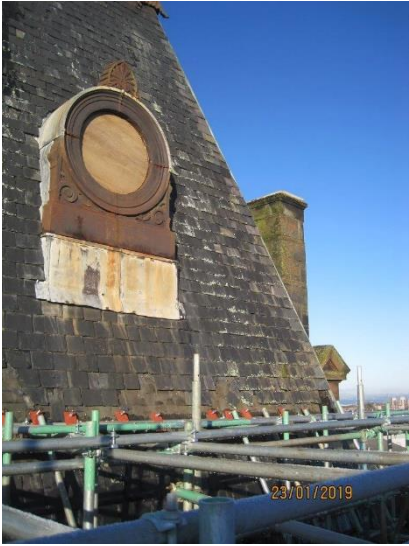
Amber
W5.2	IMG_0109	Vegetation	Elevation W5, Roof	n/a	n/a	n/a	-

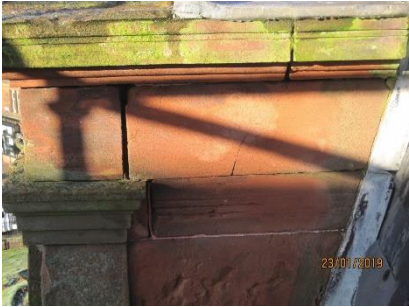
Defect ID	Photo Source	Defect Description	Defect Location	Crack Orientation	Crack Width (mm)	Crack Length (mm)	Comments	Photo	Severity Category
W5.3	IMG_0113	Cracking to sandstone	Elevation W5, Roof	Diagonal	1-2	150	-

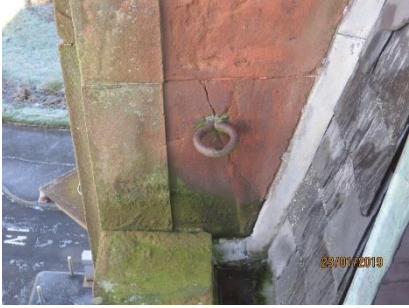
Amber
W5.4	IMG_0114	Cracking to sandstone	Elevation W5, Roof	Diagonal	1-3	300-400	Crack emanating from metal insert

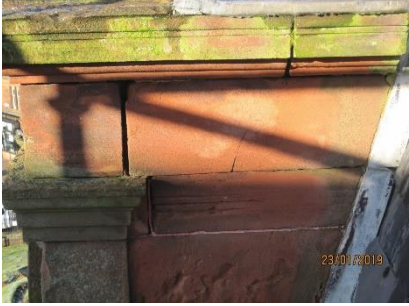
Amber
W5.5	IMG_0113	Other	Elevation W5, Roof	n/a	n/a	n/a	Loss of pointing / approx. 10mm vertical gap between masonry blocks.

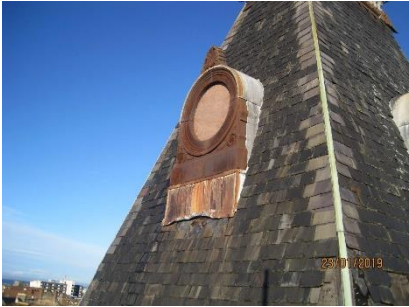
Defect ID	Photo Source	Defect Description	Defect Location	Crack Orientation	Crack Width (mm)	Crack Length (mm)	Comments	Photo	Severity Category
W5.6	IMG_0116	Staining	Elevation W5, Roof	n/a	n/a	n/a	Corrosion staining and damage to roof flashing.

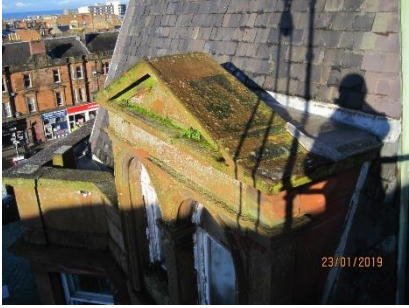
Green
W5.7	IMG_0117	Vegetation	Elevation W5, Roof	n/a	n/a	n/a	Vegetation on roof capping stone

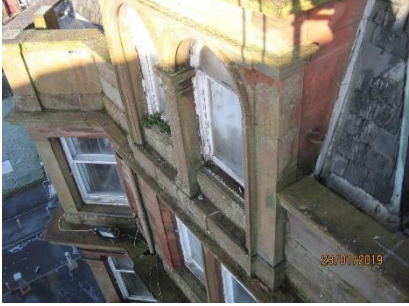
Green
W5.8	IMG_0118	Other	Elevation W5, Roof	n/a	n/a	n/a	Timber frame windows in poor condition. Vegetation growth along window frame noted

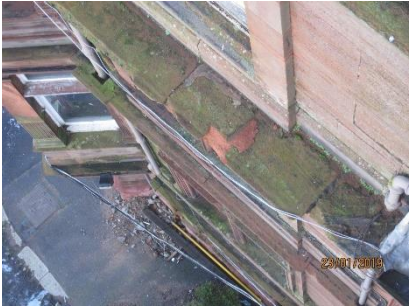
Defect ID	Photo Source	Defect Description	Defect Location	Crack Orientation	Crack Width (mm)	Crack Length (mm)	Comments	Photo	Severity Category
W5.9	IMG_0120	Spalled/damaged sandstone	Elevation W5, Wall	n/a	n/a	n/a	Delamination/erosion of/cracked/broken off sandstone to ledge feature noted

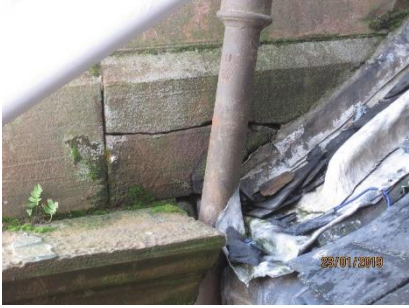
Amber
W5.10	IMG_0123	Cracking to sandstone	Elevation W5, Wall	Horizontal	3-5	400-500	-

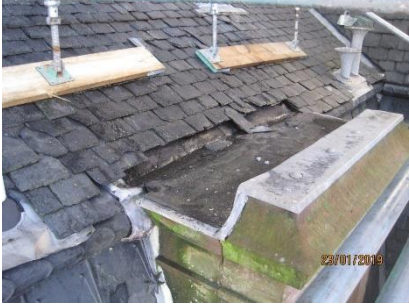
Green
W5.11	IMG_0124	Missing/damaged tiles	Elevation W5, Roof	n/a	n/a	n/a	-

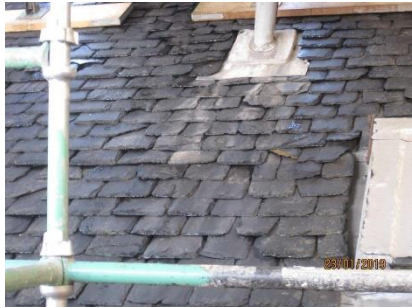
Defect ID	Photo Source	Defect Description	Defect Location	Crack Orientation	Crack Width (mm)	Crack Length (mm)	Comments	Photo	Severity Category
W5.12	IMG_0128	Dislodged/damaged tiles	Elevation W5, Roof	n/a	n/a	n/a	-

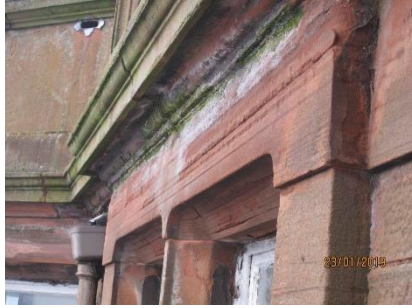
Amber
W5.13	IMG_0214-0216	Spalled/damaged sandstone	Elevation W5, Wall	-	-	-	Sandstone lintel appears to be delaminating

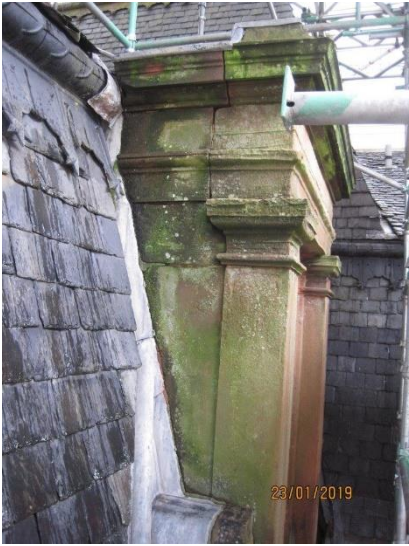
Defect ID	Photo Source	Defect Description	Defect Location	Crack Orientation	Crack Width (mm)	Crack Length (mm)	Comments	Photo	Severity Category
W5.14	IMG_0218	Vegetation staining	Elevation W5, Wall				-

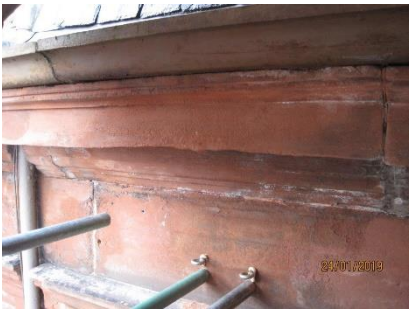
Green
W5.15	IMG_0319	Spalled/damaged sandstone	Elevation W5, Wall	n/a	n/a	n/a	Minor erosion to sandstone ledge feature

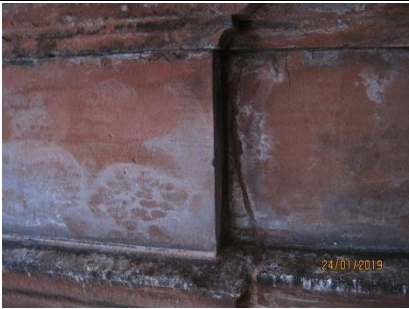
Defect ID	Photo Source	Defect Description	Defect Location	Crack Orientation	Crack Width (mm)	Crack Length (mm)	Comments	Photo	Severity Category
W5.16	IMG_0321	Cracking to sandstone	Elevation W5, Wall	Vertical	3-5	300	Crack appears to have been repaired/filled in

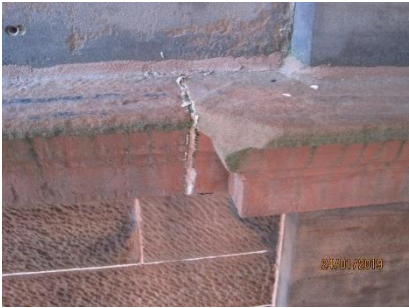
Defect ID	Photo Source	Defect Description	Defect Location	Crack Orientation	Crack Width (mm)	Crack Length (mm)	Comments	Photo	Severity Category
W5.22	IMG_0467	Spalled/damaged sandstone	Elevation W5, Wall	n/a	n/a	n/a	Cracked/broken off sandstone to ledge architectural feature

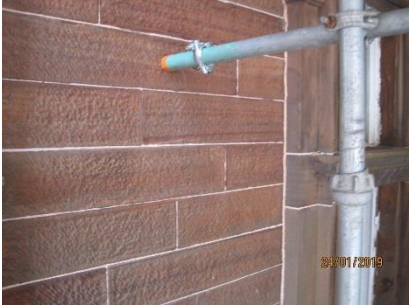
Green
W5.23	IMG_0517-0519	Cracking to sandstone	Elevation W5, Wall	Horizontal	0-1	50	-

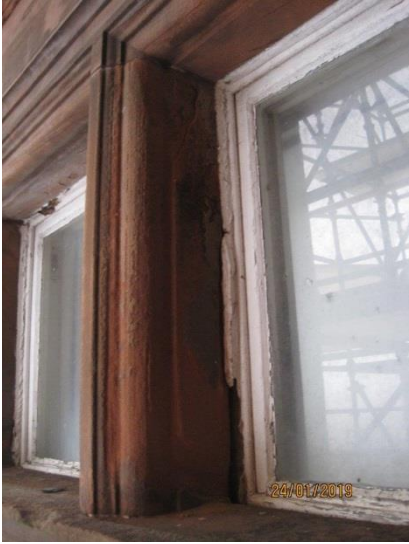
Defect ID	Photo Source	Defect Description	Defect Location	Crack Orientation	Crack Width (mm)	Crack Length (mm)	Comments	Photo	Severity Category
W5.24	IMG_0520-0525	Spalled/damaged sandstone	Elevation W5, Wall	n/a	n/a	n/a	Delamination/erosion of sandstone to window mullion

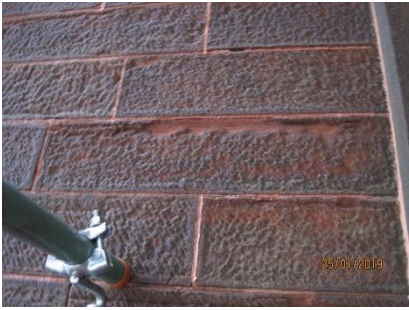
Defect ID	Photo Source	Defect Description	Defect Location	Crack Orientation	Crack Width (mm)	Crack Length (mm)	Comments	Photo	Severity Category
W5.25	IMG_0526-0534	Other	Elevation W5, Wall	n/a	n/a	n/a	Timber window frame in poor condition.	 	Green
W5.26	IMG_0594, 0595	Spalled/damaged sandstone	Elevation W5, Wall	n/a	n/a	n/a	Minor delamination/erosion to sandstone

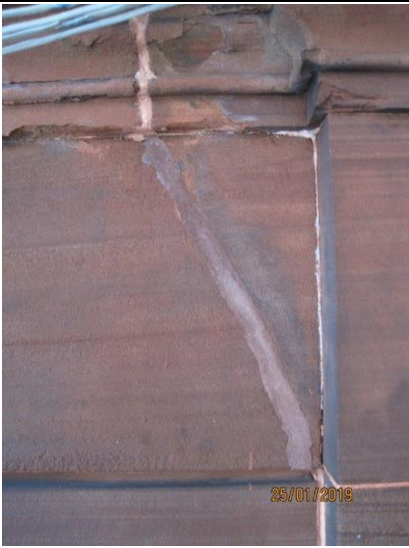
Defect ID	Photo Source	Defect Description	Defect Location	Crack Orientation	Crack Width (mm)	Crack Length (mm)	Comments	Photo	Severity Category
W5.30	IMG_0635, 0636	Cracking to sandstone	Elevation W5, Wall	Diagonal	n/a	400	Possible crack repair

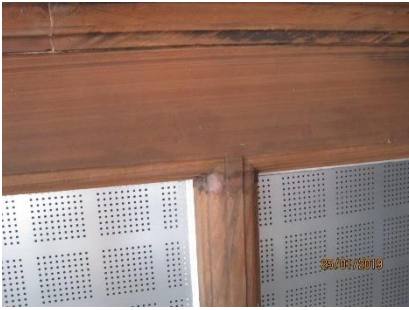
Green
W5.31	IMG_0637, 0638	Cracking to sandstone	Elevation W5, Wall	Horizontal	n/a	200	Crack/defect appears to have been repaired/filled in

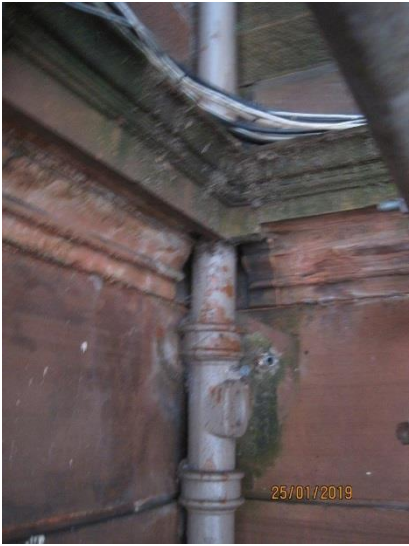
Defect ID	Photo Source	Defect Description	Defect Location	Crack Orientation	Crack Width (mm)	Crack Length (mm)	Comments	Photo	Severity Category
W5.32	IMG_0639, 0640	Vegetation growth	Elevation W5, Wall	n/a	n/a	n/a	Vegetation growth/staining at wall corner adjacent downpipe

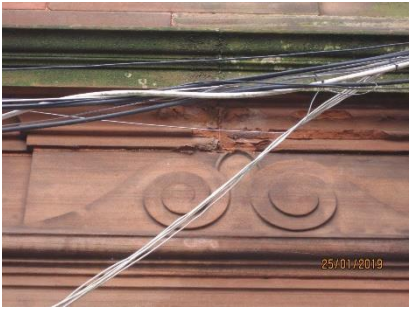
Green
W5.33	IMG_0816-0818	Spalled/damaged sandstone	Elevation W5, Wall	n/a	n/a	n/a	Minor delamination/erosion of sandstone to sandstone ledge feature

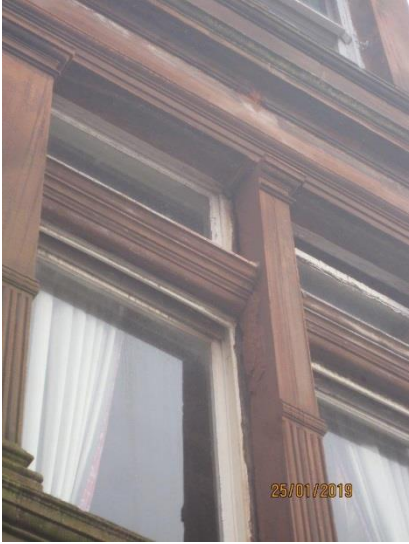
Defect ID	Photo Source	Defect Description	Defect Location	Crack Orientation	Crack Width (mm)	Crack Length (mm)	Comments	Photo	Severity Category
W5.39	IMG_0845-0850	Loss of section	Elevation W5, Wall	n/a	n/a	n/a	Loss of section to vertical sandstone block adjacent window

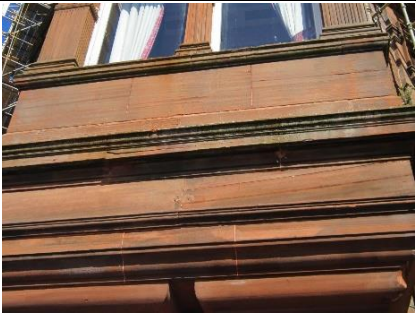
Defect ID	Photo Source	Defect Description	Defect Location	Crack Orientation	Crack Width (mm)	Crack Length (mm)	Comments	Photo	Severity Category
W6.3	IMG_2104	Crack	Elevation W6, Wall	Horizontal	1-5	800	-

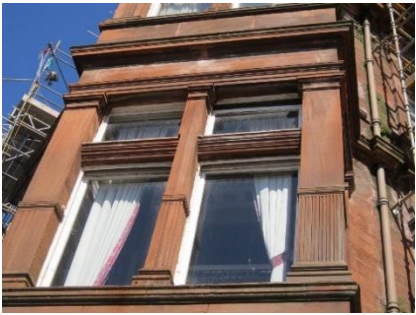
Green
W6.4	IMG_2106	Other	Elevation W6, Wall	n/a	n/a	n/a	Deteriorating timber window frame and delamination/erosion of sandstone

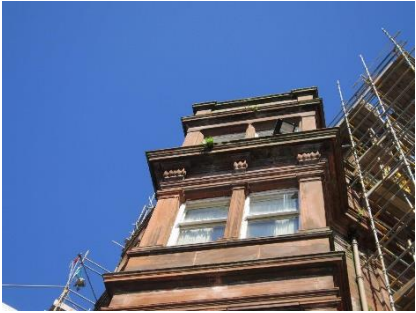
Green
W6.5	IMG_2105	Vegetation growth	Elevation W6, Wall	n/a	n/a	n/a	-

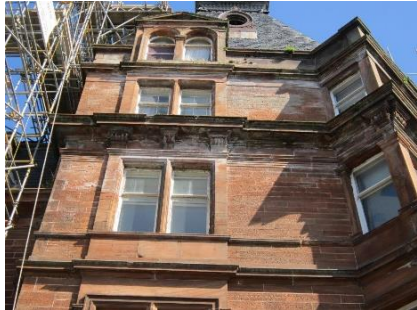
Defect ID	Photo Source	Defect Description	Defect Location	Crack Orientation	Crack Width (mm)	Crack Length (mm)	Comments	Photo	Severity Category
W6.6	IMG_2119	Mineral staining efflorescence	Elevation W6, Wall	n/a	n/a	n/a	-

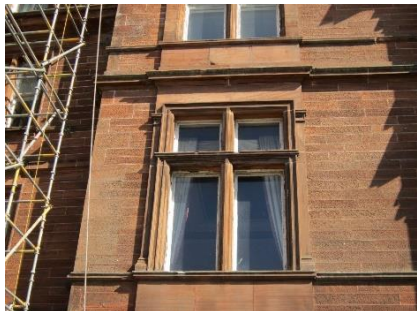
Green
W6.7	IMG_2118	Other	Elevation W6, Wall	n/a	n/a	n/a	Deteriorating timber window frame and delamination/erosion of/cracked/broken off sandstone

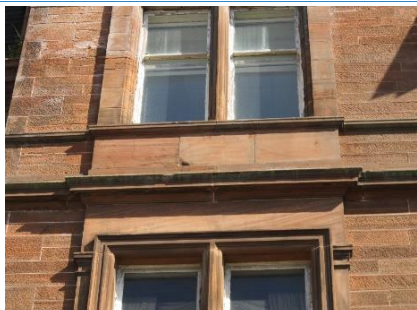
Green
W6.8	IMG_2116	Spalled/damaged sandstone	Elevation W6, Wall	n/a	n/a	n/a	Cracked/broken off sandstone to corner of sandstone block

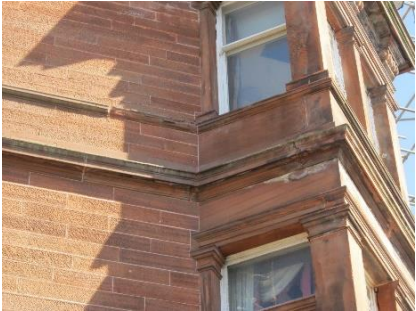
Defect ID	Photo Source	Defect Description	Defect Location	Crack Orientation	Crack Width (mm)	Crack Length (mm)	Comments	Photo	Severity Category
W6.9	IMG_2114	Mineral staining efflorescence	Elevation W6, Wall	n/a	n/a	n/a	-

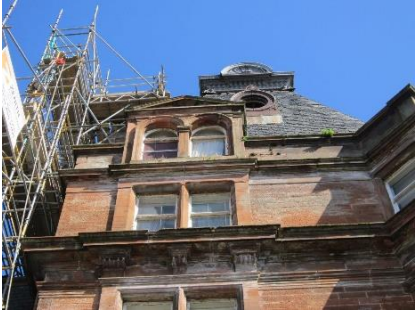
Defect ID	Photo Source	Defect Description	Defect Location	Crack Orientation	Crack Width (mm)	Crack Length (mm)	Comments	Photo	Severity Category
W6.12	IMG_2109	Vegetation growth	Elevation W6, Wall	n/a	n/a	n/a	-

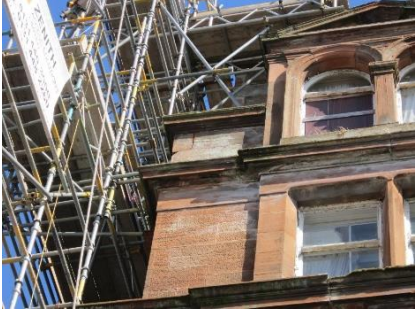
Green
W6.13	IMG_2107	Displaced corner block	Elevation W6, Wall	n/a	n/a	n/a	Left corner of 4th floor window

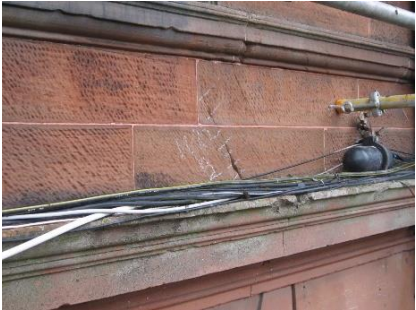
Amber
W6.14	IMG_2328	Crack	Elevation W6, Wall	Diagonal	1-3	200	-

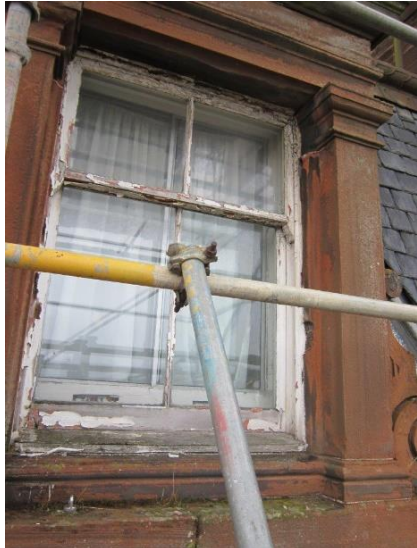
Defect ID	Photo Source	Defect Description	Defect Location	Crack Orientation	Crack Width (mm)	Crack Length (mm)	Comments	Photo	Severity Category
W6.20	IMG_2355	Poor timber window frame	Elevation W6, Wall	n/a	n/a	n/a	-

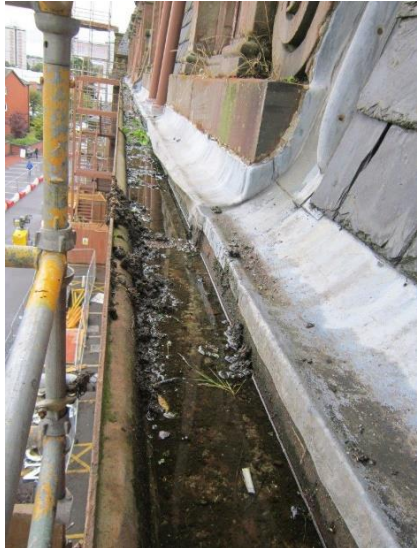
Defect ID	Photo Source	Defect Description	Defect Location	Crack Orientation	Crack Width (mm)	Crack Length (mm)	Comments	Photo	Severity Category
W6.21	IMG_2357	Vegetation growth	Elevation W6, Wall	n/a	n/a	n/a	In gutters

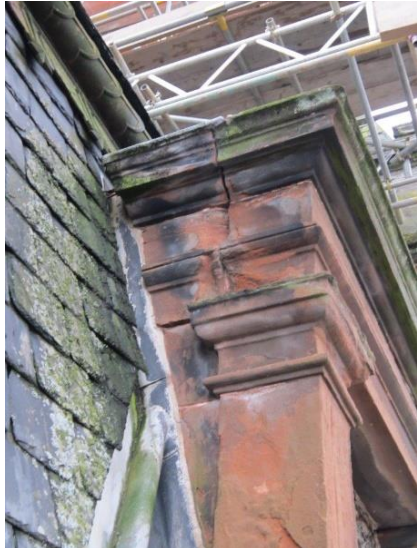
Defect ID	Photo Source	Defect Description	Defect Location	Crack Orientation	Crack Width (mm)	Crack Length (mm)	Comments	Photo	Severity Category
W6.22	IMG_2360	Mortar loss, possible crack and Spalled/damaged sandstone	Elevation W6, Wall	n/a	n/a	n/a	Significant delamination/erosion of sandstone to side face of window pilaster

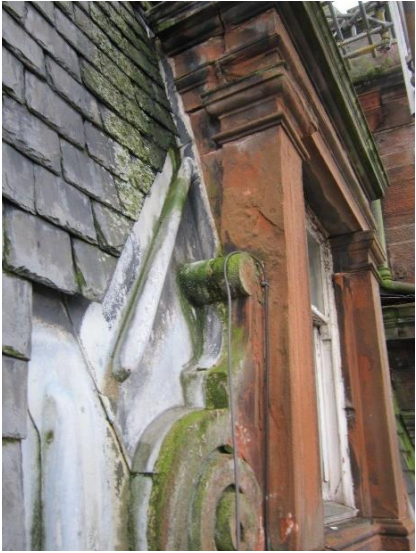
Defect ID	Photo Source	Defect Description	Defect Location	Crack Orientation	Crack Width (mm)	Crack Length (mm)	Comments	Photo	Severity Category
W6.23	IMG_2352 & 2353	Spalled/damaged sandstone	Elevation W6, Wall	n/a	n/a	n/a	Delamination/erosion of sandstone to side face of window pilaster

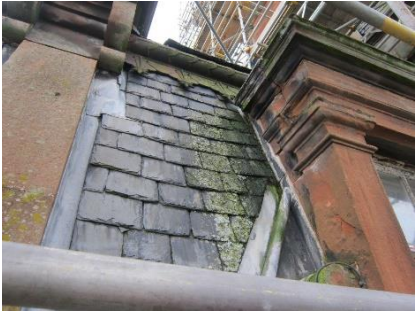
Amber
W6.24	IMG_2354	Significant vegetation growth	Elevation W6, Wall	n/a	n/a	n/a	-

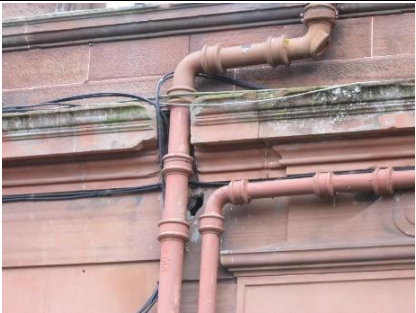
Defect ID	Photo Source	Defect Description	Defect Location	Crack Orientation	Crack Width (mm)	Crack Length (mm)	Comments	Photo	Severity Category
W6.28	IMG_2168	Missing section	Elevation W6, Wall	n/a	n/a	n/a	Hole in block behind down pipe and under projected feature

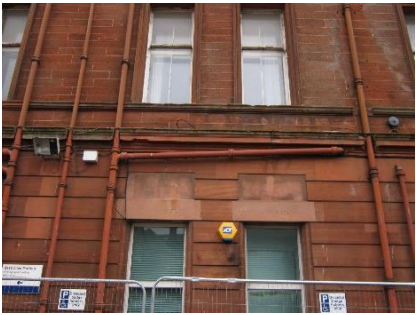
Amber
W6.29	IMG_2136	Loss of section	Elevation W6, Wall	n/a	n/a	n/a	-

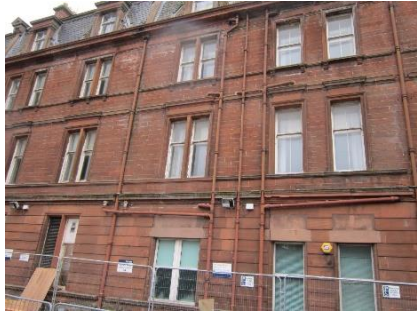
Defect ID	Photo Source	Defect Description	Defect Location	Crack Orientation	Crack Width (mm)	Crack Length (mm)	Comments	Photo	Severity Category
W6.31	IMG_2139	Deteriorating timber frames	Elevation W6, Wall	n/a	n/a	n/a	-

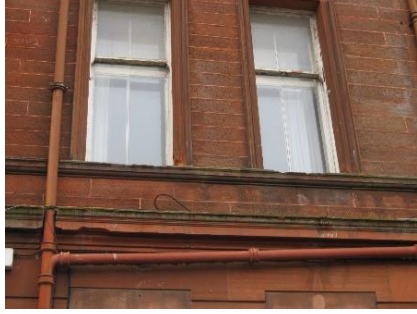
Green
W6.32	IMG_2141	Loss of section	Elevation W6, Wall	n/a	n/a	n/a	Minor loss of stonework on all 1st floor windows

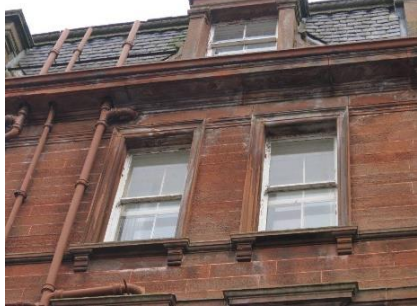
Green
W6.33	IMG_2145	Loss of section	Elevation W6, Wall	n/a	n/a	n/a	-

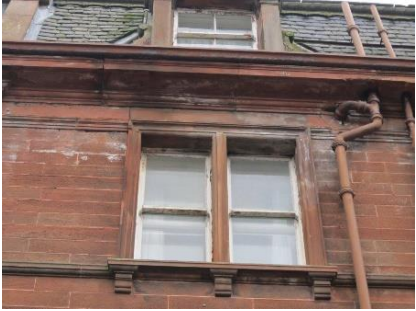
Defect ID	Photo Source	Defect Description	Defect Location	Crack Orientation	Crack Width (mm)	Crack Length (mm)	Comments	Photo	Severity Category
W6.34	IMG_2147	Mineral staining efflorescence	Elevation W6, Wall	n/a	n/a	n/a	On projected blocks, extending 1.5-2 metres	 	Green
W6.35	IMG_2151 & 2152	Mineral staining efflorescence	Elevation W6, Wall	n/a	n/a	n/a	Vegetation staining at down pipe. Heavy mineral staining on top window cills.

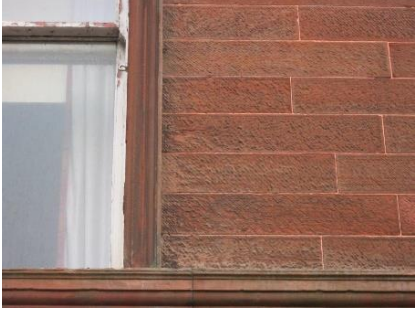
Green
W6.36	IMG_2155	Minor cracks	Elevation W6, Wall	Horizontal	1	200	-

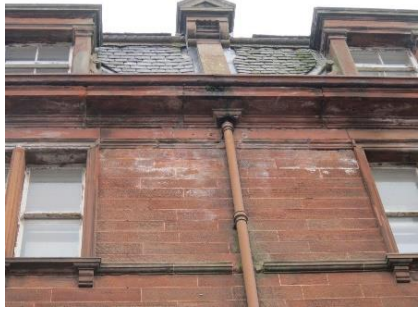
Defect ID	Photo Source	Defect Description	Defect Location	Crack Orientation	Crack Width (mm)	Crack Length (mm)	Comments	Photo	Severity Category
W6.37	IMG_2158	Possible loss of section	Elevation W6, Wall	n/a	n/a	n/a	-

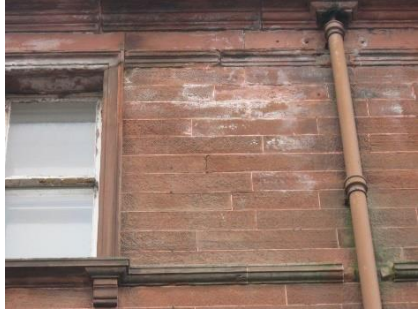
Green
W6.38	IMG_2159	Possible loss of pointing	Elevation W6, Wall	n/a	n/a	n/a	-

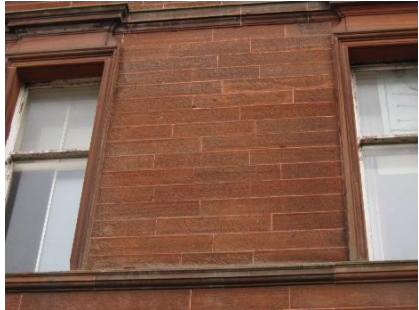
Green
W6.39	IMG_2161	Loss of section	Elevation W6, Wall	n/a	n/a	n/a	-

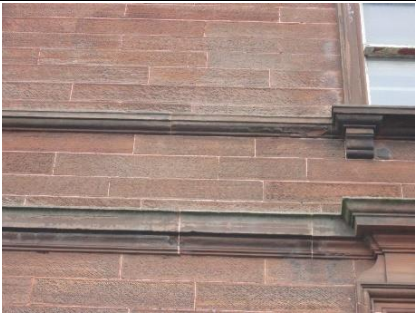
Defect ID	Photo Source	Defect Description	Defect Location	Crack Orientation	Crack Width (mm)	Crack Length (mm)	Comments	Photo	Severity Category
W6.40	IMG_2162	Loss of section	Elevation W6, Wall	n/a	n/a	n/a	-

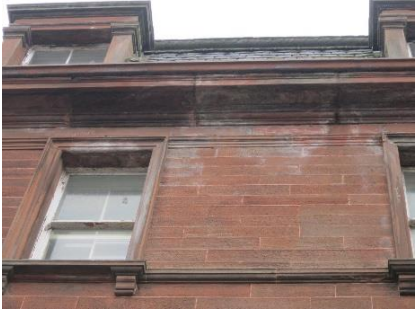
Green
W6.41	IMG_2165	Mineral staining efflorescence	Elevation W6, Wall	n/a	n/a	n/a	Staining on 2nd floor window cills

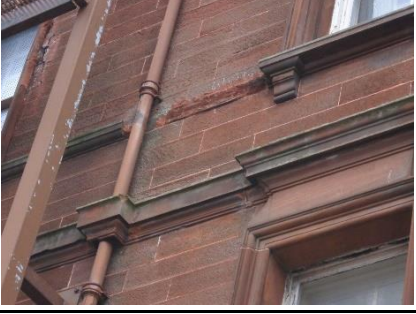
Green
W6.42	IMG_2164	Loss of section	Elevation W6, Wall	n/a	n/a	n/a	-
