Former Ayr Station Hotel Building Structural Condition

Independent Report

03 October 2019

Document reference: 399316/SNI/GLA/DOC/S2/REP/002

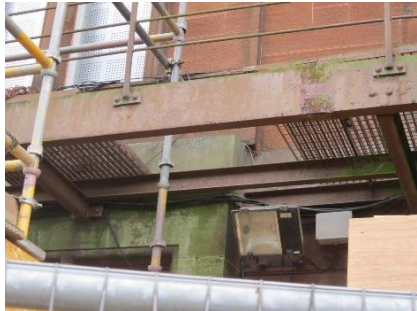
Defect ID	Photo Source	Defect Description	Defect Location	Crack Orientation	Crack Width (mm)	Crack Length (mm)	Comments	Photo	Severity Category
W6.43	IMG_2169 to 2175	Other	Elevation W6, Wall	n/a	n/a	n/a	Deterioration of paint finish, vegetation growth and localised surface corrosion to steelwork. Missing platform grating.

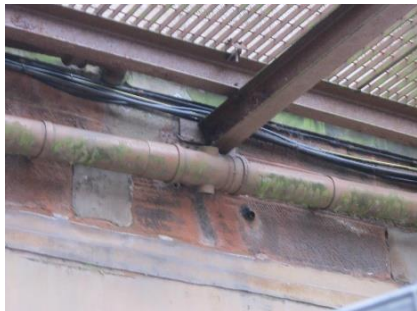
Red
W6.44	IMG_2180 & 2183	Corrosion	Elevation W6, Wall	n/a	n/a	n/a	Surface corrosion to end plate connection of outrigger

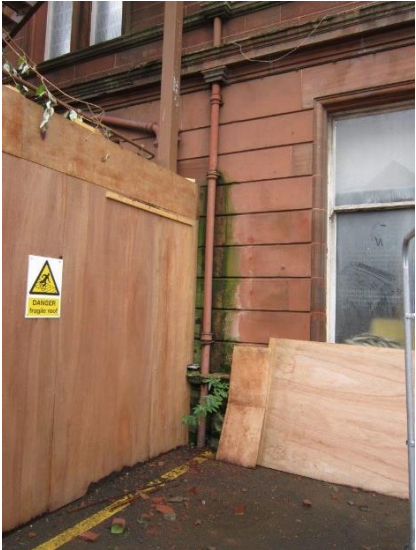
Defect ID	Photo Source	Defect Description	Defect Location	Crack Orientation	Crack Width (mm)	Crack Length (mm)	Comments	Photo	Severity Category
W6.45	IMG_2184	Vegetation staining	Elevation W6, Wall	n/a	n/a	n/a	Looks to be caused by back-up of rainwater downpipe, and water seeping/flowing from joint. Below ground drainage issue

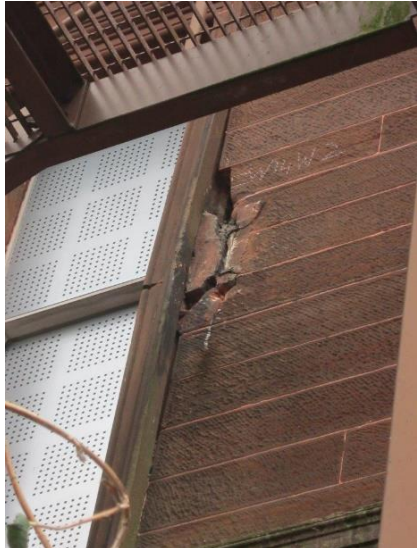
Defect ID	Photo Source	Defect Description	Defect Location	Crack Orientation	Crack Width (mm)	Crack Length (mm)	Comments	Photo	Severity Category
W6.46	IMG_2187	Loss of section & missing section	Elevation W6, Wall	n/a	n/a	n/a	Cracking caused by corrosion of wrought iron insert

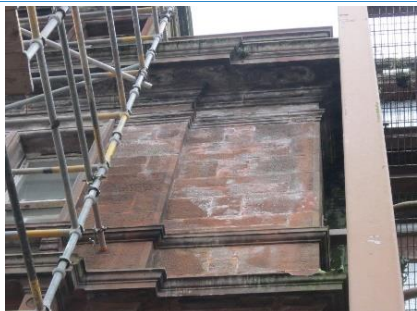
Red
W6.47	IMG_2191	Mineral staining efflorescence	Elevation W6, Wall	n/a	n/a	n/a	Heavy staining on projections and walls

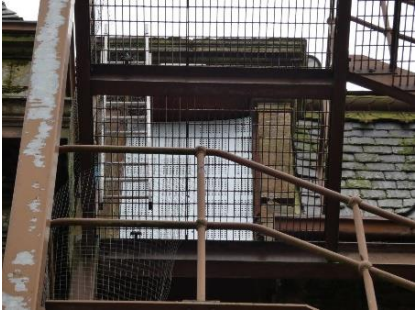
Defect ID	Photo Source	Defect Description	Defect Location	Crack Orientation	Crack Width (mm)	Crack Length (mm)	Comments	Photo	Severity Category
W6.53	P1000465	Spalled/damaged sandstone	Elevation W6, Wall	n/a	n/a	n/a	-

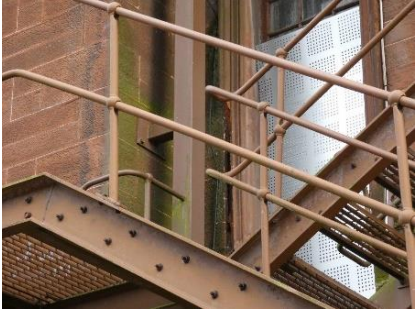
Amber
W6.54	P1000487	Spalled/damaged sandstone	Elevation W6, Wall	n/a	n/a	n/a	-

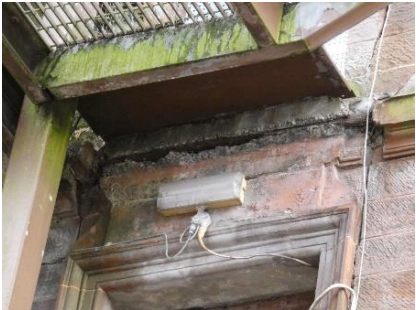
Amber
W6.55	P1000494	Spalled/damaged sandstone	Elevation W6, Wall	n/a	n/a	n/a	-

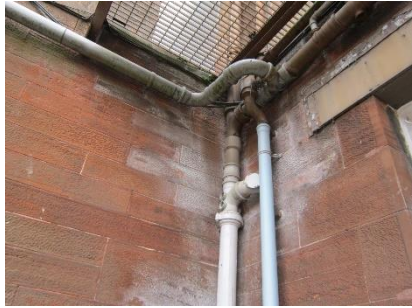
Defect ID	Photo Source	Defect Description	Defect Location	Crack Orientation	Crack Width (mm)	Crack Length (mm)	Comments	Photo	Severity Category
W7.1	IMG_2206	Spalled/damaged sandstone, Mineral staining efflorescence	Elevation W7, Wall	n/a	n/a	n/a	Minor delamination/erosion of sandstone blocks

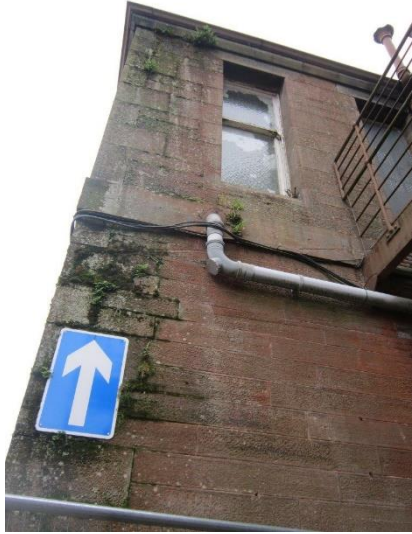
Green
W7.2	IMG_2205	Vegetation growth/staining	Elevation W7, Wall	n/a	n/a	n/a	Vegetation growth travelling along pointing. It appears pointing is missing and have been replaced with vegetation. Vegetation expands both floors

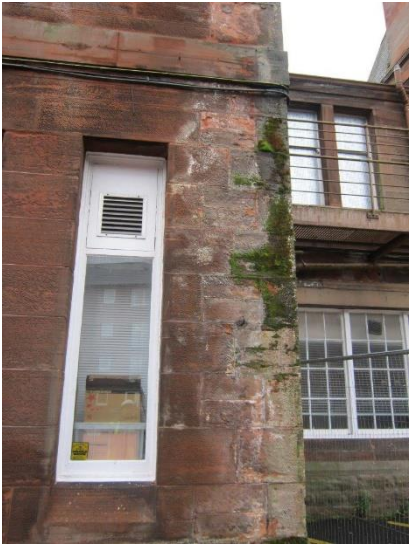
Defect ID	Photo Source	Defect Description	Defect Location	Crack Orientation	Crack Width (mm)	Crack Length (mm)	Comments	Photo	Severity Category
W8.1	IMG_2236	Spalled/damaged sandstone, Vegetation growth/staining	Elevation W8, Wall	n/a	n/a	n/a	-

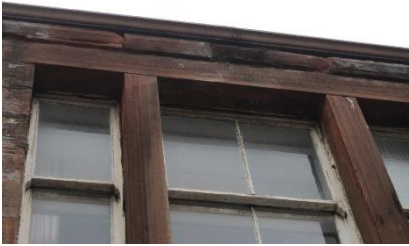
Amber
W8.2	IMG_2240	Missing section	Elevation W8, Wall	n/a	n/a	n/a	-

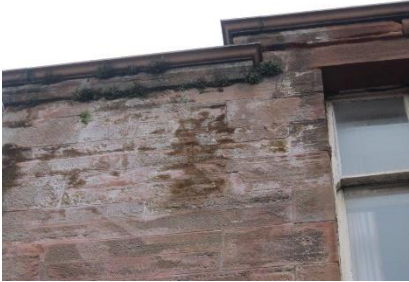
Defect ID	Photo Source	Defect Description	Defect Location	Crack Orientation	Crack Width (mm)	Crack Length (mm)	Comments	Photo	Severity Category
W8.3	IMG_2242	Spalled/damaged sandstone, Mineral staining efflorescence	Elevation W8, Wall	n/a	n/a	n/a	-

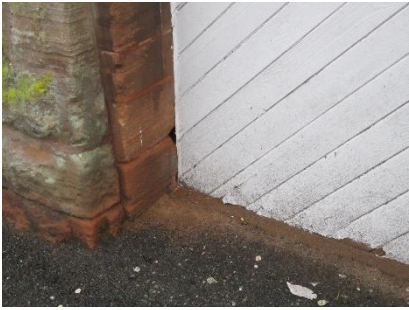
Amber
W8.4	IMG_2244	Missing section	Elevation W8, Wall	n/a	n/a	n/a	Near timber panelling under window

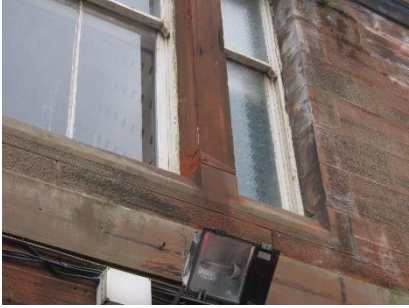
Green
W8.5	IMG_2238	Spalled/damaged sandstone	Elevation W8, Wall	n/a	n/a	n/a	Minor delamination/erosion of sandstone on window mullion

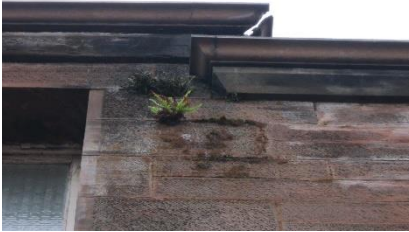
Defect ID	Photo Source	Defect Description	Defect Location	Crack Orientation	Crack Width (mm)	Crack Length (mm)	Comments	Photo	Severity Category
W8.6	IMG_2247	Missing section	Elevation W8, Wall	n/a	n/a	n/a	-

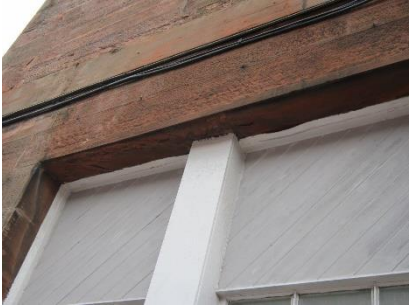
Red
W8.7	IMG_2251	Spalled/damaged sandstone	Elevation W8, Wall	n/a	n/a	n/a	Underside of upper projected feature

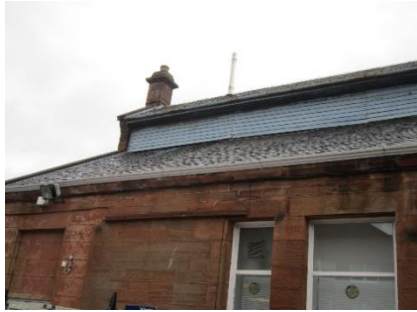
Defect ID	Photo Source	Defect Description	Defect Location	Crack Orientation	Crack Width (mm)	Crack Length (mm)	Comments	Photo	Severity Category
W10.1	IMG_2266	Loose cladding	Elevation W10, Wall	n/a	n/a	n/a	Cladding is in poor condition

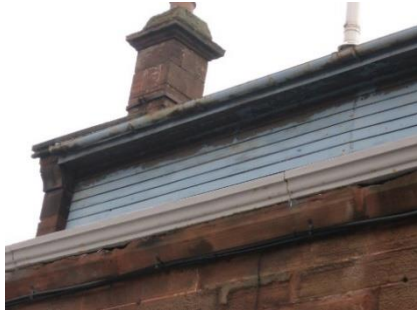
Green
W10.2	IMG_2269	Corrosion	Elevation W10, Wall	n/a	n/a	n/a	Gutters are exhibiting corrosion

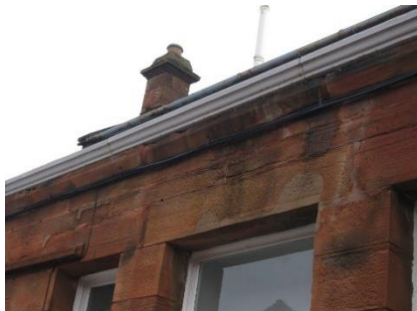
Green
W10.3	IMG_2270 to 2272	Spalled/ damaged sandstone	Elevation W10, Wall	n/a	n/a	n/a	Localized along the whole length of wall at eaves level

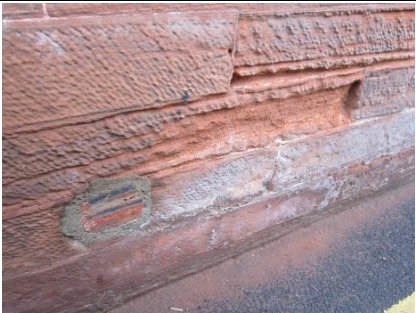
Defect ID	Photo Source	Defect Description	Defect Location	Crack Orientation	Crack Width (mm)	Crack Length (mm)	Comments	Photo	Severity Category
W10.4	IMG_2279	Spalled/damaged sandstone	Elevation W10, Wall	n/a	n/a	n/a	Spalling/delamination/erosion of sandstone

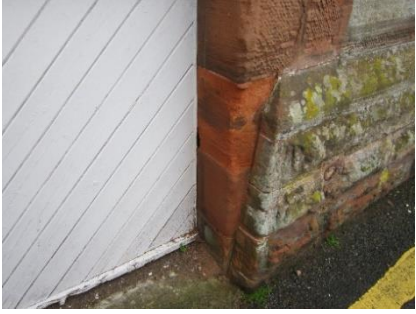
Amber
W10.5	IMG_2299	Spalled/damaged sandstone	Elevation W10, Wall	n/a	n/a	n/a	Delamination/erosion of sandstone on either side of the timber panelling

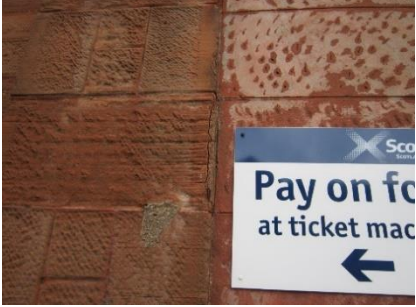
Green
W10.6	IMG_2281	Crack	Elevation W10, Wall	Vertical	1-2	400	-

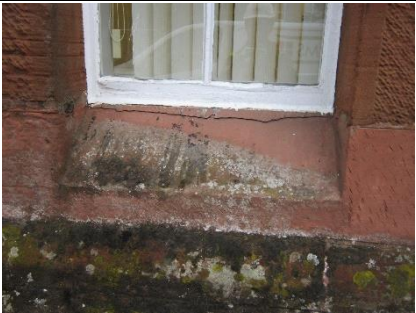
Defect ID	Photo Source	Defect Description	Defect Location	Crack Orientation	Crack Width (mm)	Crack Length (mm)	Comments	Photo	Severity Category
W10.7	IMG_2283	Crack	Elevation W10, Wall	Horizontal	1-5	800	-

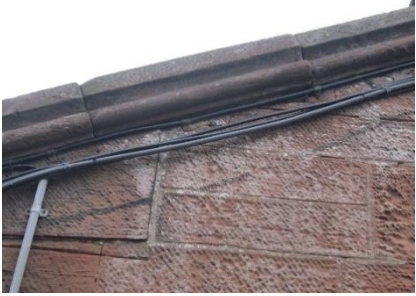
Green
W10.8	IMG_2297	Crack	Elevation W10, Wall	Diagonal	1-3	300	-

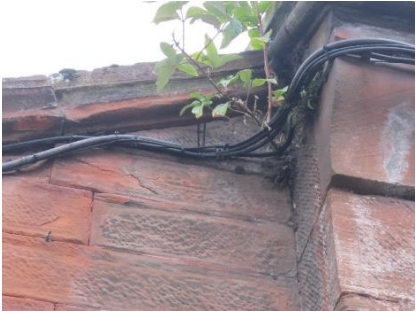
Green
W10.9	IMG_2303	Loss of pointing	Elevation W10, Wall	n/a	n/a	n/a	Vegetation growth within the absent pointing

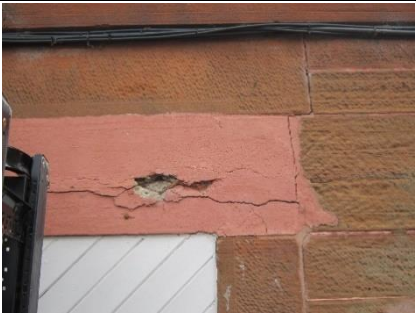
Defect ID	Photo Source	Defect Description	Defect Location	Crack Orientation	Crack Width (mm)	Crack Length (mm)	Comments	Photo	Severity Category
W10.10	IMG_2308	Cracking to lintel	Elevation W10, Wall	Horizontal	1-5	2000	Crack along lintel with spalling of surface, lintel appears to be a reinforced concrete lintel

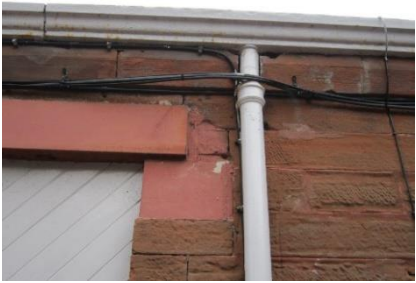
Amber
W10.11	IMG_2313	Spalled/damaged sandstone	Elevation W10, Wall	n/a	n/a	n/a	Delamination/erosion of/cracked/broken off sandstone to blocks along roof eaves level, at multiple locations

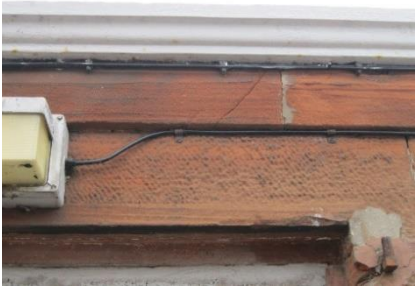
Amber
W10.12	IMG_2319	Cracking to sandstone	Elevation W10, Wall	Diagonal	1-2	300	-

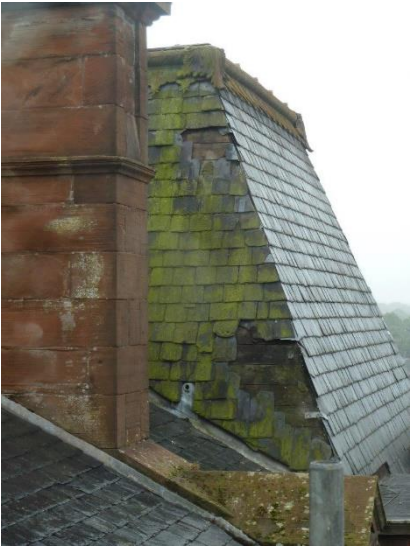
Defect ID	Photo Source	Defect Description	Defect Location	Crack Orientation	Crack Width (mm)	Crack Length (mm)	Comments	Photo	Severity Category
R1.1	P1190532	Missing/damaged tiles/roof	North face of tower	n/a	n/a	n/a	Missing slates, exposed/deteriorated timber

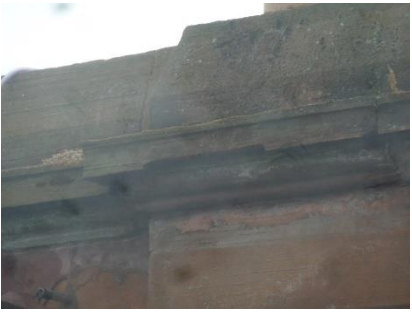
Amber
R1.2	P1190533	Spalled/damaged sandstone	Chimney stack	n/a	n/a	n/a

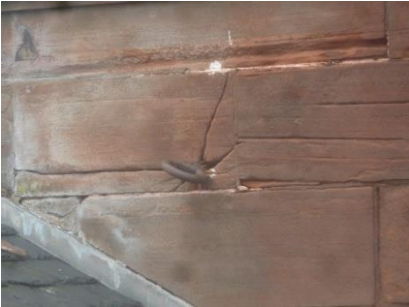
Defect ID	Photo Source	Defect Description	Defect Location	Crack Orientation	Crack Width (mm)	Crack Length (mm)	Comments	Photo	Severity Category
R1.3	P1190534	Cracking to sandstone	Chimney stack	Radial	-	-	Cracking to sandstone blocks around deadbolt anchor location

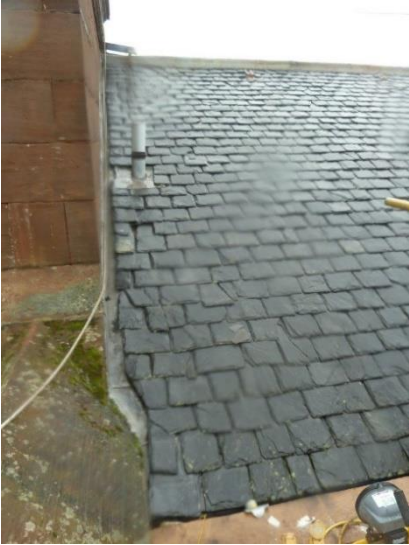
Amber
R1.4	P1190535	Missing/damaged tiles/roof	Pitched roof	n/a	n/a	n/a	-

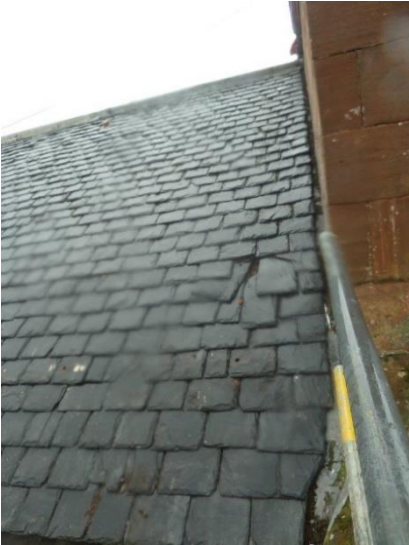
Defect ID	Photo Source	Defect Description	Defect Location	Crack Orientation	Crack Width (mm)	Crack Length (mm)	Comments	Photo	Severity Category
R1.5	P1190539	Missing/damaged tiles/roof	Pitched roof	n/a	n/a	n/a	-

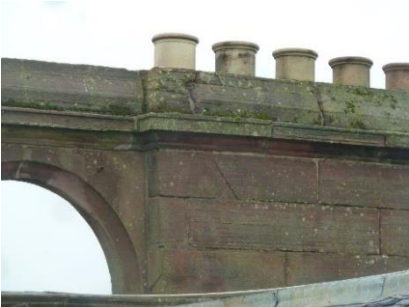
Green
R1.6	P1190547	Cracking to sandstone	Chimney stack	Diagonal	2	300	-

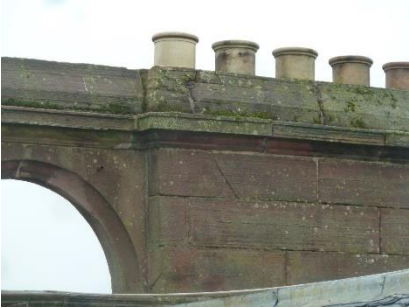
Defect ID	Photo Source	Defect Description	Defect Location	Crack Orientation	Crack Width (mm)	Crack Length (mm)	Comments	Photo	Severity Category
R1.7	P1190548	Cracking to sandstone	Chimney stack	Diagonal	2	300	-	 	Green
R1.8	P1190547	Cracking to sandstone	Chimney stack	Vertical	3	300	Cracking through chimney coping stone

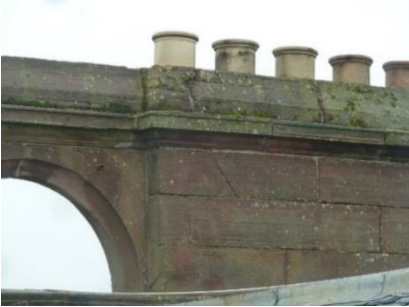
Green
R1.9	P1190547	Cracking to sandstone	Chimney stack	Horizontal	2	600	Horizontal crack through sides and length of sandstone block

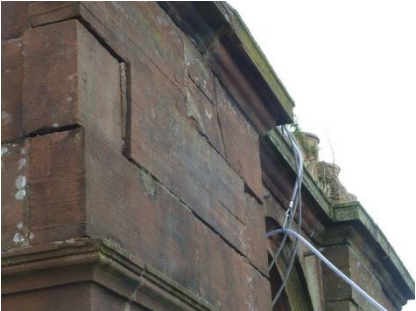
Defect ID	Photo Source	Defect Description	Defect Location	Crack Orientation	Crack Width (mm)	Crack Length (mm)	Comments	Photo	Severity Category
R2.4	P1190568	Cracking to sandstone	Chimney stack	Vertical	2	400	-

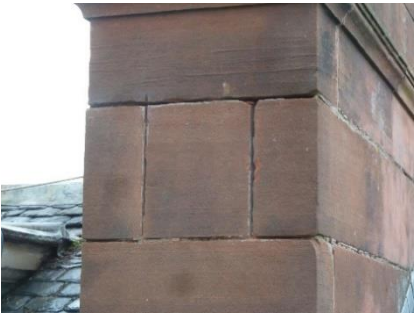
Amber
R2.5	P1190569	Other	Chimney stack	n/a	n/a	n/a	Mortar loss to sandstone blocks. Evidence of movement to edge blocks and risk of further movement. Evidence of saw cutting to mortar joints/block

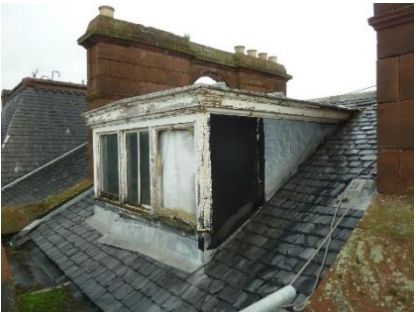
Amber
R2.6	P1190570, 0579	Other	Window framing	n/a	n/a	n/a	Degraded timber elements and flashing to dormer structure

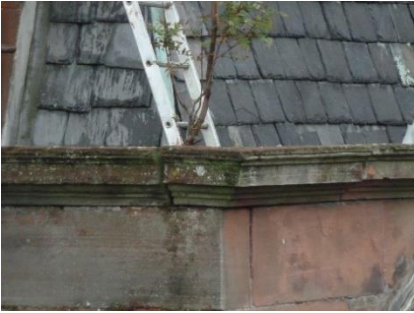
Defect ID	Photo Source	Defect Description	Defect Location	Crack Orientation	Crack Width (mm)	Crack Length (mm)	Comments	Photo	Severity Category
R2.10	P1190574	Spalled/damaged sandstone	Tower	n/a	n/a	n/a	Sandstone edge block dislodged/ loose. Potential for further movement/ failure over time

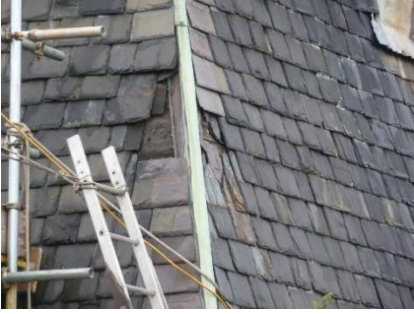
Amber
R2.11	P1190575, 0580, 0581	Missing/damaged tiles/roof	Tower	n/a	n/a	n/a	Missing slates, exposed timbers

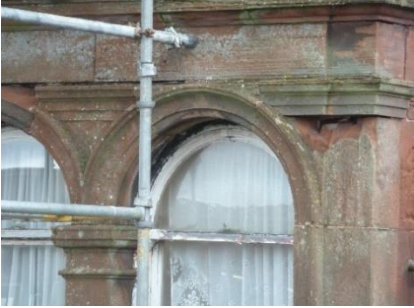
Red
R2.12	P1190576	Spalled/damaged sandstone	Tower	n/a	n/a	n/a	Cracked/broken off sandstone to edge of window arch

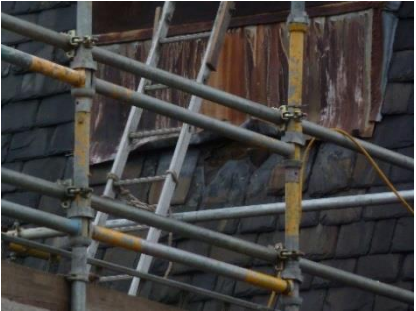
Defect ID	Photo Source	Defect Description	Defect Location	Crack Orientation	Crack Width (mm)	Crack Length (mm)	Comments	Photo	Severity Category
R2.13	P1190577	Missing/damaged tiles/roof	Tower	n/a	n/a	n/a	Slates missing, and timbers exposed below feature window

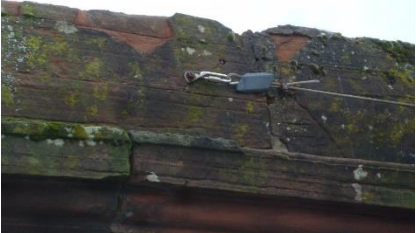
Red
R2.14	P1190582	Cracking to sandstone	Chimney stack	n/a	n/a	n/a	Delamination/cracked/broken off sandstone around chimney head

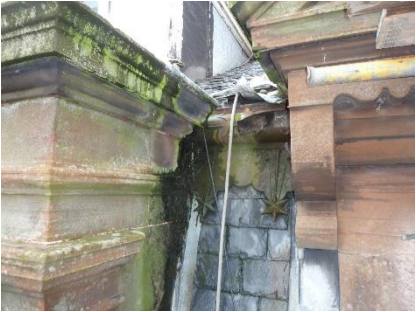
Red
R2.15	P1190585	Other		n/a	n/a	n/a	Damaged/displaced cast iron edging to roof

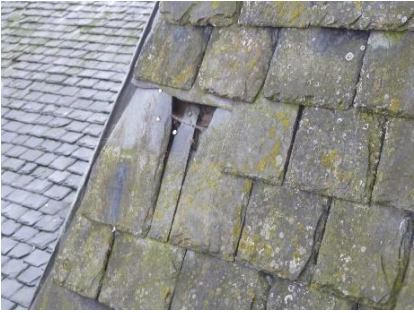
Defect ID	Photo Source	Defect Description	Defect Location	Crack Orientation	Crack Width (mm)	Crack Length (mm)	Comments	Photo	Severity Category
R3.1	P1190600	Missing/damaged tiles/roof	Tower	n/a	n/a	n/a	Missing slates, exposed timbers

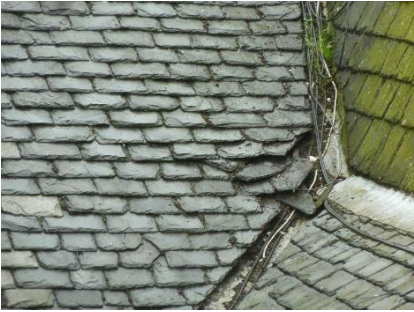
Green
R3.2	P1190601	Missing/damaged tiles/roof	Pitched roof	n/a	n/a	n/a	-

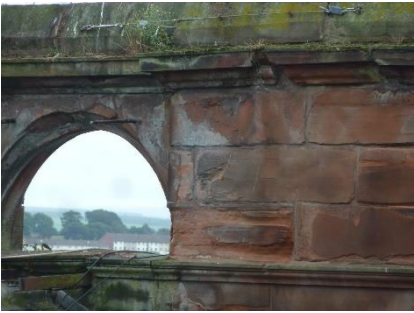
Amber
R3.3	P1190602	Spalled/damaged sandstone	Chimney stack	n/a	n/a	n/a	Delamination/erosion of sandstone blocks to chimney stack

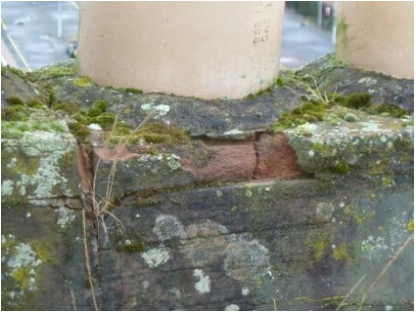
Defect ID	Photo Source	Defect Description	Defect Location	Crack Orientation	Crack Width (mm)	Crack Length (mm)	Comments	Photo	Severity Category
R3.10	P1190613	Spalled/damaged sandstone	Chimney stack	n/a	n/a	n/a	-

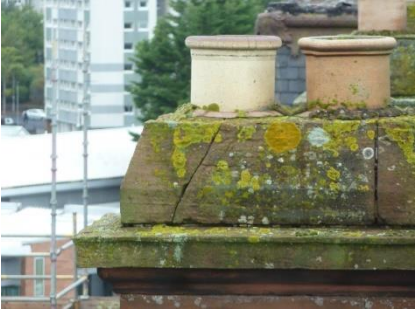
Amber
R3.11	P1190614	Cracking to sandstone		Diagonal	3	300	Crack to sandstone block around chimney pot location

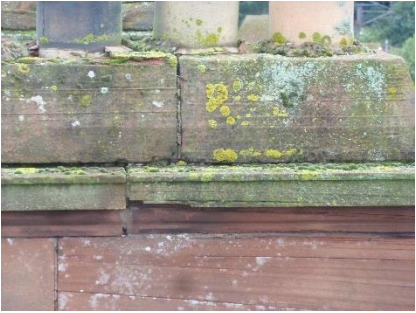
Amber
R3.12	P1190615	Spalled/damaged sandstone	Chimney stack	n/a	n/a	n/a	-

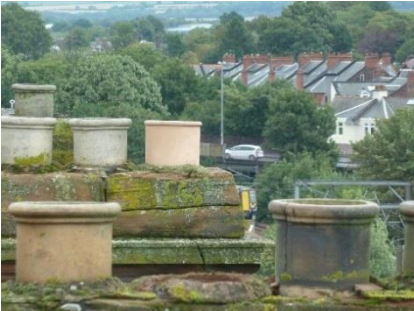
Defect ID	Photo Source	Defect Description	Defect Location	Crack Orientation	Crack Width (mm)	Crack Length (mm)	Comments	Photo	Severity Category
R3.13	P1190616	Cracking to sandstone	Chimney stack	Vertical	4	300	Crack through blockwork Sandstone ledge features tone and block below. Full extent of defect not visible from survey location

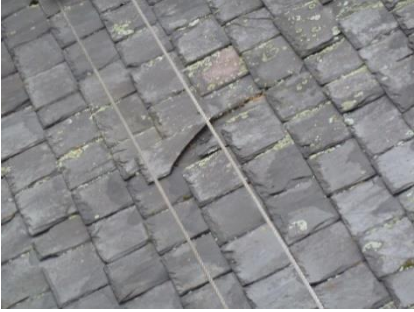
Amber
R3.14	P1190617, 0618	Missing/damaged tiles/roof	Roof	n/a	n/a	n/a	-

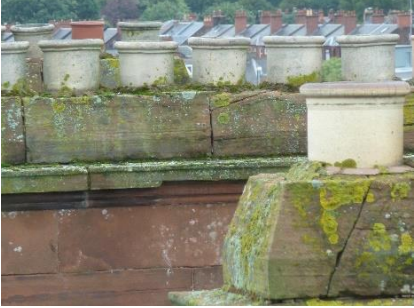
Green
R3.15	P1190619	Spalled/damaged sandstone	Chimney stack	n/a	n/a	n/a	-

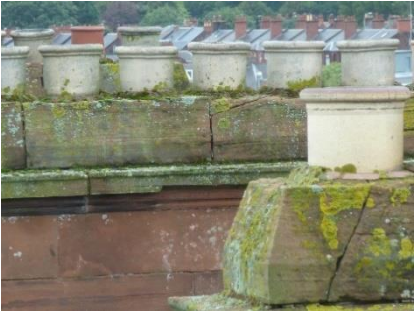
Defect ID	Photo Source	Defect Description	Defect Location	Crack Orientation	Crack Width (mm)	Crack Length (mm)	Comments	Photo	Severity Category
R3.16	P1190619	Cracking to sandstone	Chimney stack	n/a	n/a	n/a	-

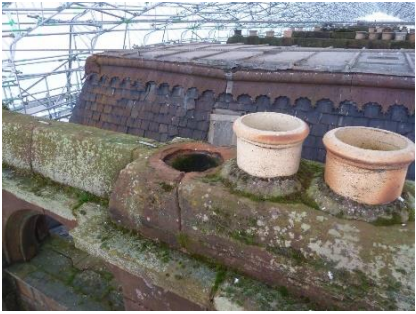
Defect ID	Photo Source	Defect Description	Defect Location	Crack Orientation	Crack Width (mm)	Crack Length (mm)	Comments	Photo	Severity Category
R4.1	P1200539	Cracking to sandstone, Other	Roof chimney	Vertical	4	300	Chimney pot missing, crack in sandstone.

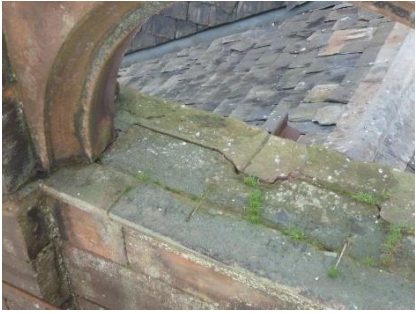
Red
R4.2	P1200540	Cracking to sandstone	Roof chimney	Horizontal	3	1000	Crack on chimney frame.

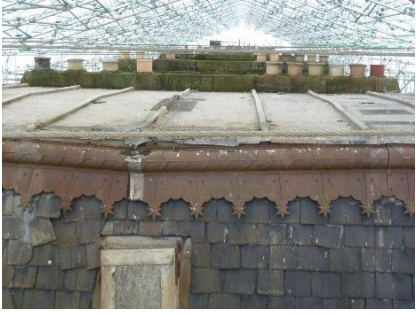
Amber
R4.3	P1200541	Damaged cast iron fittings	Roof ridge	n/a	n/a	n/a	Cast iron features detaching.

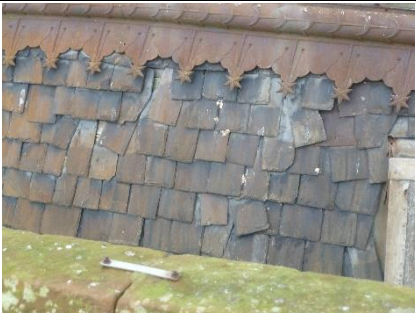
Defect ID	Photo Source	Defect Description	Defect Location	Crack Orientation	Crack Width (mm)	Crack Length (mm)	Comments	Photo	Severity Category
R4.4	P1200542	Missing/damaged tiles/roof	Roof	n/a	n/a	n/a	Various tiles loose/missing.

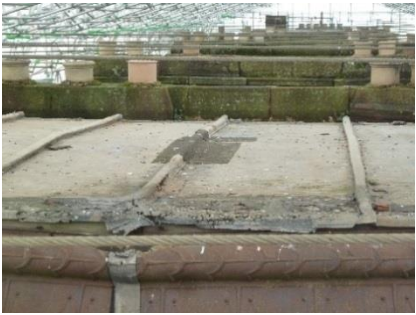
Amber
R4.5	P1200543 - 546	Other	Flat roof	n/a	n/a	n/a	Flat roof waterproofing finish shows signs of cracking and fatigue

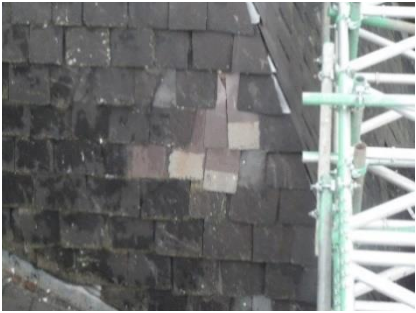
Red
R4.6	P1200547	Missing/damaged tiles/roof	Roof	n/a	n/a	n/a	Various tiles loose.

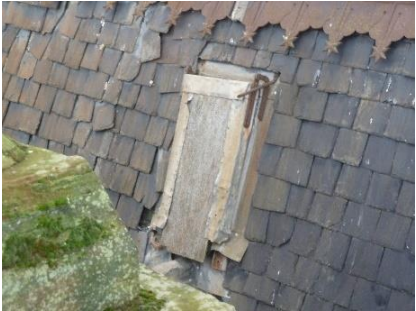
Defect ID	Photo Source	Defect Description	Defect Location	Crack Orientation	Crack Width (mm)	Crack Length (mm)	Comments	Photo	Severity Category
R4.7	P1200548	Other	Roof access hatch	n/a	n/a	n/a	Damage to door of roof access hatch.

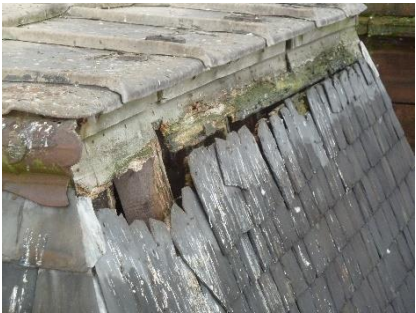
Amber
R4.8	P1200549 - 552	Missing/damaged tiles/roof, Damaged cast iron fittings, Other	Roof ridge	n/a	n/a	n/a	Cast iron features missing. Various tiles loose/missing. Exposed timber rotting.

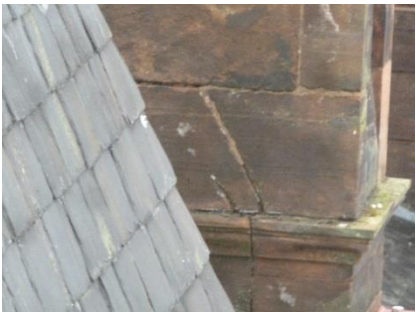
Red
R4.9	P1200553	Cracking to sandstone	Chimney	Diagonal	3	300	Crack on sandstone.

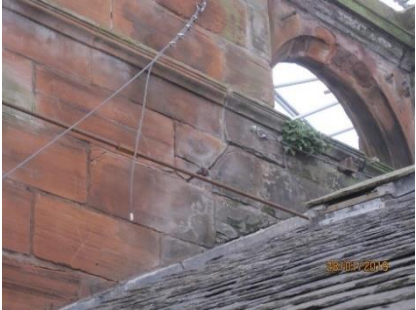
Defect ID	Photo Source	Defect Description	Defect Location	Crack Orientation	Crack Width (mm)	Crack Length (mm)	Comments	Photo	Severity Category
R4.16	IMG_0860	Cracking to sandstone	Chimney stack	Diagonal	5	400	Crack through sandstone.

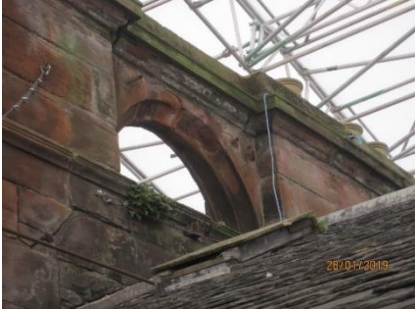
Amber
R4.17	IMG_0861	Spalled/damaged sandstone	Chimney stack	n/a	n/a	n/a	Delamination/erosion of sandstone above arch

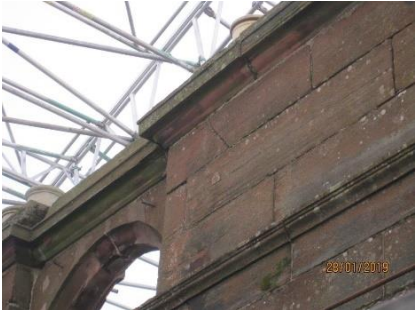
Red
R4.18	IMG_0862	Cracking to sandstone	Chimney stack	Diagonal	2	400	Crack on sandstone block.

Green

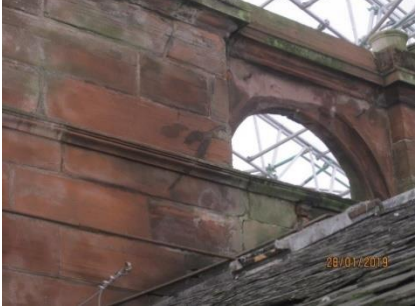
Defect ID	Photo Source	Defect Description	Defect Location	Crack Orientation	Crack Width (mm)	Crack Length (mm)	Comments	Photo	Severity Category
R4.19	IMG_0863	Cracking to sandstone	Chimney stack	Diagonal	2	800	Crack on 2 sandstone blocks (> shape).	 	Green
R4.20	IMG_0864	Spalled/damaged sandstone	Chimney stack	n/a	n/a	n/a	Delamination/erosion of sandstone at last block of wall with gap/loss of section observed	 	Amber
R4.21	IMG_0865	Cracking to sandstone	Chimney stack	Diagonal	2	400	Repaired cracks on sandstone blocks

Red

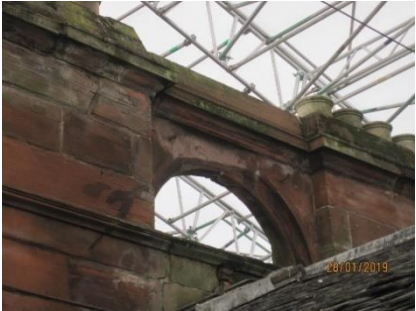
Defect ID	Photo Source	Defect Description	Defect Location	Crack Orientation	Crack Width (mm)	Crack Length (mm)	Comments	Photo	Severity Category
R4.22	IMG_0866	Spalled/damaged sandstone	Chimney stack	n/a	n/a	n/a	Delamination/erosion of/cracked/broken off sandstone above arch

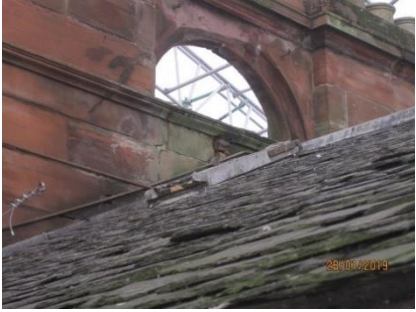
Red
R4.23	IMG_0867	Spalled/damaged sandstone	Pipe	n/a	n/a	n/a	Small area of delamination/erosion of/cracked/broken off sandstone next to pipe

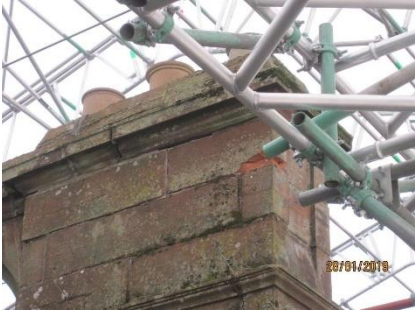
Defect ID	Photo Source	Defect Description	Defect Location	Crack Orientation	Crack Width (mm)	Crack Length (mm)	Comments	Photo	Severity Category
R4.25	IMG_0869	Spalled/damaged sandstone	Chimney stack	n/a	n/a	n/a	Cracked/broken off sandstone to chimney stack wall

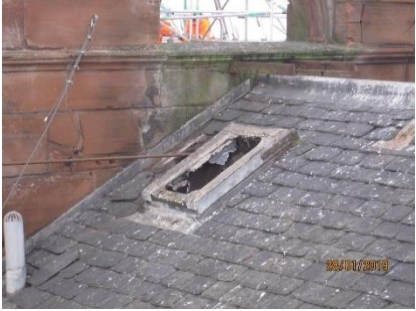
Amber
R4.26	IMG_0870, 0873	Other	Roof	n/a	n/a	n/a	Skylight window broken

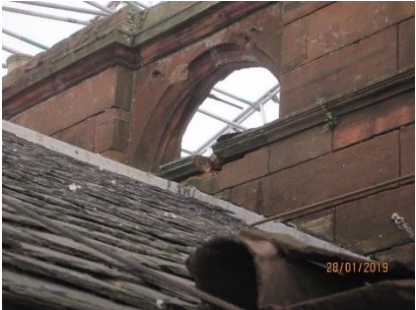
Red
R4.27	IMG_0871	Cracking to sandstone	Chimney stack	n/a	n/a	n/a	Significant cracked/broken off sections of sandstone blocks to chimney

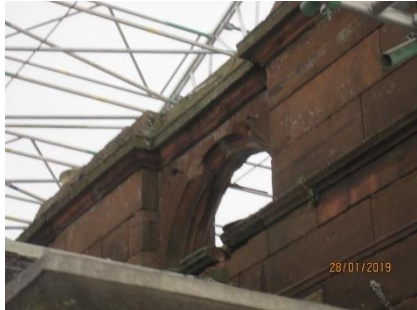
Defect ID	Photo Source	Defect Description	Defect Location	Crack Orientation	Crack Width (mm)	Crack Length (mm)	Comments	Photo	Severity Category
R4.28	IMG_0872	Spalled/damaged sandstone	Chimney stack	n/a	n/a	n/a	Delamination/erosion of/cracked/broken off sandstone on arch

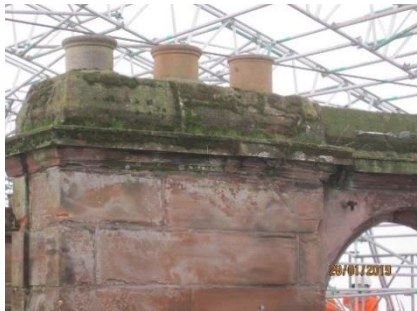
Red
R4.29	IMG_0874	Water staining efflorescence	Chimney stack	n/a	n/a	n/a	Water staining below chimney pots. General comment for all chimney stacks

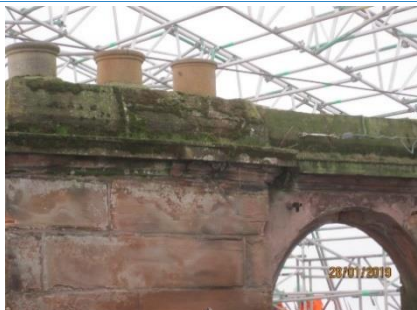
Amber
R4.30	IMG_0875	Cracking to sandstone	Chimney stack	Diagonal	3mm	400mm	Diagonal crack on sandstone block

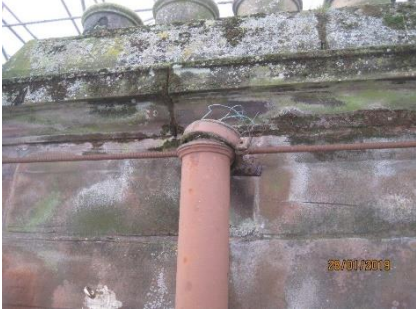
Defect ID	Photo Source	Defect Description	Defect Location	Crack Orientation	Crack Width (mm)	Crack Length (mm)	Comments	Photo	Severity Category
R4.34	IMG_0879	Damaged cast iron fittings	Roof	n/a	n/a	n/a	Cast iron features missing.	 	Amber
R4.35	IMG_0880	Missing/damaged tiles/roof	Roof	n/a	n/a	n/a	Tiles loose/missing.	 	Amber
R4.36	IMG_0881	Damaged/defective gutter/drainage	Pipe	n/a	n/a	n/a	Broken pipe connection.

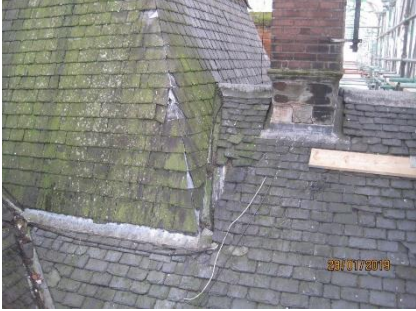
Defect ID	Photo Source	Defect Description	Defect Location	Crack Orientation	Crack Width (mm)	Crack Length (mm)	Comments	Photo	Severity Category
R4.37	IMG_0882	Cracking to sandstone	Chimney stack	Diagonal	1	300	Repaired crack to sandstone block.	 	Amber
R4.38	IMG_0883	Spalled/damaged sandstone	Chimney stack	n/a	n/a	n/a	Delamination/erosion of/cracked/broken off sandstone at chimney	 	Amber
R4.39	IMG_0884	Missing/damaged tiles/roof	Roof	n/a	n/a	n/a	Tiles loose/missing

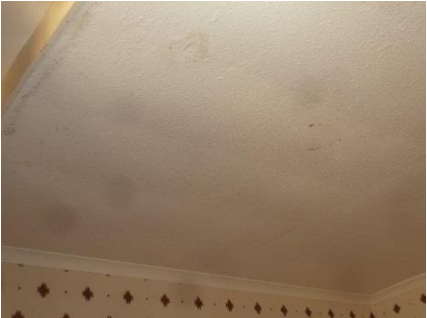
Green
WE2.3	P1200 803-812	Evidence of vermin, Dampness/water ingress	Bedroom 206	n/a	n/a	n/a	Evidence of vermin (808) Dampness/water ingress (809-810, 811, 812)

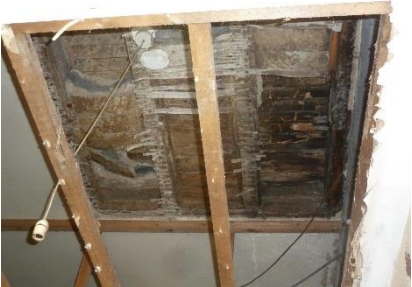
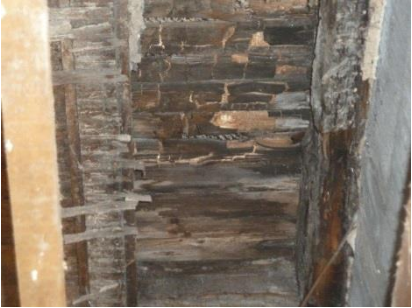
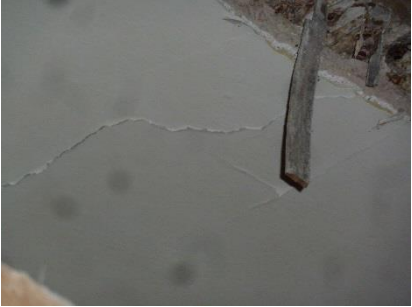
Defect ID	Photo Source	Defect Description	Defect Location	Crack Orientation	Crack Width (mm)	Crack Length (mm)	Comments	Photo	Severity Category
WE2.5	P1200 787-802	Collapsed ceiling plaster, Timber degradation, Dampness/water ingress, Plaster crack, Evidence of vermin	Bedroom 210	n/a	n/a	n/a	<p>Plaster collapse to suspended ceiling and main ceiling above, approx. 25% area (791, 792)</p> <p>Evidence of timber degradation of suspended floor joists above (793-795) Evidence of timber degradation of suspended floorboards above (796-797)</p> <p>Dampness/water ingress (798)</p> <p>Plaster crack (799)</p> <p>Peeling wallpaper. Possible evidence of dampness behind (800, 801)</p> <p>Evidence of vermin (802)</p>

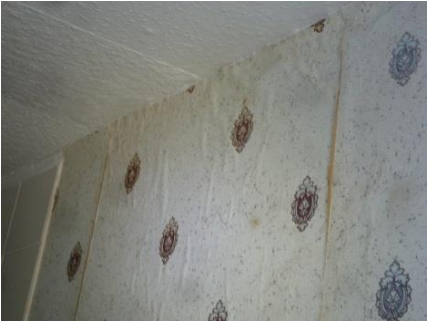
Defect ID	Photo Source	Defect Description	Defect Location	Crack Orientation	Crack Width (mm)	Crack Length (mm)	Comments	Photo	Severity Category
WE2.8	P1200 768-774	Dampness/water ingress	En suite (adj. Bedroom 216)	n/a	n/a	n/a	Dampness/water ingress (773, 774)

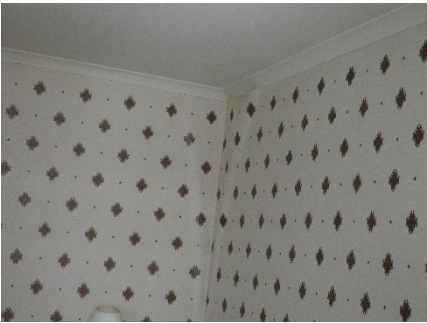
n/a
WE2.10	P1010 068-080	Other	Bedroom 218	n/a	n/a	n/a	Peeling wallpaper to wall (080)

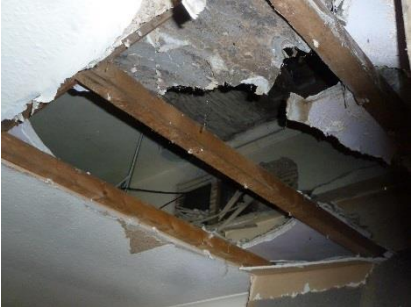
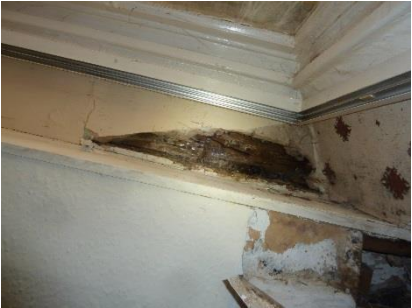
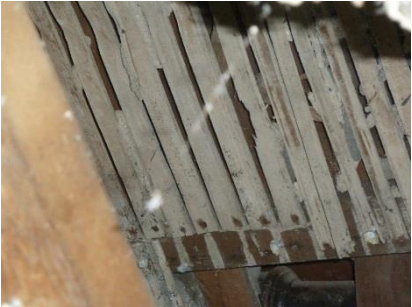
Defect ID	Photo Source	Defect Description	Defect Location	Crack Orientation	Crack Width (mm)	Crack Length (mm)	Comments	Photo	Severity Category
WE2.11	P1200 750-767	Collapsed ceiling plaster, Collapsed wall plaster, Dampness/water ingress, Plaster crack	Bedroom 220	n/a	n/a	n/a	Plaster collapse to suspended ceiling and main ceiling above, approx. 10% area (755-758) Plaster collapse to side wall. Approx. 0.5m2 (759-760) Dampness/water ingress (763) Collapsed ceiling plaster (764) Dampness/water ingress (765, 766) Plaster crack (767)

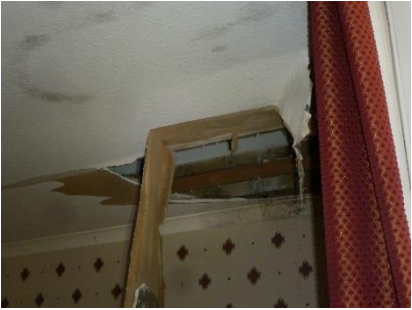
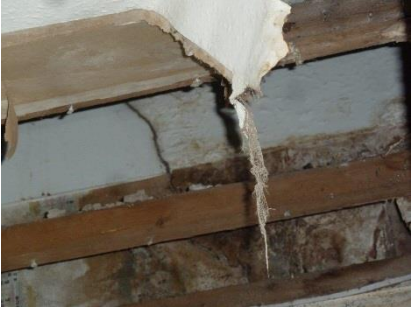
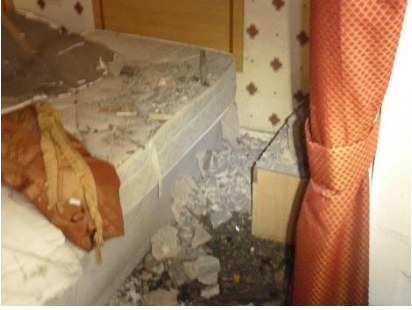
Defect ID	Photo Source	Defect Description	Defect Location	Crack Orientation	Crack Width (mm)	Crack Length (mm)	Comments	Photo	Severity Category
WE2.12	P1200 734-747	Collapsed ceiling plaster, Dampness/water ingress, Plaster crack	Bedroom 222	Horizontal	2	300	Plaster collapse to suspended ceiling (738-742) Dampness/water ingress (743) Plaster crack (744-745) Dampness/water ingress (746) Dampness/water ingress (747)

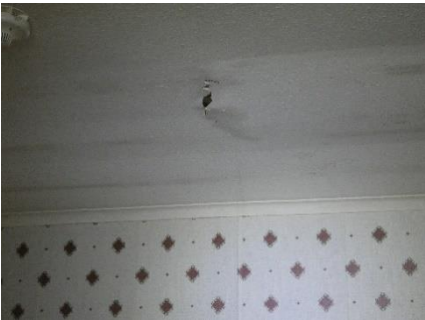
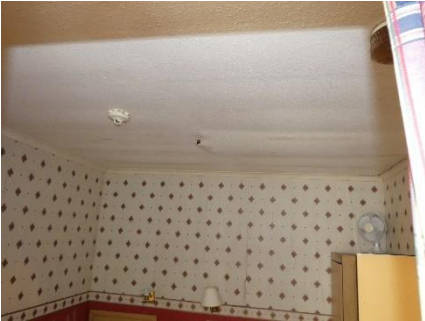
n/a
WN2.2	P1010 244-270	Dampness/water ingress, Staining, Other	Bedroom 202	n/a	n/a	n/a	Water ingress/visible water dripping from middle of ceiling onto bed (256) Ceiling bulging (270) Black staining to edges of ceiling, likely to be mould (267) Peeling and bubbling wallpaper (262) White staining to wall (264) Room generally very damp/wet, carpet appears to be saturated (260)

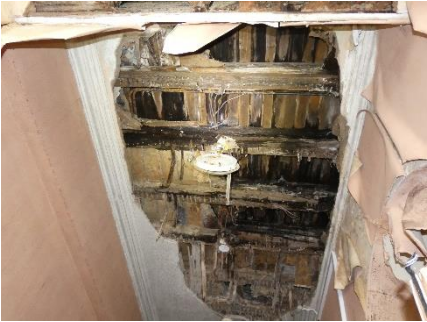
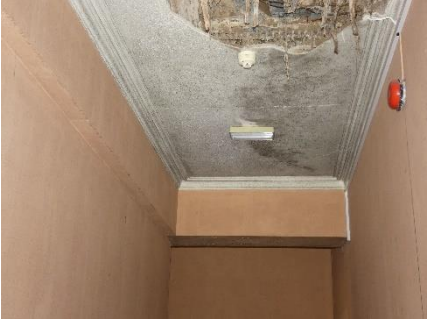
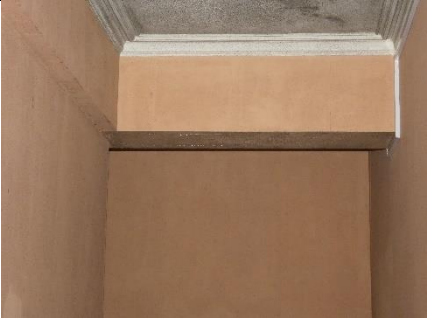
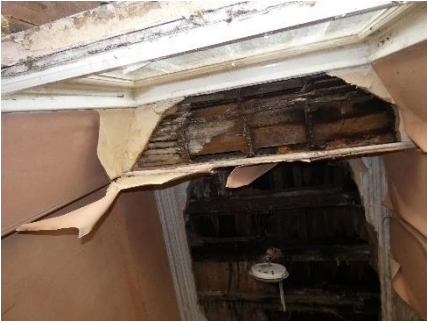
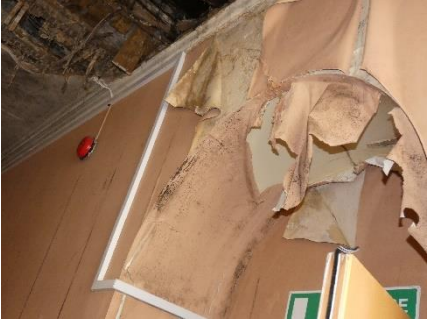
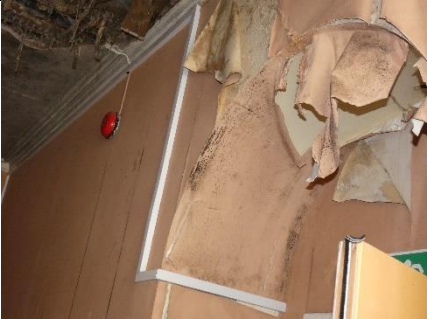
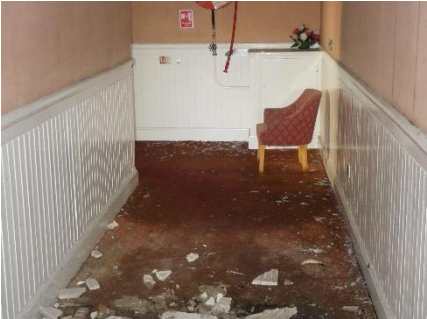
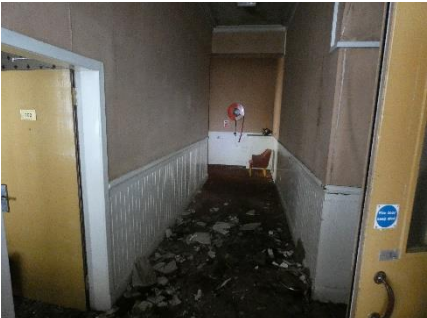
Defect ID	Photo Source	Defect Description	Defect Location	Crack Orientation	Crack Width (mm)	Crack Length (mm)	Comments	Photo	Severity Category
								 	Green
WN2.3	P1010 273-313	Collapsed ceiling plaster, Dampness/water ingress, Staining, Other	Hallway (adj. Bedroom 203)	n/a	n/a	n/a	<p>Approx. 50% of the original ceiling collapsed (298)</p> <p>Patches of dampness on ceiling, possibly mould (282)</p> <p>Water ingress/dripping from soffit and areas of collapsed ceiling (285)</p> <p>Collapsed ceiling plaster adjacent to window (294)</p> <p>Extensive peeling of wallpaper and bulging noted above doorway (292)</p> <p>Evidence of black mould above doorway (304)</p> <p>Floor damp due to constant dripping from ceiling (286)</p>

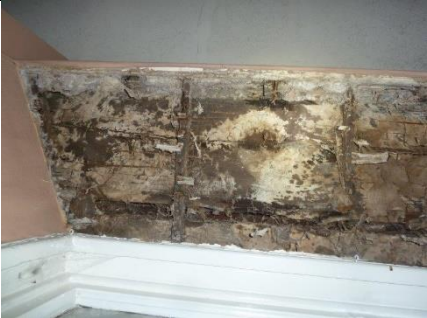
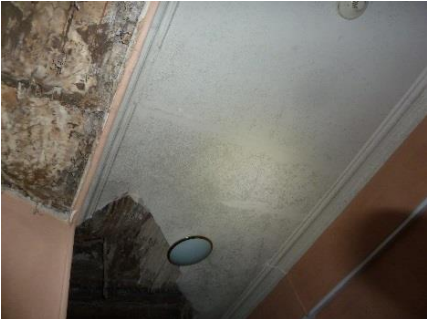
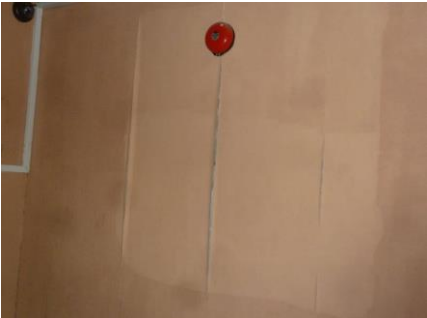
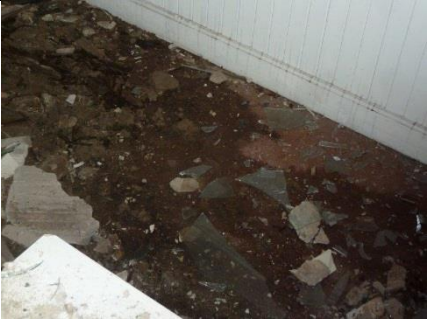
Defect ID	Photo Source	Defect Description	Defect Location	Crack Orientation	Crack Width (mm)	Crack Length (mm)	Comments	Photo	Severity Category
WN2.4	P1200 818-837	Collapsed ceiling plaster, Timber degradation, Plaster crack, Dampness/water ingress	Hallway (adj. Bedroom 203)	Diagonal	1	300	Plaster collapse to main ceiling above, approx. 2m2 area (825) Evidence of timber degradation of suspended floor joists above (826-828) Plaster crack (829) Water ingress, loss of plaster to ceiling directly above window (830-834) Dampness/water ingress (835) Dampness/water ingress (836) Dampness/water ingress (837)

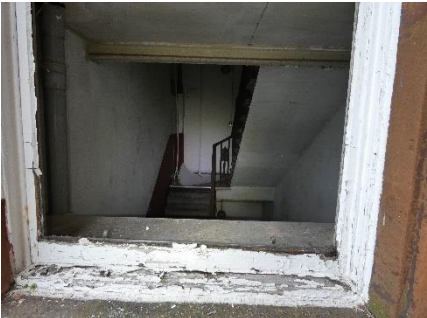
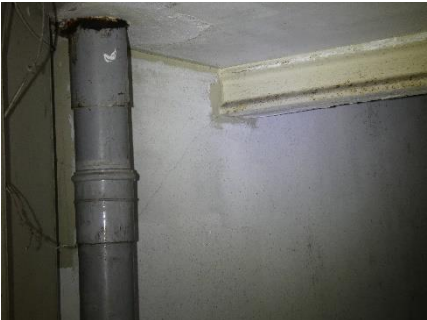
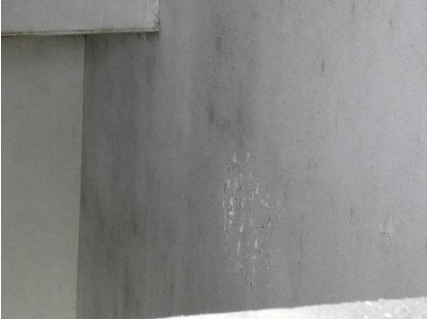
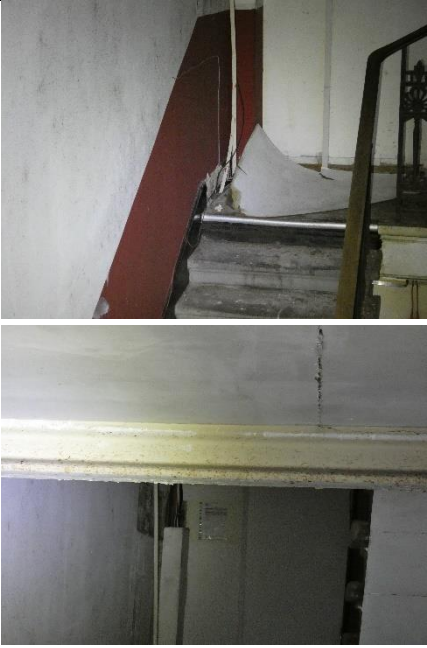
Defect ID	Photo Source	Defect Description	Defect Location	Crack Orientation	Crack Width (mm)	Crack Length (mm)	Comments	Photo	Severity Category
WS2.1	P1000 974-993	Crack, Other	Stair well (adj. Bedroom 203)	Diagonal	1	400	Crack (974/979) Spalling to paint finish (988/993) Damage to plaster wall and skirting separating (985) Mild corrosion to metal support beam (981)

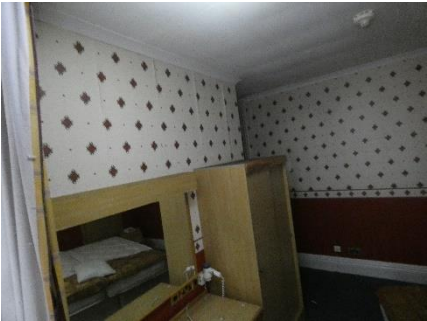
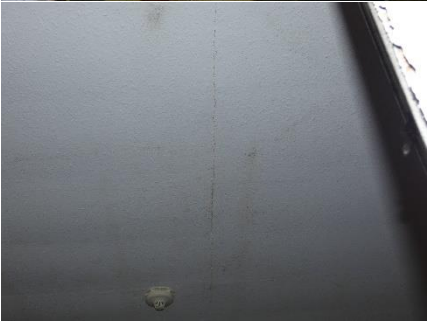
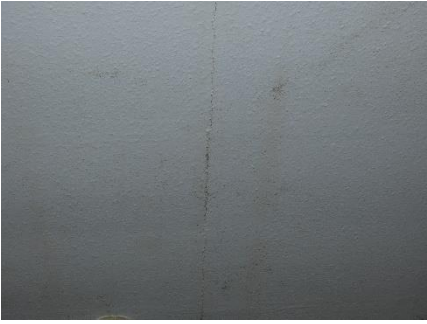
Defect ID	Photo Source	Defect Description	Defect Location	Crack Orientation	Crack Width (mm)	Crack Length (mm)	Comments	Photo	Severity Category
WW2.1	P1000 994-999 P1010 001-012	Staining, Crack, Evidence of vermin	Bedroom 205	Horizontal	1	3000	Peeling wallpaper and staining on the wall (999, 002) Crack on ceiling/possibly plaster ceiling joint line (011/012) Evidence of vermin (006)

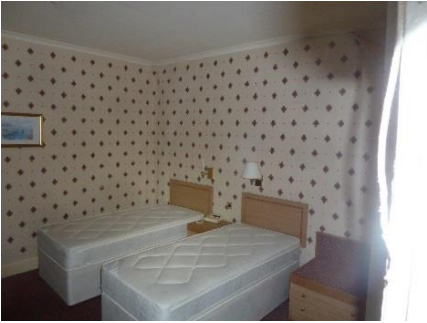
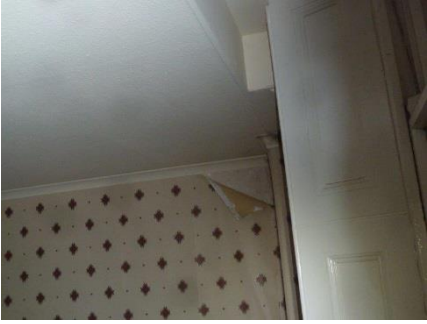
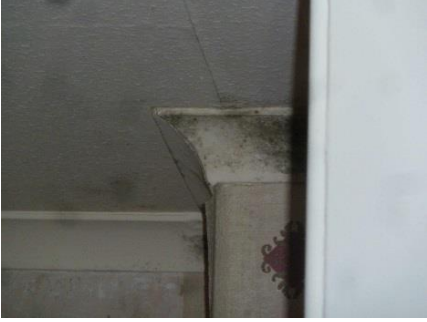
Defect ID	Photo Source	Defect Description	Defect Location	Crack Orientation	Crack Width (mm)	Crack Length (mm)	Comments	Photo	Severity Category
WW2.3	P1200 700-707	Dampness/ water ingress	Bedroom 209	n/a	n/a	n/a	Peeling wallpaper. Possible evidence of dampness behind (704) Dampness/water ingress (705, 706) Peeling wallpaper. Possible evidence of dampness behind (707)

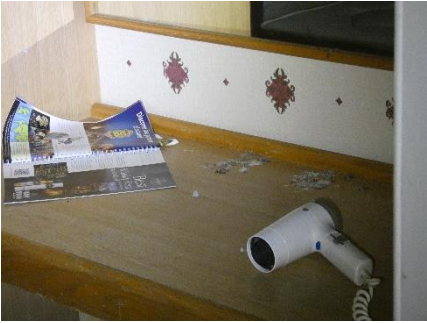
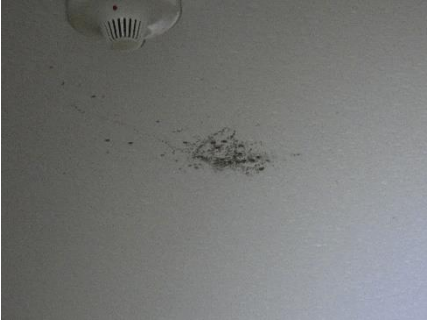
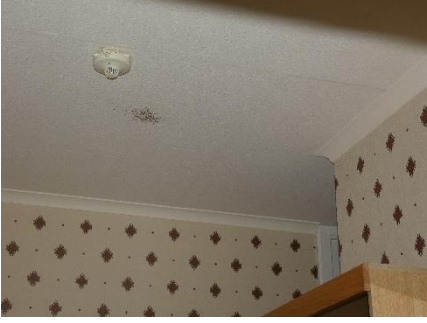
Defect ID	Photo Source	Defect Description	Defect Location	Crack Orientation	Crack Width (mm)	Crack Length (mm)	Comments	Photo	Severity Category
WW2.4	P1010 013-033	Evidence of vermin, Staining, Other, Crack	Bedroom 211	Horizontal	<1	1500	Evidence of vermin, Staining (019) Black localised staining on ceiling, possibly mould (020) Crack on ceiling/possibly plaster ceiling joint line (028/033)

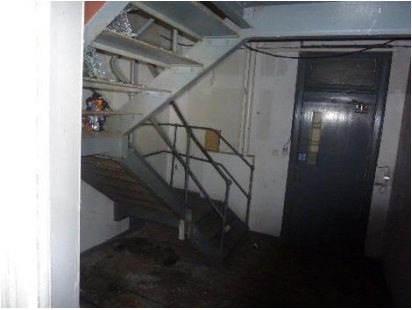
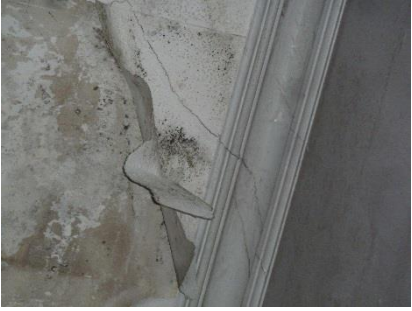
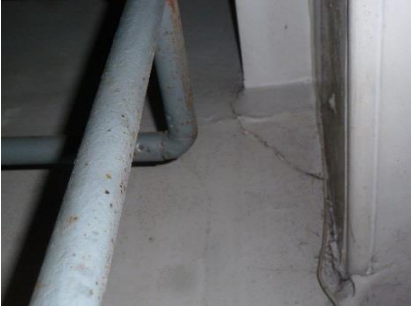
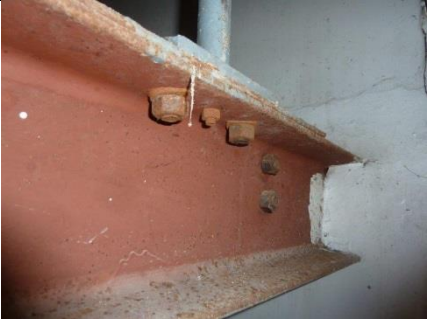
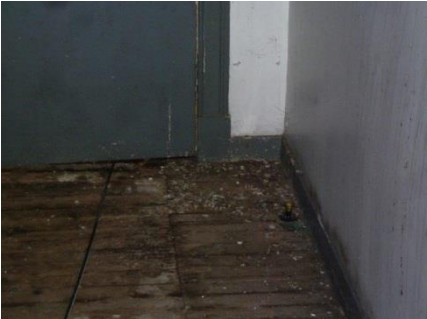
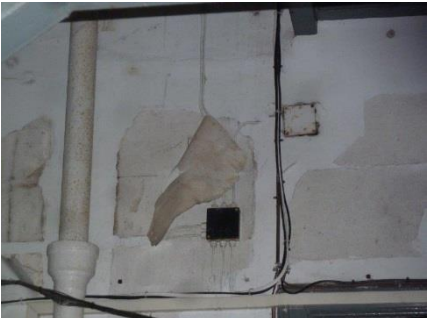
Defect ID	Photo Source	Defect Description	Defect Location	Crack Orientation	Crack Width (mm)	Crack Length (mm)	Comments	Photo	Severity Category
WW2.7	P1200 714-733	Dampness/ water ingress, Plaster crack, Metal corrosion, Evidence of vermin	Stair well (adj. Bedroom 217)	n/a	n/a	n/a	Dampness/water ingress (719) Dampness/water ingress (720, 721) Dampness/water ingress (722) Plaster crack (723) Plaster crack (724) Plaster crack (725, 726) Mild corrosion to stairwell support beam (727, 728) Dampness/water ingress (729) Evidence of vermin (730) Dampness/water ingress (731) Plaster crack (732) Peeling wallpaper. Possible evidence of dampness behind (733)
