Former Ayr Station Hotel Building Structural Condition

Independent Report

03 October 2019

Document reference: 399316/SNI/GLA/DOC/S2/REP/002

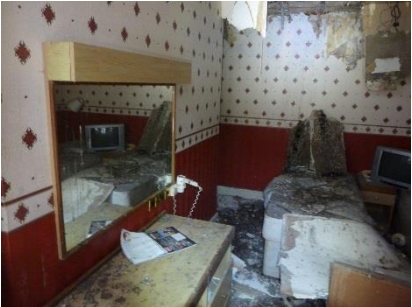
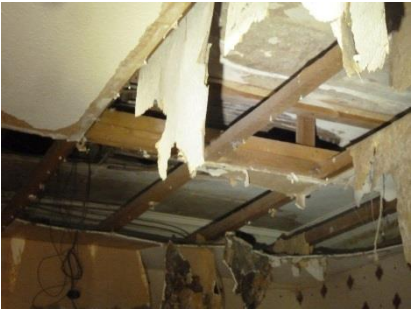
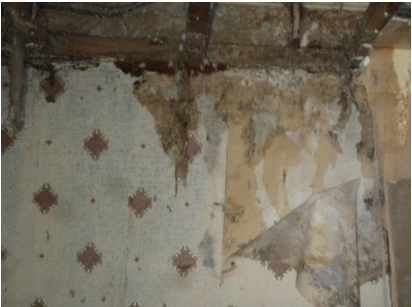
Defect ID	Photo Source	Defect Description	Defect Location	Crack Orientation	Crack Width (mm)	Crack Length (mm)	Comments	Photo	Severity Category
WE3.2	P1200609-621	Collapsed ceiling plaster, Dampness/water ingress, Evidence of vermin	Bedroom 322	n/a	n/a	n/a	Plaster collapse to suspended ceiling and main ceiling above (615) Dampness/water ingress (610, 620) Evidence of vermin (621)

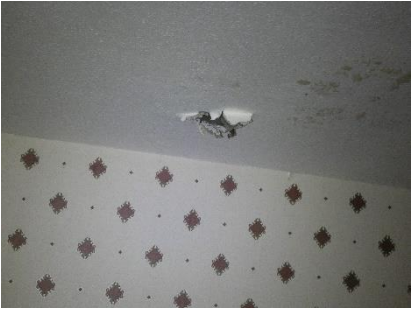
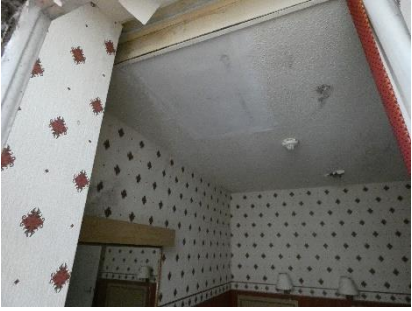
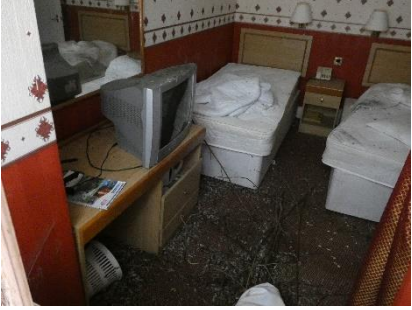
Defect ID	Photo Source	Defect Description	Defect Location	Crack Orientation	Crack Width (mm)	Crack Length (mm)	Comments	Photo	Severity Category
WE3.3	P1000569-578	Collapsed ceiling plaster, Evidence of vermin, Dampness/water ingress, Staining	Bedroom 320	n/a	n/a	n/a	Localised collapse of ceiling plaster (573) Staining to ceiling (574) Patch noted on ceiling (572) Staining on wall, and possible dampness (575) Bubbling behind wallpaper indicates possible dampness (575) Evidence of vermin (576)

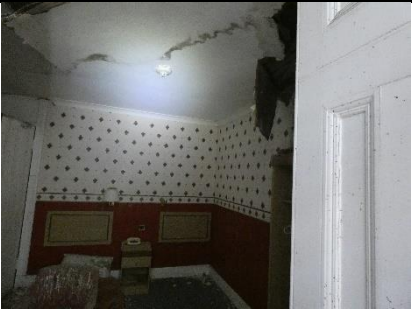
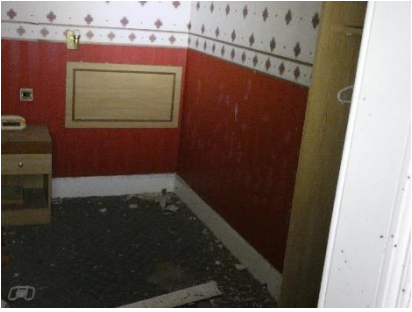
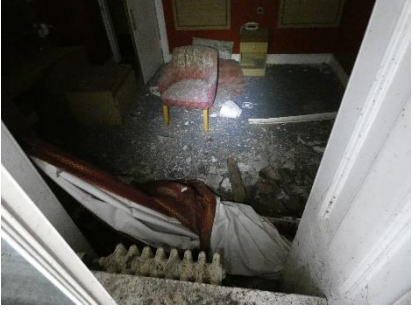
Defect ID	Photo Source	Defect Description	Defect Location	Crack Orientation	Crack Width (mm)	Crack Length (mm)	Comments	Photo	Severity Category
WE3.7	P1000 587-600	Collapsed ceiling plaster, Evidence of vermin, Staining	Bedroom 314	n/a	n/a	n/a	Significant collapse of false ceiling and original ceiling above it (589, 595) Staining to ceiling (598) White staining to wall (600) Evidence of vermin (597)	 	<p data-bbox="1995 331 2063 352">Amber</p> <p data-bbox="1995 660 2063 681">Amber</p>

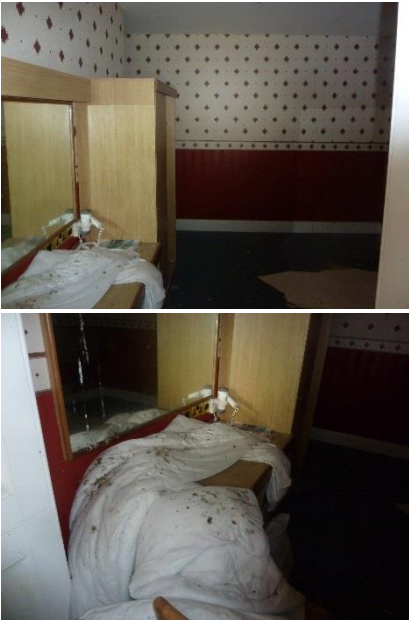
Defect ID	Photo Source	Defect Description	Defect Location	Crack Orientation	Crack Width (mm)	Crack Length (mm)	Comments	Photo	Severity Category
WE3.10	P1200 641-647	Collapsed ceiling plaster, Evidence of vermin	Bedroom 308	n/a	n/a	n/a	Collapsed ceiling plaster (647) Evidence of vermin (646)

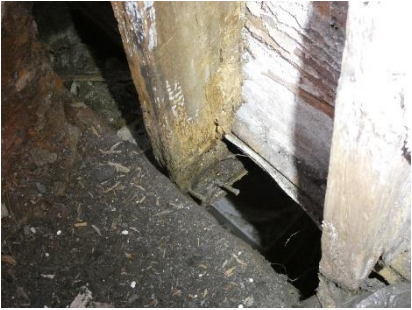
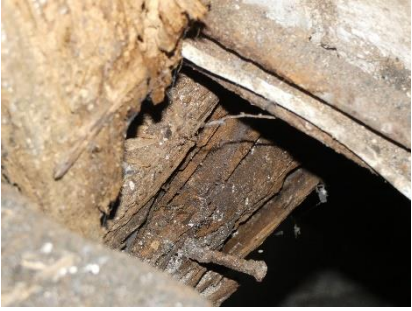
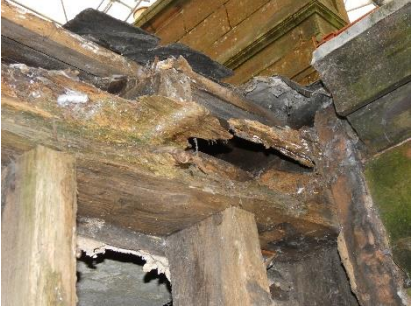
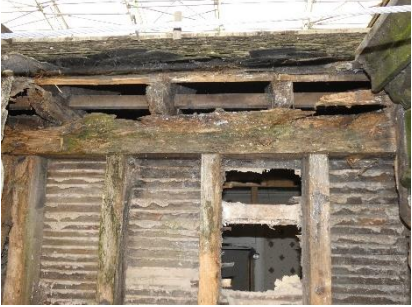
Defect ID	Photo Source	Defect Description	Defect Location	Crack Orientation	Crack Width (mm)	Crack Length (mm)	Comments	Photo	Severity Category
WE3.14	P1000 674-688	Deteriorating/rotting timber, Dampness/water ingress, Other	Exposed section of mansard roof (External inspection)	n/a	n/a	n/a	Vertical roof posts are side fixed to horizontal joists below, but post ends have now rotted away and are no longer connected (674-680). Possible onset of rot/decay Significant deterioration of horizontal timber roof beam (681-688)

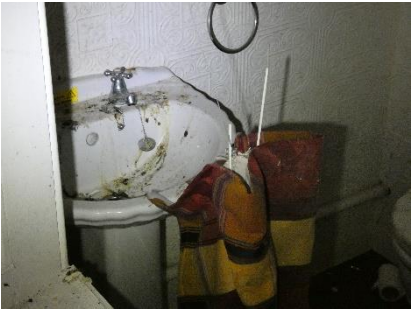
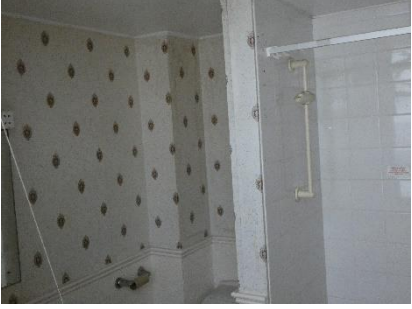
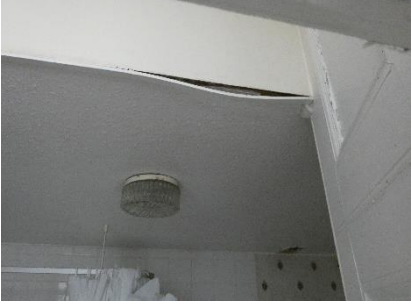
Defect ID	Photo Source	Defect Description	Defect Location	Crack Orientation	Crack Width (mm)	Crack Length (mm)	Comments	Photo	Severity Category
WN3.1	P1000 624-638	Evidence of vermin, Dampness/water ingress, Staining, Collapsed ceiling plaster	Bathroom (adj. Bedroom 302)	n/a	n/a	n/a	Evidence of vermin (628, 629) Water staining and evidence of water ingress (626) Ceiling sagging (634)

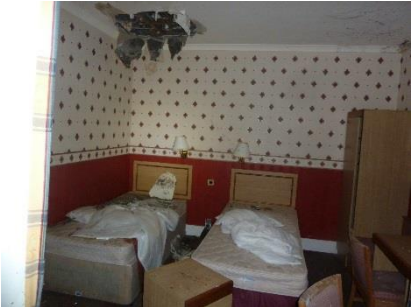
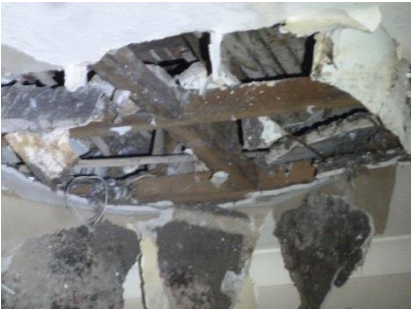
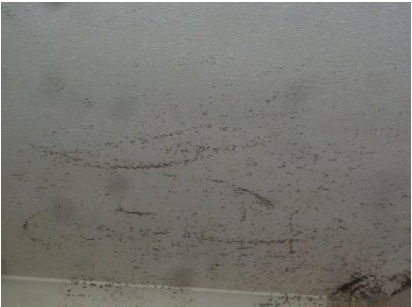
Defect ID	Photo Source	Defect Description	Defect Location	Crack Orientation	Crack Width (mm)	Crack Length (mm)	Comments	Photo	Severity Category
WN3.2	P1200 660-670	Collapsed ceiling plaster, Dampness/water ingress, Evidence of vermin	Bedroom 302	n/a	n/a	n/a	Plaster collapse to ceiling (664) Dampness/water ingress (668, 670) Evidence of vermin (669)

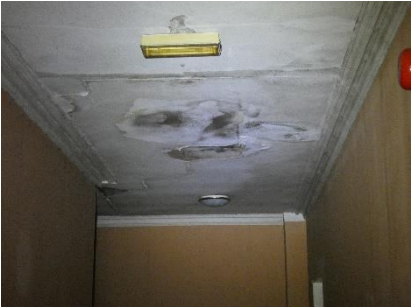
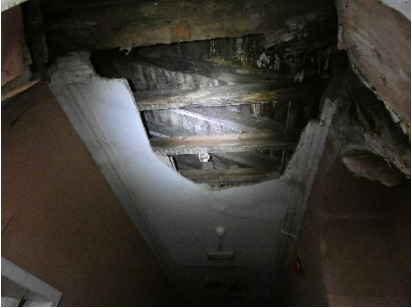
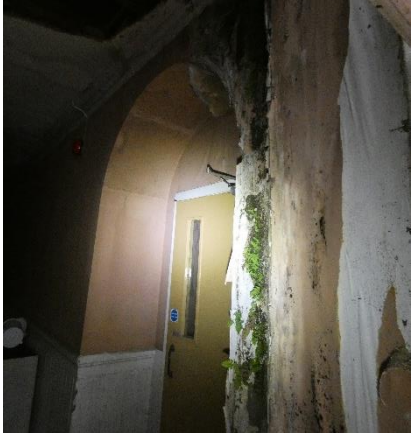
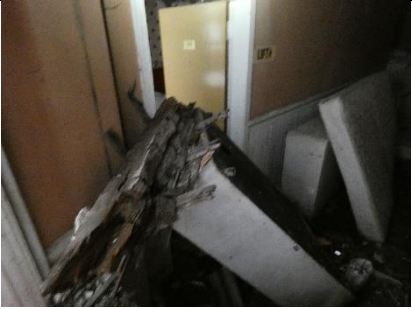
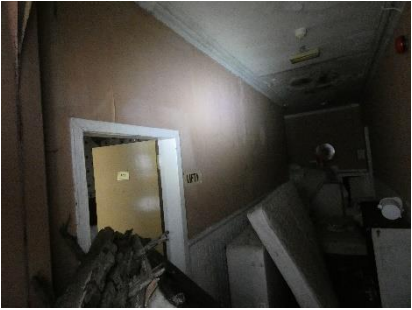
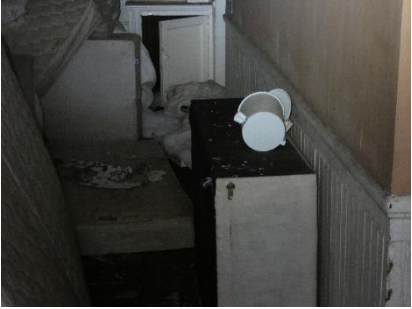
Defect ID	Photo Source	Defect Description	Defect Location	Crack Orientation	Crack Width (mm)	Crack Length (mm)	Comments	Photo	Severity Category
WN3.3	P1000 639-658	Collapsed ceiling plaster, Collapsed wall plaster, Deteriorating/rotting timber, Evidence of vermin, Dampness/water ingress, Staining, Other	Hallway (near Bedroom 302)	n/a	n/a	n/a	Black mould stain and evidence of water ingress to ceiling (642) Significant failure of ceiling, exposed timber joists (645) Dampness/vegetation growth to wall (653) Collapsed section of roof timbers (650) LHS water ingress (647) Evidence of vermin (658)

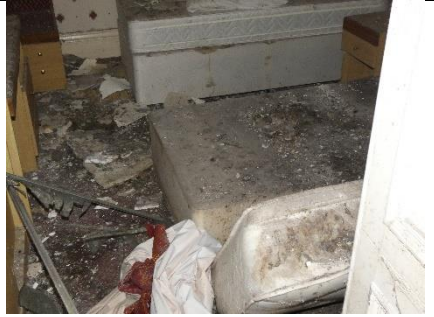
Defect ID	Photo Source	Defect Description	Defect Location	Crack Orientation	Crack Width (mm)	Crack Length (mm)	Comments	Photo	Severity Category
WW3.1	P1000 941-973	Collapsed ceiling plaster, Evidence of vermin, Staining	Bedroom 321	n/a	n/a	n/a	Significant collapse of false ceiling and original ceiling above it, roof void above visible (949-952) Staining on ceiling (955) Staining on wall (953) Evidence of vermin (947)

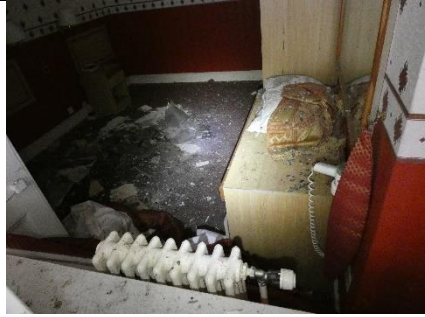
Defect ID	Photo Source	Defect Description	Defect Location	Crack Orientation	Crack Width (mm)	Crack Length (mm)	Comments	Photo	Severity Category
WW3.2	P1000 732-759	Collapsed ceiling plaster, Evidence of vermin, Staining	Bedroom 319	n/a	n/a	n/a	Significant collapse of ceiling (761) 2x Staining on ceiling (744, 746) 2x Staining on wall (748, 751) Evidence of vermin (754)	     	<div style="background-color: red; color: white; padding: 5px; text-align: center;">Red</div> <div style="background-color: red; color: white; padding: 5px; text-align: center;">Amber</div> <div style="background-color: red; color: white; padding: 5px; text-align: center;">Amber</div>

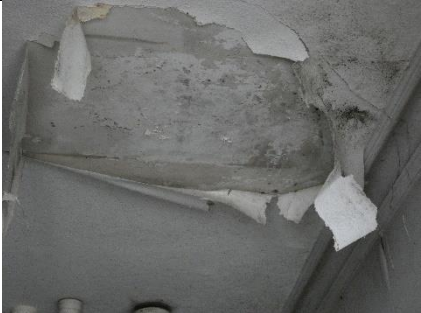
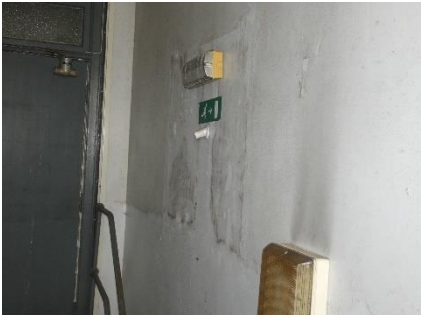
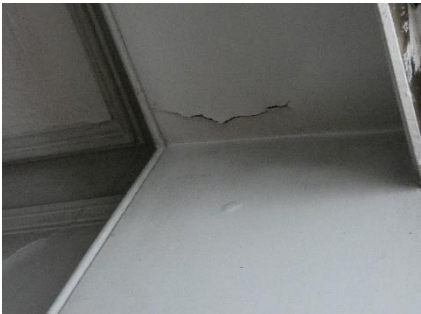
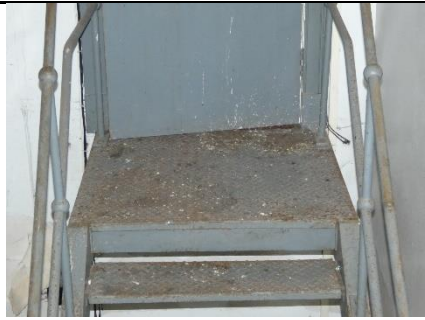
Defect ID	Photo Source	Defect Description	Defect Location	Crack Orientation	Crack Width (mm)	Crack Length (mm)	Comments	Photo	Severity Category
WW3.3	P1000 896-940	Collapsed plaster on wall, Evidence of vermin, Other	Stairs (adj. Bedroom 319)	n/a	n/a	n/a	Wallpaper on wall to LHS of door (939, 940) Window cill broken with hole (900) 2x Crack to wall of window cill (902) Mould staining on ceiling, wallpaper detached from ceiling (910, 921, 922) Walls appear re-plastered (-) Black stain to wall above light (925, 926) Crack/tear in wall finish to wall at RHS of window (913) Evidence of vermin (928)

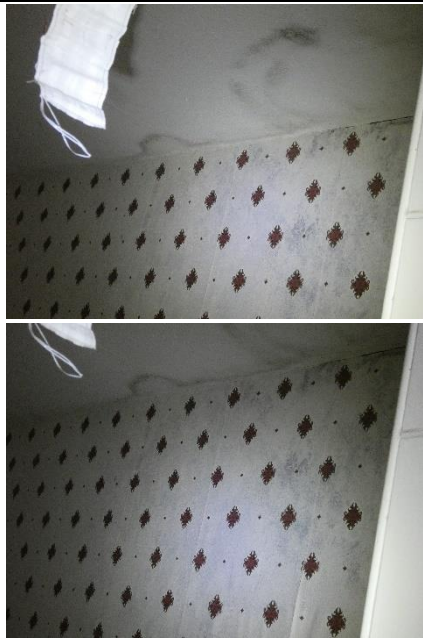
Defect ID	Photo Source	Defect Description	Defect Location	Crack Orientation	Crack Width (mm)	Crack Length (mm)	Comments	Photo	Severity Category
WW3.5	P1000 868-881	Staining	Bedroom 315	n/a	n/a	n/a	Staining on ceiling (876) Staining on wall, possible water ingress (878)

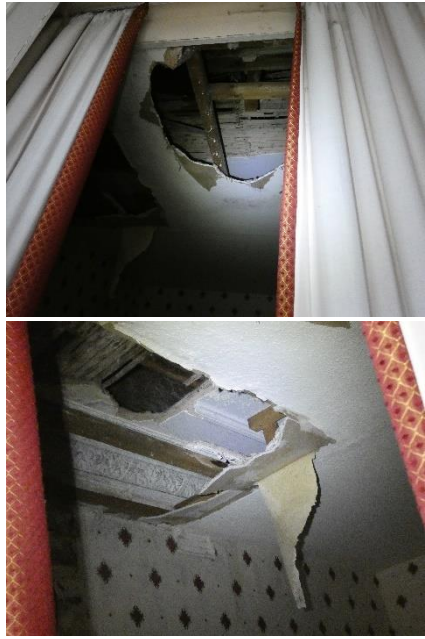
Defect ID	Photo Source	Defect Description	Defect Location	Crack Orientation	Crack Width (mm)	Crack Length (mm)	Comments	Photo	Severity Category
WW3.6	P1000 846-867	Collapsed ceiling plaster	Bedroom 311	n/a	n/a	n/a	Significant collapse of false ceiling and original ceiling above it (862, 867)

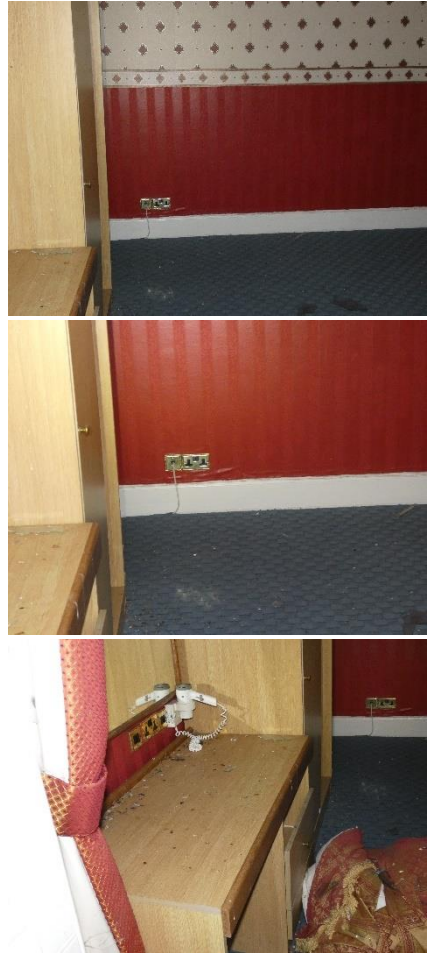
Defect ID	Photo Source	Defect Description	Defect Location	Crack Orientation	Crack Width (mm)	Crack Length (mm)	Comments	Photo	Severity Category
WW3.7	P1000 831-845	Staining, Possible evidence of dampness, Evidence of vermin	Bedroom 309	n/a	n/a	n/a	Small area of bubbling wallpaper, may indicate dampness (839, 840) Evidence of vermin (843)

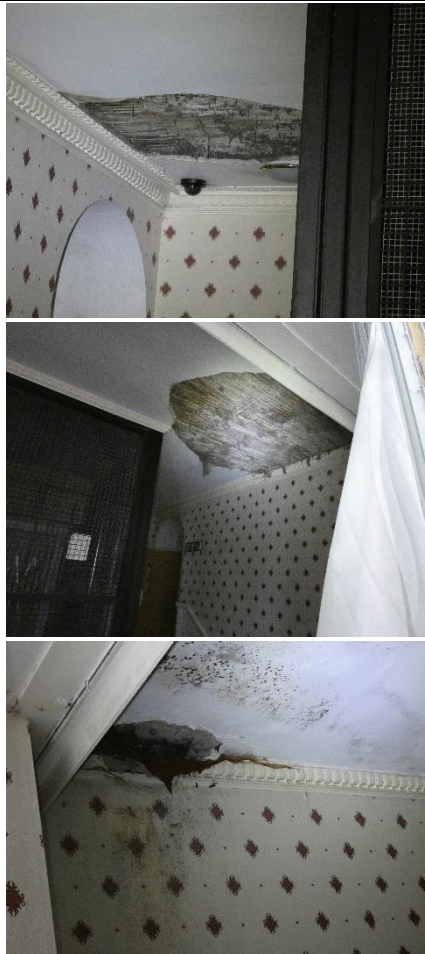
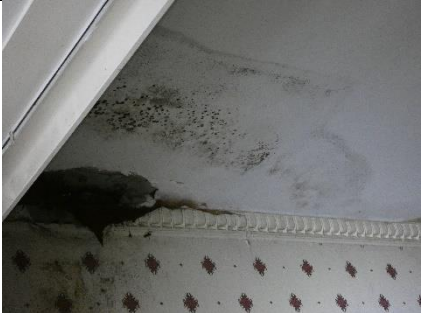
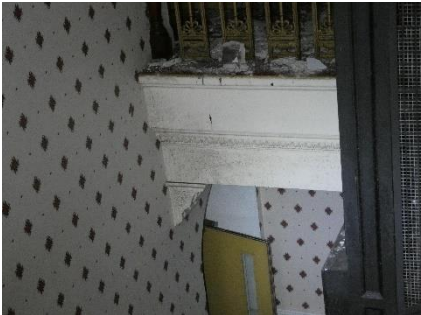
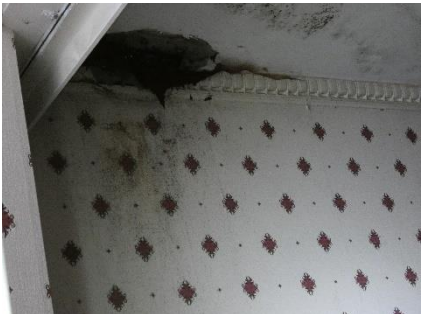
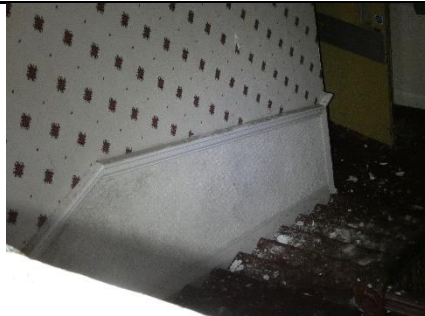
Defect ID	Photo Source	Defect Description	Defect Location	Crack Orientation	Crack Width (mm)	Crack Length (mm)	Comments	Photo	Severity Category
WW3.9	P1000 787-819	Collapsed ceiling plaster, Collapsed wall plaster, Staining, Bulging/collapsed	Stair well/lift shaft	n/a	n/a	n/a	Partial collapse of ceiling plaster at 3x locations (791, 794, 797) Staining on ceiling (800) Staining on floor (804) Staining on wall (802, 806)

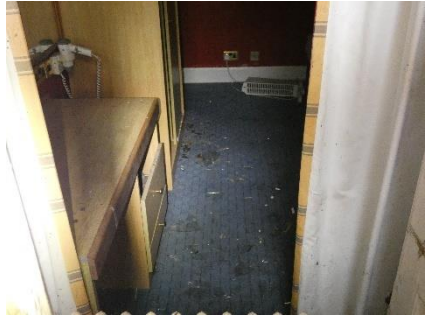
Amber
WW3.10	P1000 777-786	Evidence of vermin	Bedroom 305	n/a	n/a	n/a	No obvious defects observed Evidence of vermin (783)

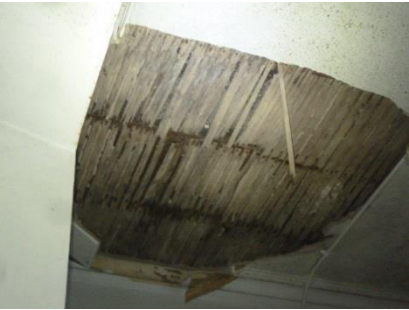
Defect ID	Photo Source	Defect Description	Defect Location	Crack Orientation	Crack Width (mm)	Crack Length (mm)	Comments	Photo	Severity Category
WW1.1	P1210 110-111	Collapsed ceiling plaster	Dry goods store	n/a	n/a	n/a	-

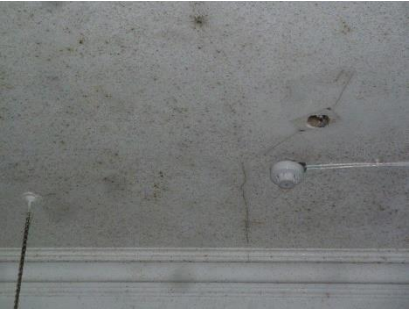
Amber
WW1.1	P1210 112-114	Plaster crack	Dry goods store	Horizontal	1	1000	Approx. 8no. cracks to ceiling

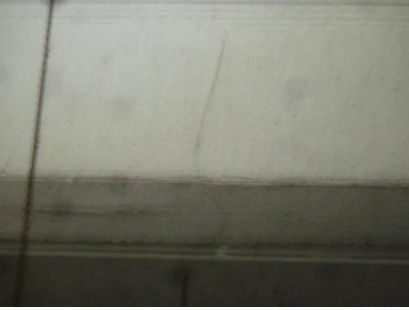
Green
WW1.1	P1210115	Plaster crack	Dry goods store	Vertical	1	500	Plaster crack to downstand beam

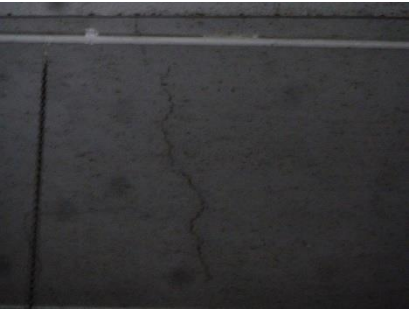
Defect ID	Photo Source	Defect Description	Defect Location	Crack Orientation	Crack Width (mm)	Crack Length (mm)	Comments	Photo	Severity Category
WW1.1	P1210 116-118	Plaster crack	Dry goods store	n/a	1	2000	Crack to ceiling

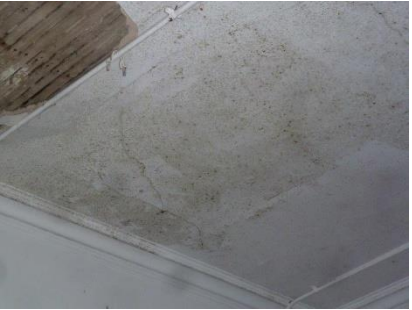
Green
WW1.1	P1210 119-120	Dampness/water ingress	Dry goods store	n/a	n/a	n/a

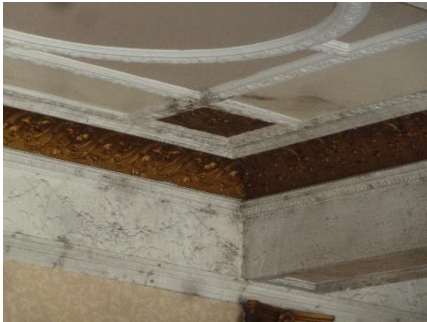
Defect ID	Photo Source	Defect Description	Defect Location	Crack Orientation	Crack Width (mm)	Crack Length (mm)	Comments	Photo	Severity Category
WW1.2	P1210076-079	Dampness/water ingress	Arran room	n/a	n/a	n/a	Damp staining to cornicing

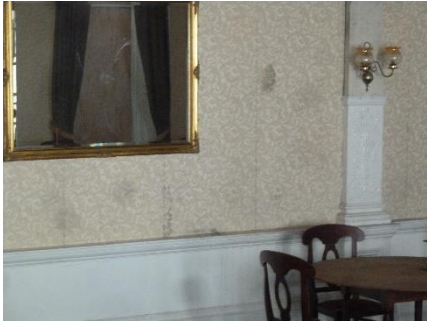
Green
WW1.2	P1210080	Dampness/water ingress	Arran room	n/a	n/a	n/a	Damp staining to wall

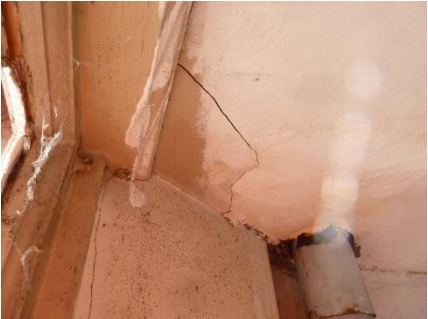
n/a
WS1.1	P1210086	Plaster crack	Stairwell	n/a	n/a	n/a	Crack to ceiling plaster

Amber

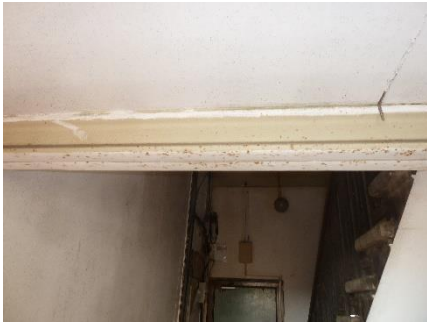
Defect ID	Photo Source	Defect Description	Defect Location	Crack Orientation	Crack Width (mm)	Crack Length (mm)	Comments	Photo	Severity Category
WS1.1	P1210087	Metal corrosion	Stairwell	n/a	n/a	n/a	Mild corrosion to metal beams

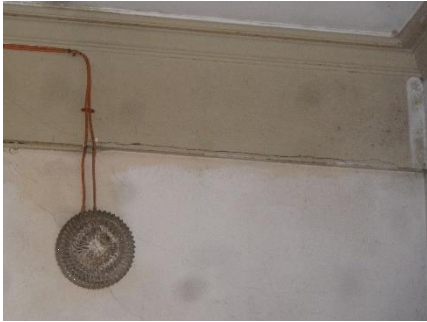
Green
WS1.1	P1210088	Plaster crack	Stairwell	Vertical	2	1000	-

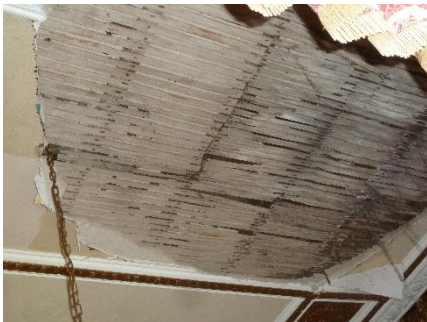
n/a
WE1.1	P1200 910-912	Collapsed ceiling plaster	Conference/ dining room	n/a	n/a	n/a	Collapsed ceiling plaster. Approx. 2x3m

Amber

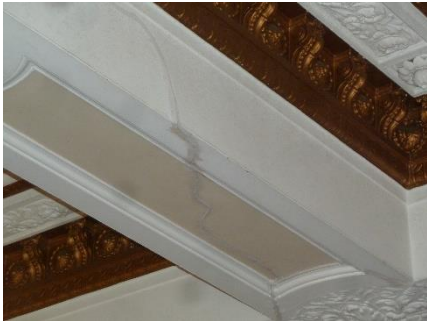
Defect ID	Photo Source	Defect Description	Defect Location	Crack Orientation	Crack Width (mm)	Crack Length (mm)	Comments	Photo	Severity Category
WE1.1	P1200918	Plaster crack	Conference/ dining room	Diagonal	2	800	Diagonal crack to ceiling downstand

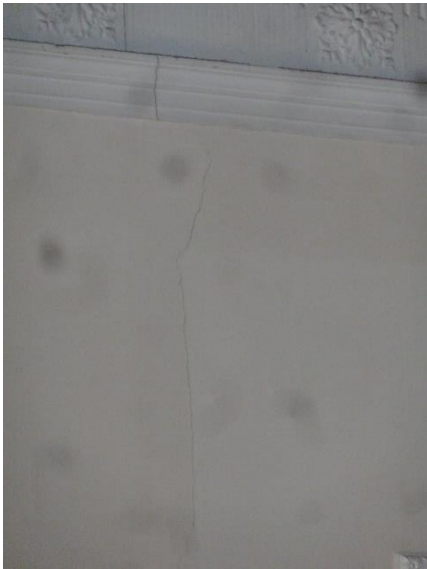
Green
WE1.1	P1200919	Plaster crack	Conference/ dining room	Vertical	1	1000

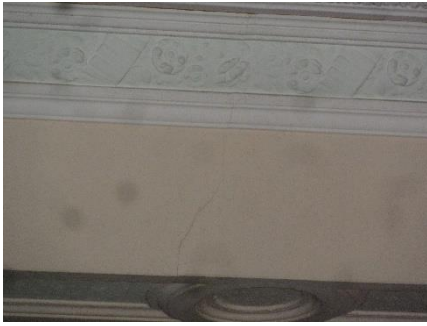
Defect ID	Photo Source	Defect Description	Defect Location	Crack Orientation	Crack Width (mm)	Crack Length (mm)	Comments	Photo	Severity Category
WE1.2	P1200995	Plaster crack	Lounge/ bar area	Vertical	1	400	Plaster crack to ceiling downstand

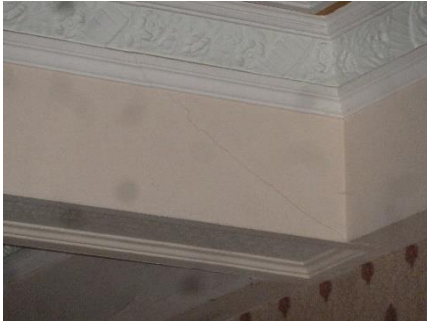
Green
WE1.2	P1200996	Plaster crack	Lounge/ bar area	Diagonal	1	500	Plaster crack to ceiling downstand

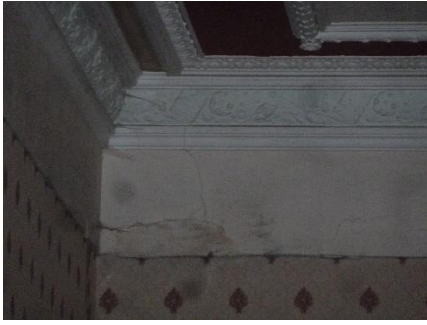
Green
WE1.2	P1200997	Plaster crack	Lounge/ bar area	Vertical	1	300	Plaster crack to wall

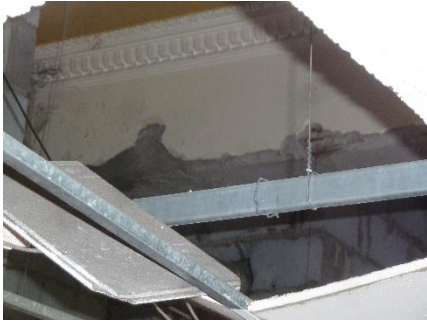
Defect ID	Photo Source	Defect Description	Defect Location	Crack Orientation	Crack Width (mm)	Crack Length (mm)	Comments	Photo	Severity Category
WE1.3	P1210 043-044	Collapsed ceiling plaster	Corridor	n/a	n/a	n/a	Collapsed plaster from ceiling (above false ceiling)	 	Green
WE1.3	P1210 045-046	Collapsed ceiling plaster	Corridor	n/a	n/a	n/a	Collapsed plaster from ceiling (above false ceiling)	 	Green
WE1.3	P1210 047-050	Collapsed ceiling plaster	Corridor	n/a	n/a	n/a	Collapsed ceiling plaster to ceiling downstand

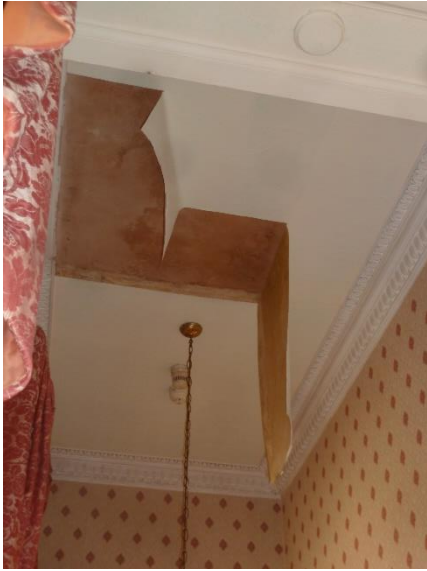
Defect ID	Photo Source	Defect Description	Defect Location	Crack Orientation	Crack Width (mm)	Crack Length (mm)	Comments	Photo	Severity Category
WE1.4	P1200928	Dampness/water ingress	Corridor	n/a	n/a	n/a	Peeling wallpaper to ceiling. Possible indication of damp

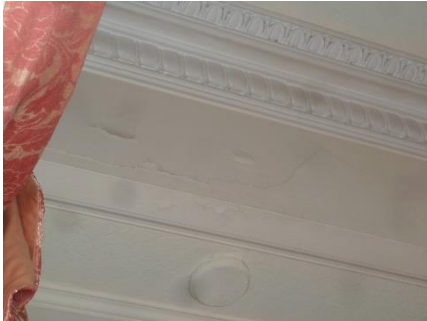
Green
WE1.4	P1200929-930	Plaster crack	Corridor	Horizontal	1	1000	Cracking to window downstand

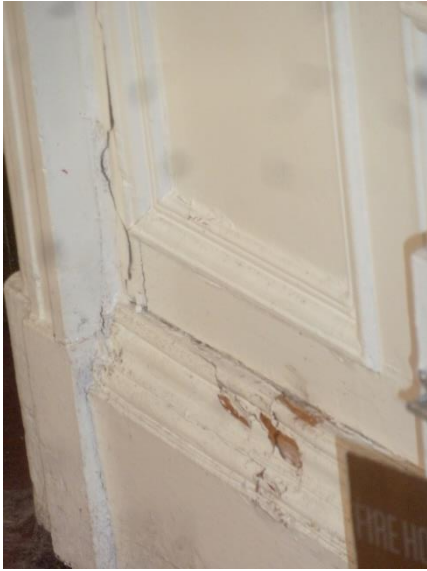
Defect ID	Photo Source	Defect Description	Defect Location	Crack Orientation	Crack Width (mm)	Crack Length (mm)	Comments	Photo	Severity Category
WE1.4	P1200931	Crack	Corridor	n/a	n/a	n/a	Crack to timber skirting

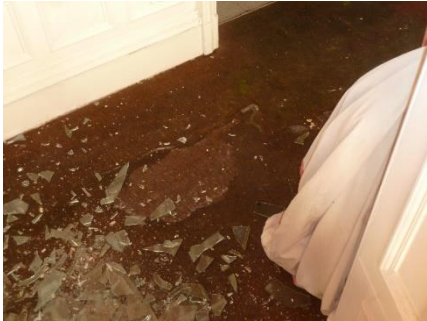
Green
WE1.4	P1200932-933	Dampness/water ingress	Corridor	n/a	n/a	n/a	Mould/damp to floor

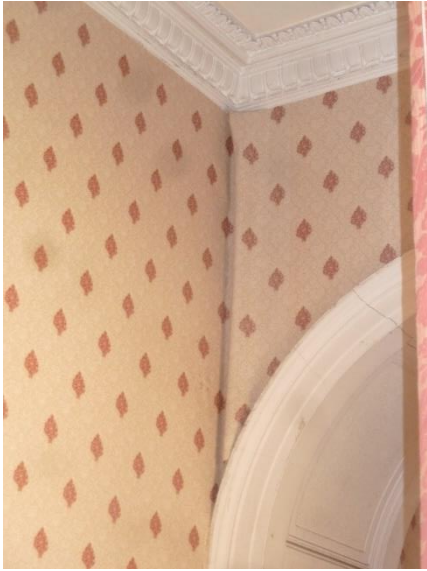
Defect ID	Photo Source	Defect Description	Defect Location	Crack Orientation	Crack Width (mm)	Crack Length (mm)	Comments	Photo	Severity Category
WE1.4	P1200934	Dampness/water ingress	Corridor	n/a	n/a	n/a	Peeling wallpaper to arch. Possible indication of damp

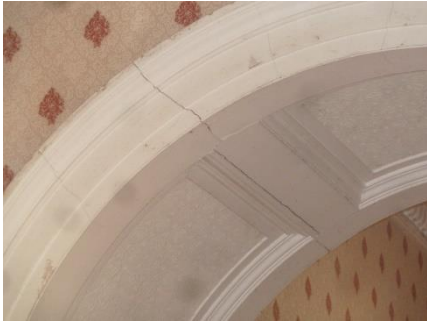
Green
WE1.4	P1200935-937	Plaster crack	Corridor	Varies	1	200-1000	Cracks to arch

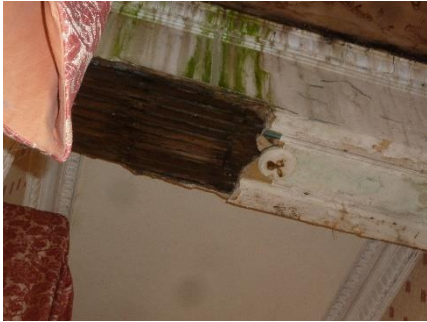
n/a
WE1.5	P1200959	Collapsed ceiling plaster	Corridor	n/a	n/a	n/a	Plaster collapse to ceiling downstand

Red
WE1.5	P1200 960-962	Dampness/water ingress	Corridor	n/a	n/a	n/a	-

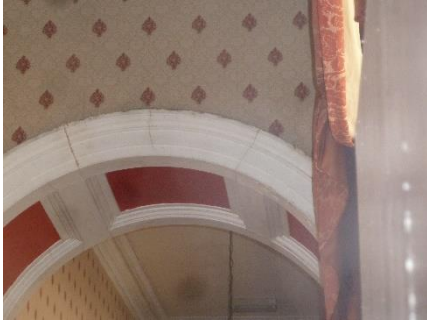
Defect ID	Photo Source	Defect Description	Defect Location	Crack Orientation	Crack Width (mm)	Crack Length (mm)	Comments	Photo	Severity Category
WE1.5	P1200975	Plaster crack	Corridor		2	300	Cracks to plaster around collapsed ceiling

Amber
WE1.5	P1200976-977	Dampness/water ingress	Corridor	n/a	n/a	n/a	-

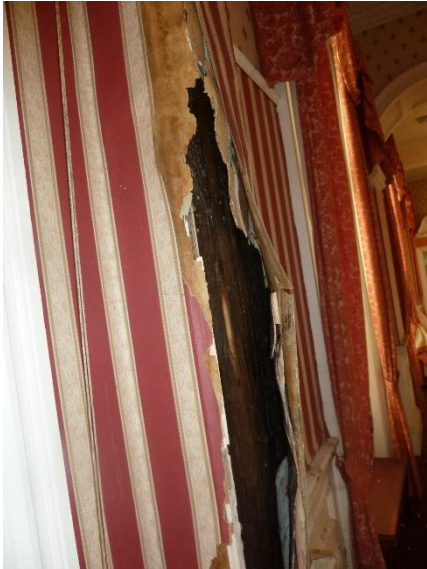
Defect ID	Photo Source	Defect Description	Defect Location	Crack Orientation	Crack Width (mm)	Crack Length (mm)	Comments	Photo	Severity Category
WE1.5	P1200978-979	Dampness/water ingress	Corridor	n/a	n/a	n/a	Peeling wallpaper to ceiling. Possible indication of damp

Amber
WE1.6	P1200999-P1210007	n/a	Lounge / bar area	n/a	n/a	n/a	General photos

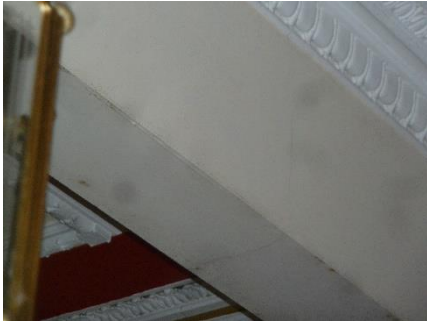
Green
WE1.6	P1210009-012	Plaster crack	Lounge / bar area	n/a	1	500	Plaster cracks to downstand beam

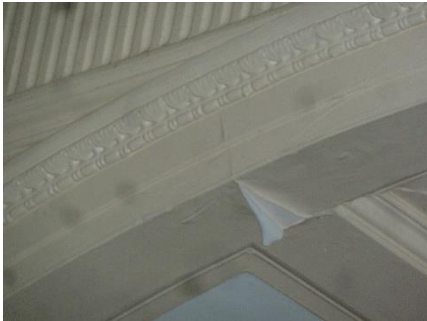
Defect ID	Photo Source	Defect Description	Defect Location	Crack Orientation	Crack Width (mm)	Crack Length (mm)	Comments	Photo	Severity Category
WE1.7	P1210031	Plaster crack	Stairwell	1	100	Crack to feature arch

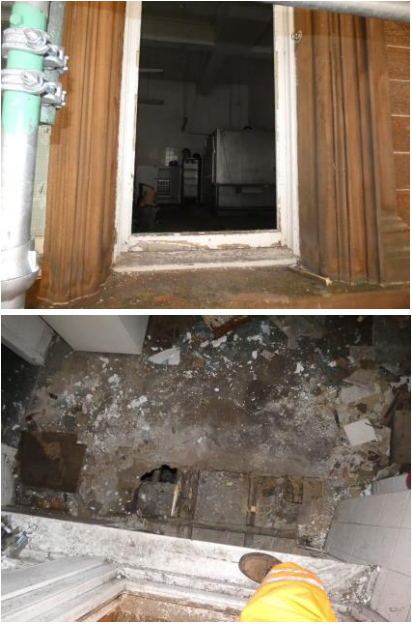
Defect ID	Photo Source	Defect Description	Defect Location	Crack Orientation	Crack Width (mm)	Crack Length (mm)	Comments	Photo	Severity Category
WW1.1	P1020 250-262	Other	Dry goods store	n/a	n/a	n/a	Joist timbers in satisfactory condition

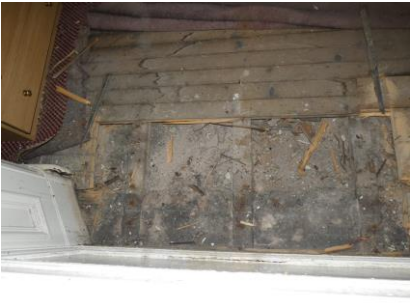
n/a
WW2.4	P1020 231-236	Evidence of water ingress	Bedroom 211	n/a	n/a	n/a	Joists ends connection to wall. Evidence of water ingress. Minimal section loss noted

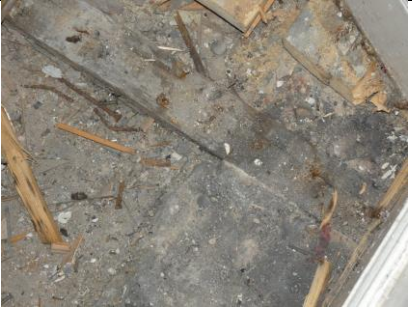
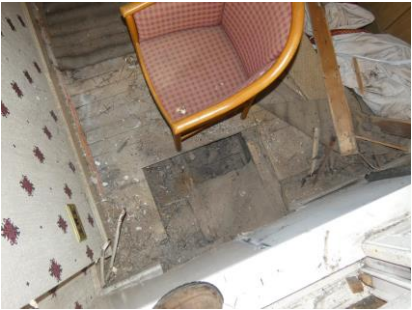
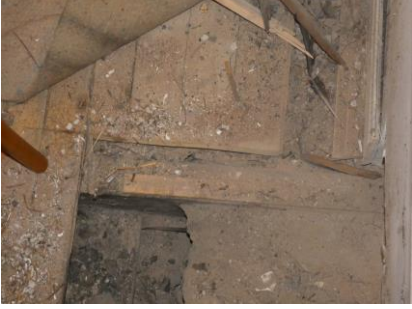
WW2.6	P1020 214-222	Other	Bedroom 217	n/a	n/a	n/a	Joist timbers in satisfactory condition

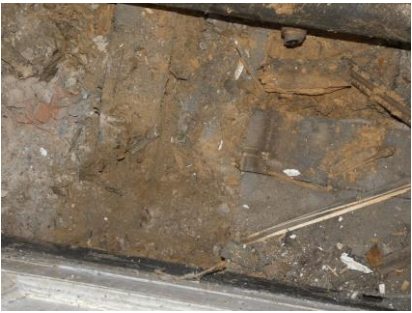
n/a
WW3.2	P1010 841	Degraded timber/loss of section	Bedroom 319	n/a	n/a	n/a	Evidence of water ingress and section loss to timber at connection to wall. Approx. 300mm length and up to 80mm section loss from top of section. Joist notched to allow pipe run through joist.

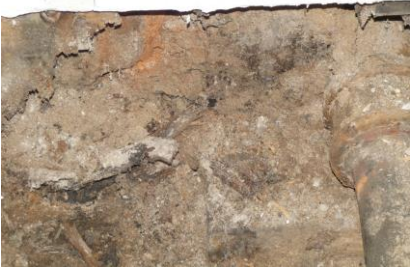
Amber
WW3.2	P1010 840	Other	Bedroom 319	n/a	n/a	n/a	Evidence of sandstone crumbling behind timber facing panel at window

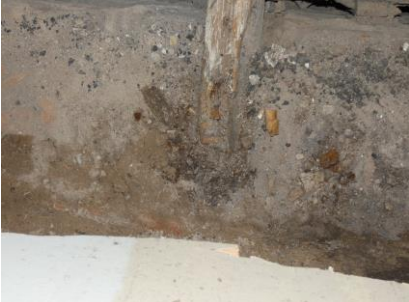
Defect ID	Photo Source	Defect Description	Defect Location	Crack Orientation	Crack Width (mm)	Crack Length (mm)	Comments	Photo	Severity Category
WW3.7	P1010 819-825	n/a	Bedroom 309	n/a	n/a	n/a	General photos	 	n/a
WW3.7	P1010 827	Degraded timber/loss of section	Bedroom 309	n/a	n/a	n/a	Evidence of water ingress and section loss to timber at connection to wall. Approx. 300mm length and up to 50mm section loss from top of section. Joist notched to allow pipe run through joist.

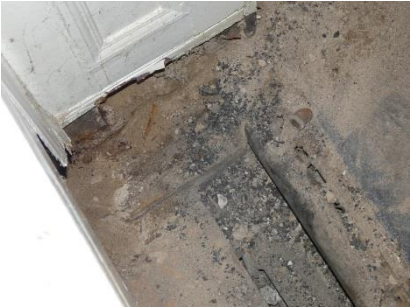
Defect ID	Photo Source	Defect Description	Defect Location	Crack Orientation	Crack Width (mm)	Crack Length (mm)	Comments	Photo	Severity Category
WW3.7	P1010 823	Other	Bedroom 309	n/a	n/a	n/a	Evidence of sandstone crumbling behind timber facing panel at window

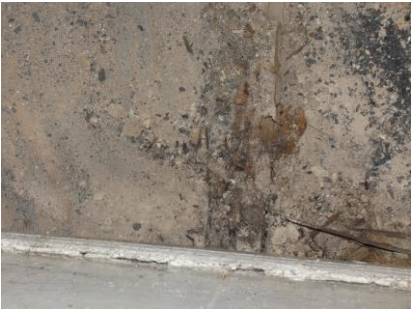
Defect ID	Photo Source	Defect Description	Defect Location	Crack Orientation	Crack Width (mm)	Crack Length (mm)	Comments	Photo	Severity Category
WW3.10	P1010 817	Degraded timber/loss of section	Bedroom 305	n/a	n/a	n/a	Section loss to timber at connection point with wall. Approx. 300mm length and up to 50mm section loss from top of section

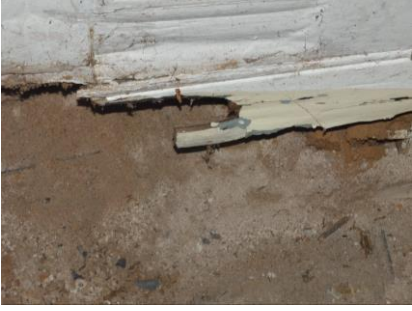
Amber
WW3.10	P1010 818	Other	Bedroom 305	n/a	n/a	n/a	Evidence of sandstone crumbling behind timber facing panel at window

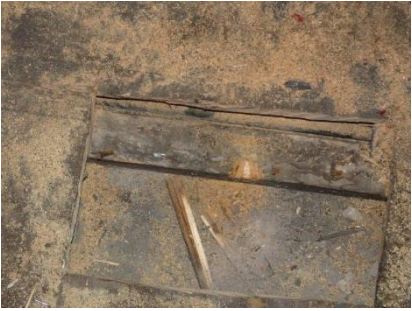
Defect ID	Photo Source	Defect Description	Defect Location	Crack Orientation	Crack Width (mm)	Crack Length (mm)	Comments	Photo	Severity Category
WE1.1	P1020 676	Other	Conference room	n/a	n/a	n/a	Timbers generally in good condition. Joists run North-South (parallel with wall) some signs of water ingress to joist ends. Minimal section loss. Timbers generally in good condition

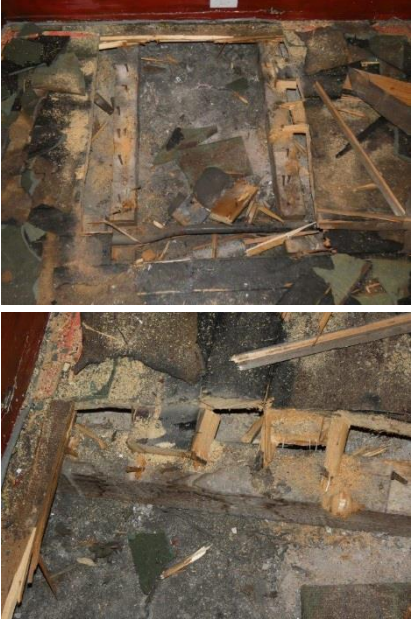
Green
WE1.2	P1020 699-703	Other	Lounge / Bar area	n/a	n/a	n/a	General room photos. Timbers generally in good condition. Timbers notched to approx. half depth of joist

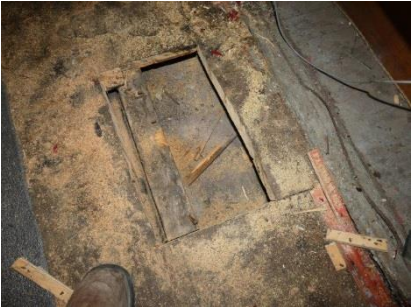
Defect ID	Photo Source	Defect Description	Defect Location	Crack Orientation	Crack Width (mm)	Crack Length (mm)	Comments	Photo	Severity Category
WE1.3	P1020 681	Other	Corridor	n/a	n/a	n/a	General room photos. Timbers generally in good condition. Joists running north-south supported on intermediate blockwork wall. No section loss

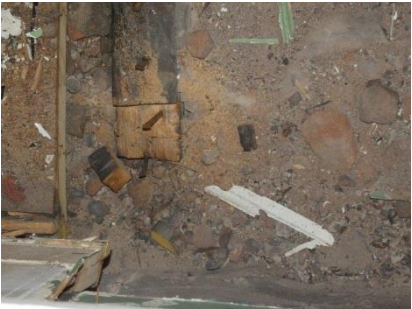
Green
WE2.1	P1020 647-653	Other	Bedroom 204	n/a	n/a	n/a	general room photos. Timbers in good condition. Notched at ends. No signs of degradation

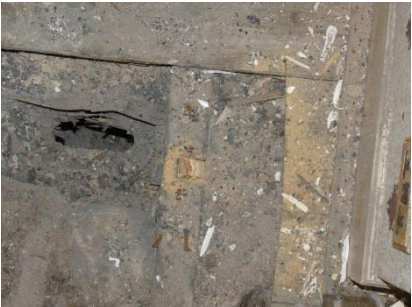
Green
WE2.5	P1020 654-662	Other	Bedroom 210	n/a	n/a	n/a	General room photos. Timbers in good condition. Evidence of water ingress at connection to wall. Minimal section loss to timber.

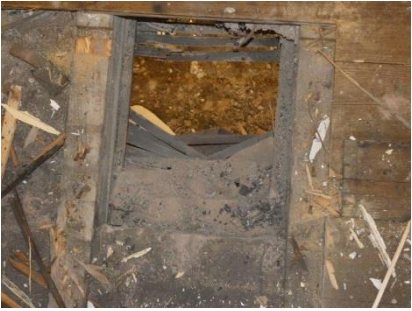
Defect ID	Photo Source	Defect Description	Defect Location	Crack Orientation	Crack Width (mm)	Crack Length (mm)	Comments	Photo	Severity Category
WE2.9	P1020 663-674	Other	Bedroom 216	n/a	n/a	n/a	General room photos. Timbers generally in good condition. Signs of water ingress at connection to wall. Minimal section loss to timber

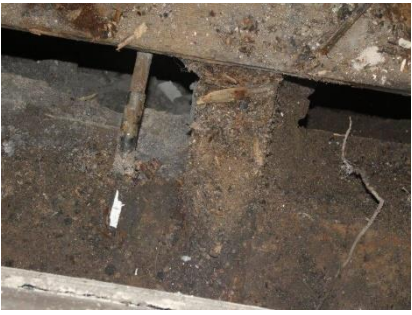
n/a
WE3.8	P1010807	Other	Bedroom 312	n/a	n/a	n/a	Degradation of timber joists at connection to wall. Approx. 30mm section loss from top of section. 60-75mm length

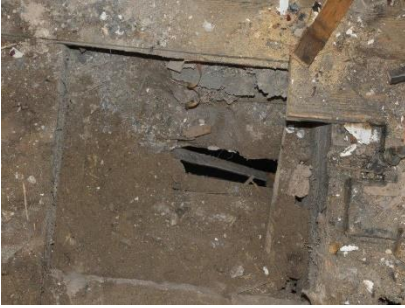
n/a
WE3.11	P10108010	Other	Bedroom 306	n/a	n/a	n/a	Mild degradation to joists at wall. Minor section loss. Timbers generally in good condition.

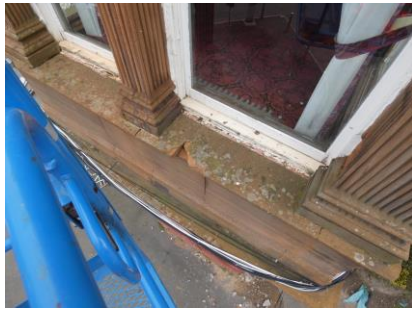
Red
CP2	P1020295-296	Spalled/damaged sandstone	Carrick Room adj. Bedroom 103	n/a	n/a	n/a	Large piece of sandstone spalled from sill (external defect)

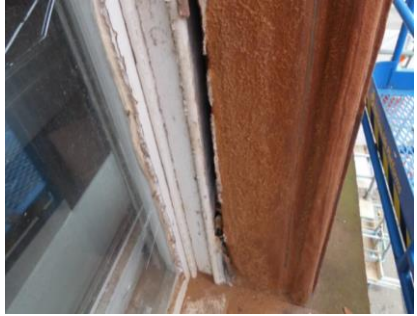
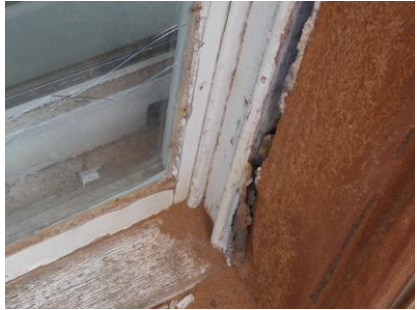
CP10	n/a	n/a	n/a	n/a	n/a	n/a	Reference not used	n/a	n/a
CP11	n/a	n/a	n/a	n/a	n/a	n/a	Reference not used	n/a	n/a
CP12	P1020320-329	No internal defects noted, Other	Bedroom 233	n/a	n/a	n/a	No internal defects noted. Separation of outer blockwork and mullion (external defect)

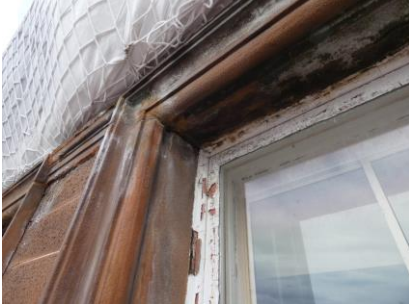
n/a
CP14	P1020341-350	n/a	Bedroom 237	n/a	n/a	n/a	No internal defects noted

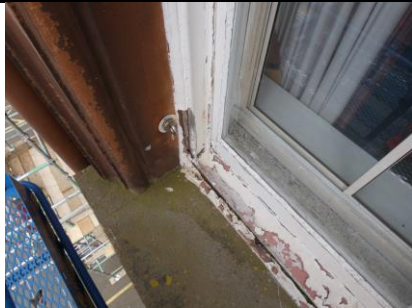
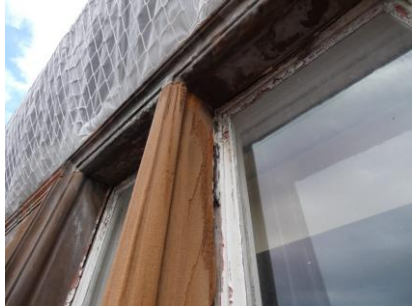
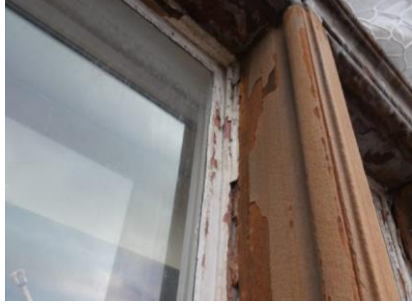
CP15	P1020394-409	Other	Bedroom 241	n/a	n/a	n/a	No internal defects noted. Mullion separating from surrounding frame (external defect)

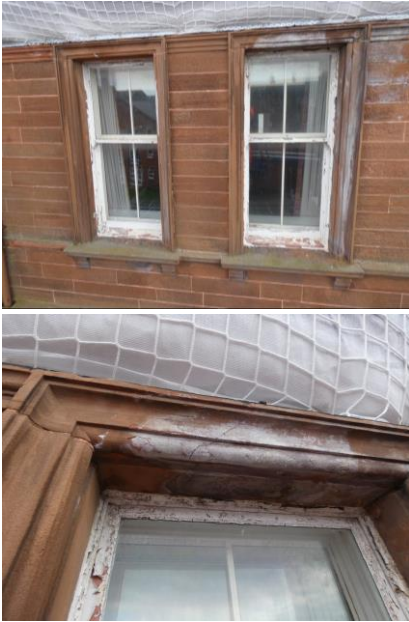
Defect ID	Photo Source	Defect Description	Defect Location	Crack Orientation	Crack Width (mm)	Crack Length (mm)	Comments	Photo	Severity Category
CP16	P1020410-417	Other	Bedroom 243	n/a	n/a	n/a	No internal defects noted. Crack in lintel (external defect)

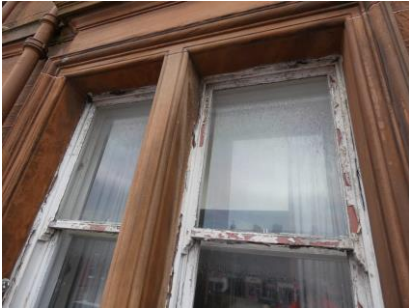
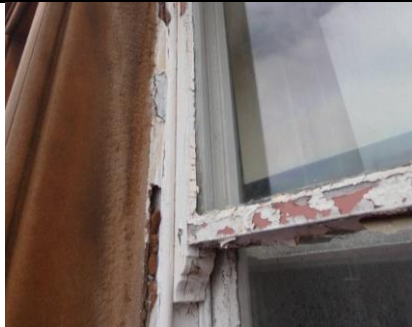
n/a Green
CP17	P1020377-393	Other	Bedroom 105	n/a	n/a	n/a	No internal defects noted. Separation of frame from blockwork to LHS of window (external defect)

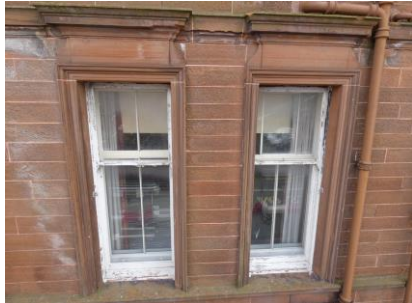
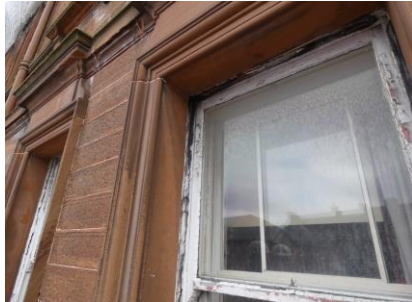
Green
CP18	P1020366-376	Other	Bedroom 107	n/a	n/a	n/a	No internal defects noted. Cracking/gap to lintel to RHS of window (external defect)

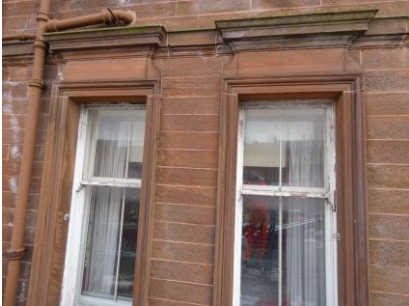
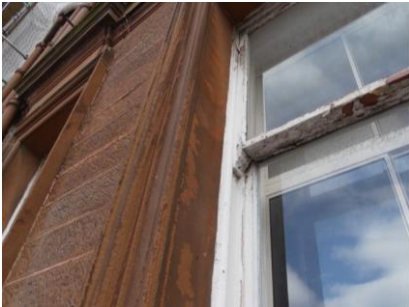
Defect ID	Photo Source	Defect Description	Defect Location	Crack Orientation	Crack Width (mm)	Crack Length (mm)	Comments	Photo	Severity Category
CP19	P1020351-365	n/a	Bedroom 109	n/a	n/a	n/a	No internal defects noted

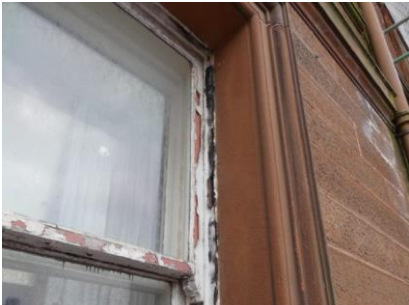
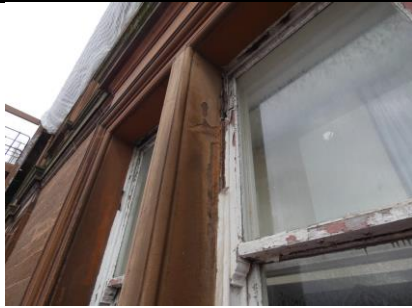
n/a
CP20	P1020427-438	Other	Bedroom 115	n/a	n/a	n/a	No internal defects noted. Mullion separation to RHS of window (external defect)

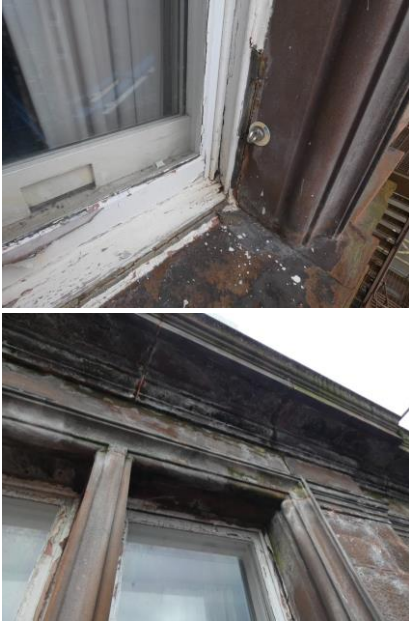
Defect ID	Photo Source	Defect Description	Defect Location	Crack Orientation	Crack Width (mm)	Crack Length (mm)	Comments	Photo	Severity Category
CP22	P1020448-462	Other	Bedroom 347	n/a	n/a	n/a	No internal defects noted. Separation of mullion from frame (external defect)

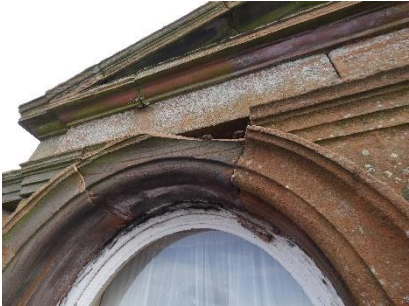
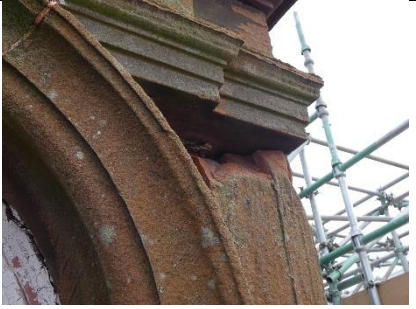
n/a Green
CP23	P1020266-270	Spalled/damaged sandstone	Stairs adj. Bedroom 301	n/a	n/a	n/a	No internal defects noted. Cracked/broken off sandstone to window arch and below ledge feature (external defects)

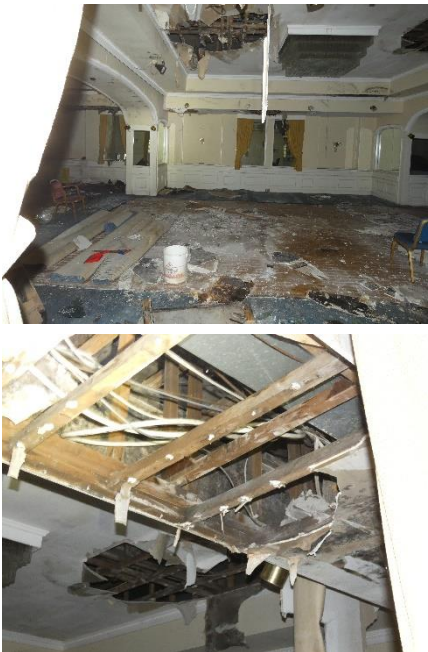
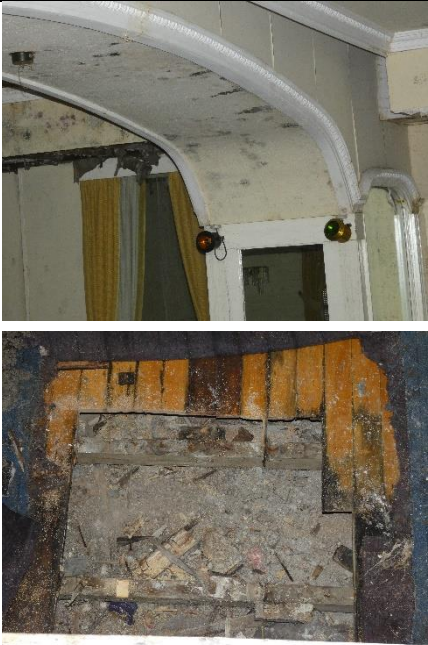
Defect ID	Photo Source	Defect Description	Defect Location	Crack Orientation	Crack Width (mm)	Crack Length (mm)	Comments	Photo	Severity Category
FO01	P1020 716-727, 742-750	Ceiling bulkhead removed, Mould	South Block, Ground level, Kintyre Suite	n/a	n/a	n/a	<p>Looking into the Kintyre Suite, room generally ok.</p> <p>Ceiling removed within bulkhead, support timbers exposed (742, 743), cannot see joists.</p> <p>Ceiling where not removed appears ok. Walls also ok, painted paper on plaster.</p> <p>Some areas of plaster have black mould (749, 750)</p> <p>Carpet in centre lifted, levelling screed on timber battens.</p> <p>The floorboards span onto timber joists. joists sit onto hard floor – possibly concrete. Not just sound deadening material.</p> <p>Floor opened up at window, joists looked dry, sample taken (746, 747).</p>

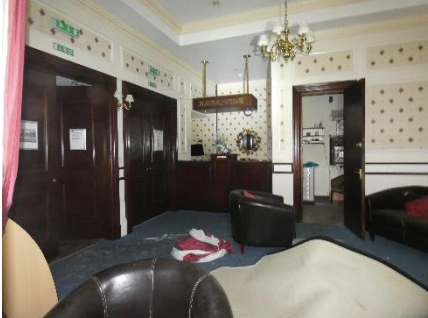
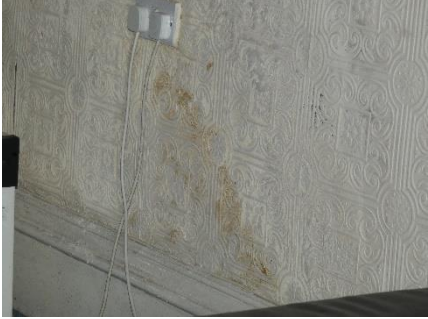
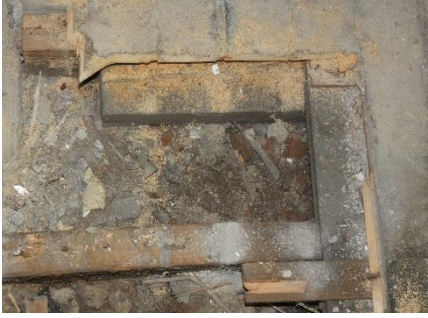
Defect ID	Photo Source	Defect Description	Defect Location	Crack Orientation	Crack Width (mm)	Crack Length (mm)	Comments	Photo	Severity Category
FO02	P1020 731-741	Dampness/water ingress, Other	South block, Ground level, Reception area	n/a	n/a	n/a	<p>Reception area in very good state. Ceiling all intact.</p> <p>Walls also intact – one area of damp (732, 734)</p> <p>Carpet still down on most floor area.</p> <p>Floor opened up, timber boards in good condition. Boards on timber joists on hard floor – possibly concrete (735-739).</p>
