Former Ayr Station Hotel Building Structural Condition

Independent Report

03 October 2019

Document reference: 399316/SNI/GLA/DOC/S2/REP/002

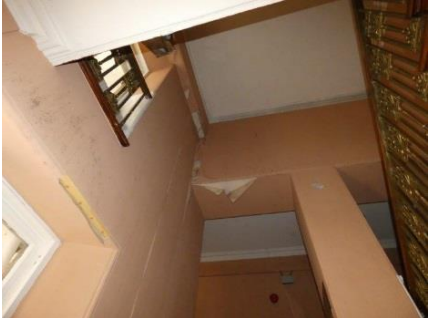
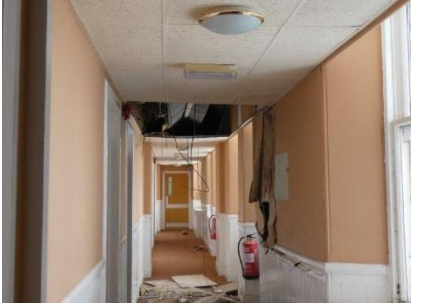
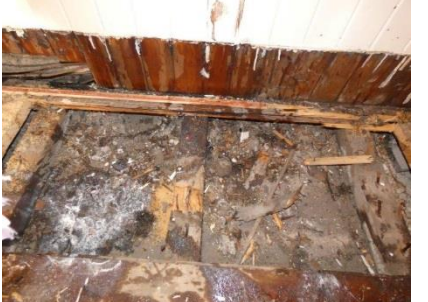
Defect ID	Photo Source	Defect Description	Defect Location	Crack Orientation	Crack Width (mm)	Crack Length (mm)	Comments	Photo	Severity Category
FO03	P1020 463-485	Dampness/ water ingress, Degradation to timbers, Plaster crack, Stain, Other	North block, Staircase (2 nd floor)	n/a	n/a	n/a	<p>General condition of area is fair. Signs of water ingress and cracking to plaster. Floor timbers appear in fair condition. Minor signs of damp/water ingress and degradation to joist timbers. Minimal section loss (463-471)</p> <p>Crack to ceiling plaster (472)</p> <p>Crack to ceiling plaster (473)</p> <p>damp stain to wall (474)</p> <p>ceiling collapse to corridor (475-478)</p> <p>Damp staining to wall. Evidence of water ingress (479-482)</p> <p>damp staining to internal wall above window (483)</p> <p>minor signs of degradation to joist timbers. Minimal section loss (484, 485)</p>

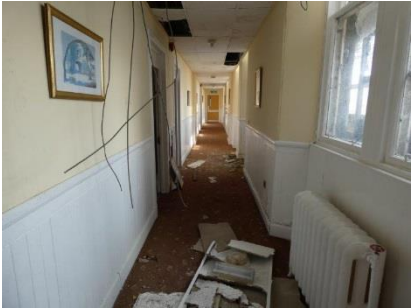
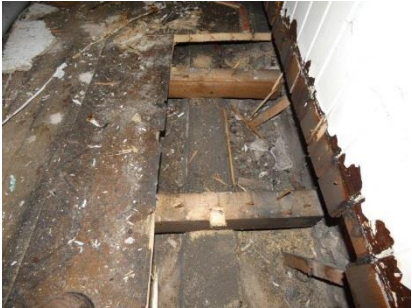
Defect ID	Photo Source	Defect Description	Defect Location	Crack Orientation	Crack Width (mm)	Crack Length (mm)	Comments	Photo	Severity Category
FO04	P1020494-510	Timber degradation, Crack to masonry, Other	North block, Corridor (1 st floor)	n/a	n/a	n/a	<p>Joist timbers in good condition. Beam ends supported on soleplate on wall. Minimal section loss to timbers (494-500)</p> <p>Suspended ceiling tile collapse. Possibly taken down by thieves. Evidence of copper pipes removed (499)</p> <p>Crack to masonry at ceiling arch above false ceiling (509, 5110)</p>

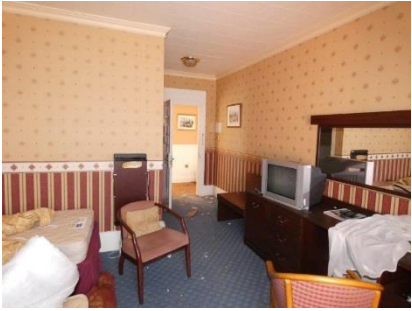
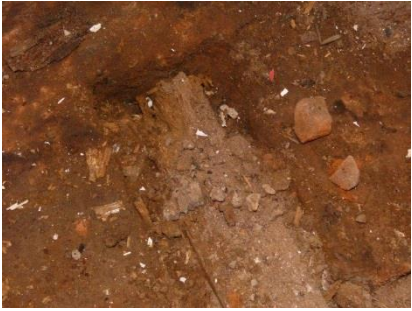
Defect ID	Photo Source	Defect Description	Defect Location	Crack Orientation	Crack Width (mm)	Crack Length (mm)	Comments	Photo	Severity Category
FO05	P1020517-525	Timber degradation	North block, Bedroom 339	n/a	n/a	n/a	General condition is good. Timber joists built into sandstone walls (approx. 200mm bearing). Timbers generally in good condition. Section over walls show minor sign of degradation. Section loss to top of timbers (approx. 30-50mm) noted.

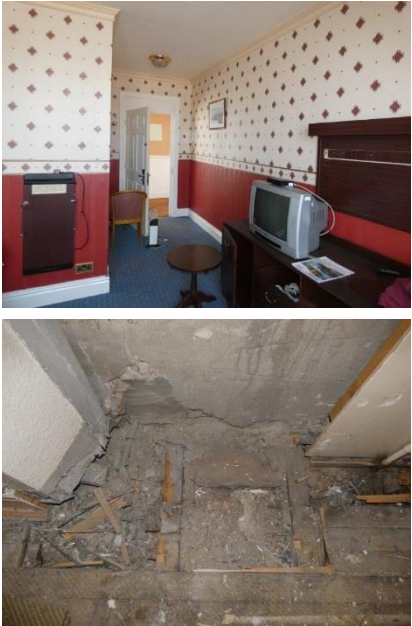
Defect ID	Photo Source	Defect Description	Defect Location	Crack Orientation	Crack Width (mm)	Crack Length (mm)	Comments	Photo	Severity Category
FO06	P1020532-544	Timber degradation	North block, Bedroom 239	n/a	n/a	n/a	<p>General condition is good. Timber joists built into sandstone walls (approx. 200mm bearing). Timbers generally in good condition. Section over walls show minor sign of degradation. Section loss to top of timbers (approx. 30-50mm) noted (532-544).</p> <p>Section loss to top of timber floor joists, top 30-50mm (523).</p>

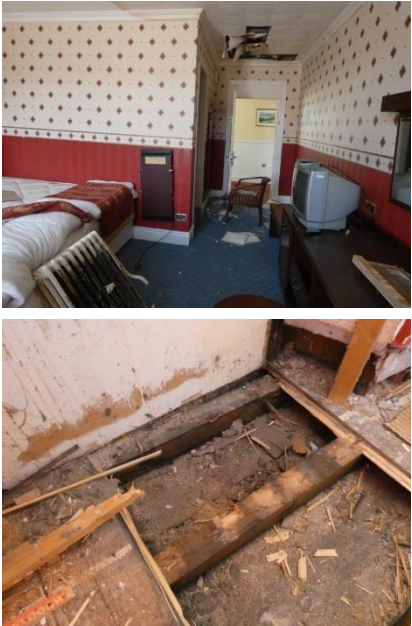
Defect ID	Photo Source	Defect Description	Defect Location	Crack Orientation	Crack Width (mm)	Crack Length (mm)	Comments	Photo	Severity Category
FO07	P1020 548-555	Evidence of water ingress, Collapsed ceiling tiles	North block, Bedroom 111	n/a	n/a	n/a	<p>General condition is fair. Evidence of water ingress to ceiling. Collapsed tiles and signs of water damage. Floor joists run North-South (parallel to wall), timber joists in good condition (548-554).</p> <p>Signs of water ingress to ceiling. Isolated area of collapsed tiles (551).</p> <p>Evidence of water ingress at cornice level (555).</p>

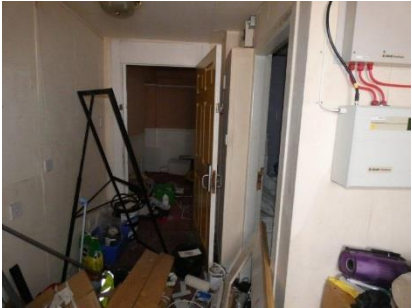
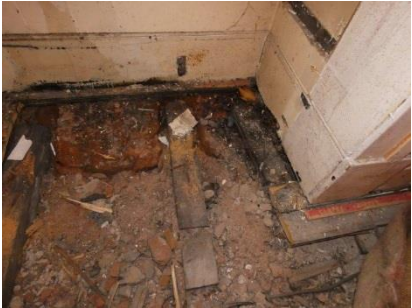
Defect ID	Photo Source	Defect Description	Defect Location	Crack Orientation	Crack Width (mm)	Crack Length (mm)	Comments	Photo	Severity Category
FO08	P1020 555-568	Timber degradation, Evidence of water ingress, Damp staining, Collapsed ceiling tiles	North block, Bedroom 331 / office	n/a	n/a	n/a	<p>General condition is fair/ Timber joists built into sandstone walls (approx. 200mm bearing). Timbers generally in good condition. Section over walls show minor sign of degradation. Minimal section loss to timber noted (556-568).</p> <p>Minor signs of water ingress and related degradation to timber floor joists (558).</p> <p>Damp staining to ceiling tiles (564).</p> <p>Collapsed/removed ceiling tiles (567).</p>

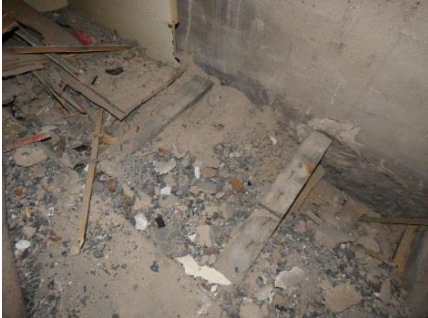
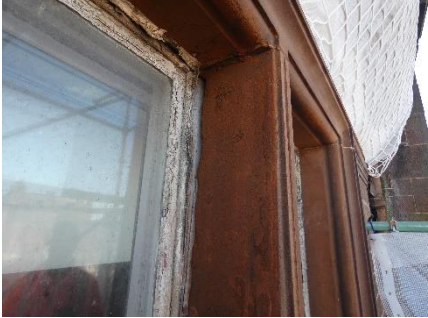
Defect ID	Photo Source	Defect Description	Defect Location	Crack Orientation	Crack Width (mm)	Crack Length (mm)	Comments	Photo	Severity Category
FO09	P1020 569-577	Other	North block, Bedroom 231	n/a	n/a	n/a	<p>General condition is good. Timber joists built into sandstone walls with cantilever end (approx. 150mm). Timbers generally in good condition. No signs of degradation. Room in good condition (569-574).</p> <p>External defect. Mullion displaced. Evidence of movement away from frame (575-577).</p>

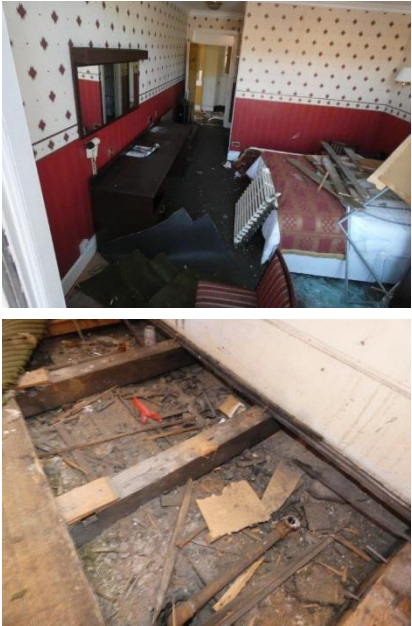
Defect ID	Photo Source	Defect Description	Defect Location	Crack Orientation	Crack Width (mm)	Crack Length (mm)	Comments	Photo	Severity Category
FO10	P1020 577-591	Other	North block, Bedroom 103 / office	n/a	n/a	n/a	General condition is good. Timber joists built into sandstone walls. Timbers generally in good condition.

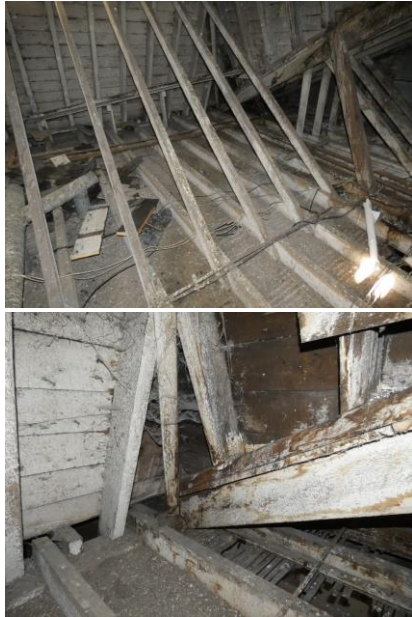
Defect ID	Photo Source	Defect Description	Defect Location	Crack Orientation	Crack Width (mm)	Crack Length (mm)	Comments	Photo	Severity Category
RS1	P1020004-024	Other	South block roof space	n/a	n/a	n/a	Timbers generally in fair condition. Evidence of rot to vertical rafters. Horizontal timbers generally in fair/good condition. Some minor mortar loss to masonry walls

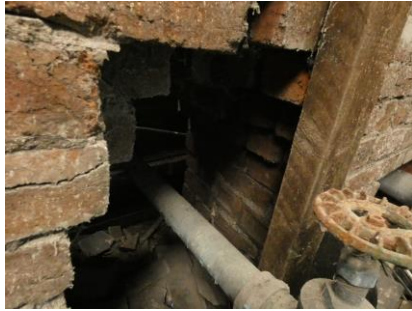
Defect ID	Photo Source	Defect Description	Defect Location	Crack Orientation	Crack Width (mm)	Crack Length (mm)	Comments	Photo	Severity Category
RS2	P1020049-051, 062, 067, 079	Other	South block roof space	n/a	n/a	n/a	Timbers generally in good condition. Masonry in good condition. Minimal mortar loss. Openings noted in chimney support brickwork with no lintel.

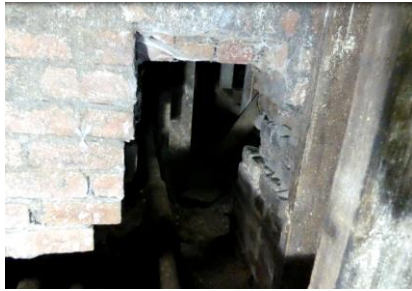
Amber Red
RS3	P1020049-051, 062, 067, 079	Other	South block roof space	n/a	n/a	n/a	Timbers generally in good condition. Masonry in good condition. Minimal mortar loss. Openings noted in chimney support brickwork with no lintel.

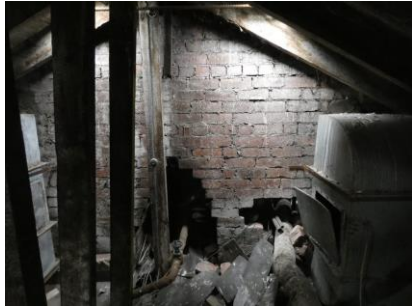
Amber Red
RS4	P1020049-051, 062, 067, 079	Other	South block roof space	n/a	n/a	n/a	Timbers generally in good condition. Masonry in good condition. Minimal mortar loss. Openings noted in chimney support brickwork with no lintel.

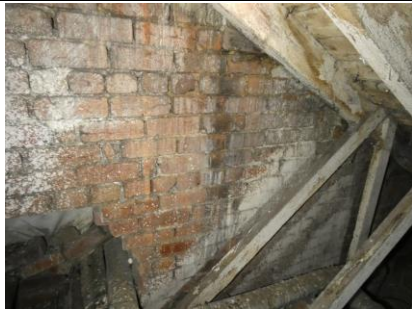
Defect ID	Photo Source	Defect Description	Defect Location	Crack Orientation	Crack Width (mm)	Crack Length (mm)	Comments	Photo	Severity Category
RS5	P1020049-051, 062, 067, 079	Other	South block roof space	n/a	n/a	n/a	Timbers generally in good condition. Masonry in good condition. Minimal mortar loss. Openings noted in chimney support brickwork with no lintel.

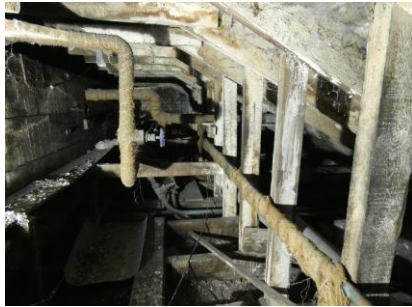
Amber Red
RS6-RS7	P1020029 - 051	Other	South block roof space	n/a	n/a	n/a	Timbers generally in good condition. Masonry in good condition. Minimal mortar loss. Openings noted in chimney support brickwork with no lintel. Existing water tank and pipes cut (thieves) with water actively running from pipe through building.

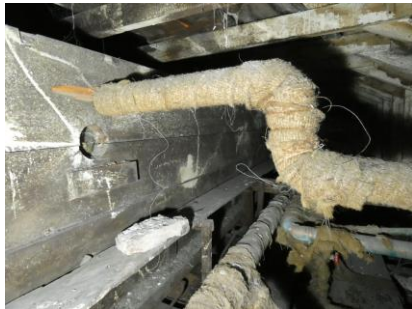
Amber Red
RS8	P1020029 - 051	Other	South block roof space	n/a	n/a	n/a	Timbers generally in good condition. Masonry in good condition. Minimal mortar loss. Openings noted in chimney support brickwork with no lintel. Existing water tank and pipes cut (thieves) with water actively running from pipe through building.

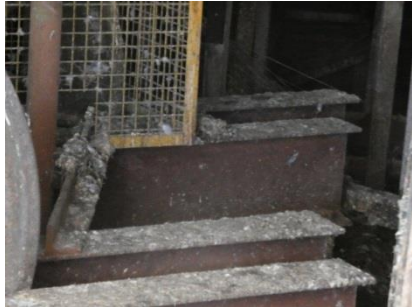
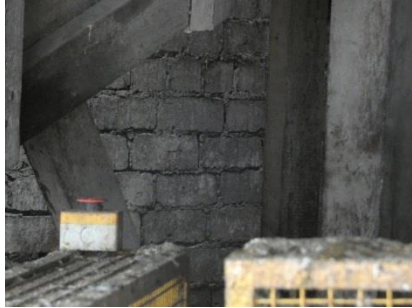
Defect ID	Photo Source	Defect Description	Defect Location	Crack Orientation	Crack Width (mm)	Crack Length (mm)	Comments	Photo	Severity Category
RF1 (West)	P1010842-864	Evidence of water ingress, Metal corrosion, Damage to mortar Other	South block roof	n/a	n/a	n/a	Evidence of water ingress to rafter ends (857) Evidence of vermin (858) Corrosion to support beams for lift gear. Minimal section loss (859-862) Minor mortar loss to masonry wall (863-864)

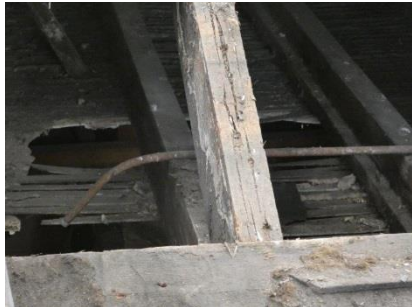
Amber
RF2 (West)	P1010873-874	Staining to timber, Other	South block roof	n/a	n/a	n/a	White staining to roof timbers (873) Local collapse to lathe and plaster ceiling (874)

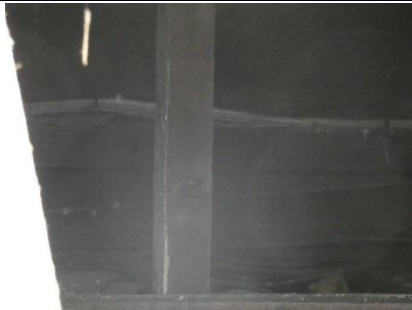
Defect ID	Photo Source	Defect Description	Defect Location	Crack Orientation	Crack Width (mm)	Crack Length (mm)	Comments	Photo	Severity Category
RF3 (West)	P1010882-883	Staining to timber, Other	South block roof	n/a	n/a	n/a	White staining to roof timbers (882) Canisters sitting above ceiling. Risk of ceiling collapse or injury during demolition operations (883)

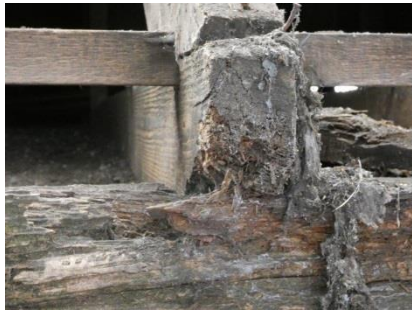
Amber
TH1 (West)	n/a	n/a	South block roof	n/a	n/a	n/a	Inspection of TH1 was abandoned due to poor access and visibility. Refer to RS1.	n/a	n/a
RF1 (East)	P1010775	Degraded timber/loss of section, Staining to timber, Other	South block roof	n/a	n/a	n/a	Section loss to timber at rafter ends. Section loss to eaves beam (up to 50-60%) (788-790) White staining to timber members. Possible indication of rot (795-796) Timber section loss to ties at edge of the rafter (797) Corroded nails and fixings (798) Minor mortar loss to chimney stack masonry (775-756)

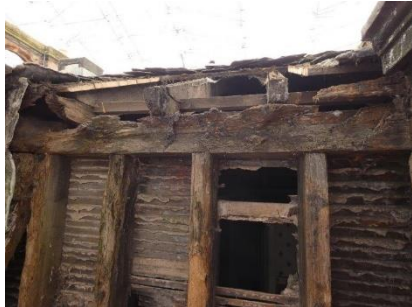
Defect ID	Photo Source	Defect Description	Defect Location	Crack Orientation	Crack Width (mm)	Crack Length (mm)	Comments	Photo	Severity Category
RF2 (East)	P1010777-800	Degraded timber/loss of section, Staining to timber, Other	South block roof	n/a	n/a	n/a	Section loss to joists. Loss of support (789) Section loss to vertical posts between eaves and joists below (790-793) White staining to timber generally (794-795) Section loss to rafter ends (796-797) Corroded nails and fixings (798) Section loss to eaves beams support (799) White staining to timber members internally at roof (800)

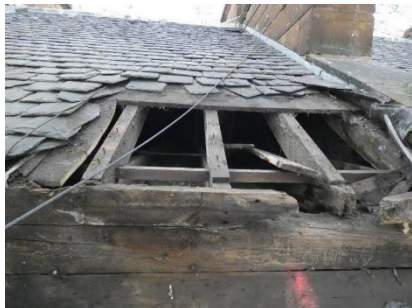
Red
RF3 (East)	P1010193-205	Degraded timber/loss of section, Other	South block roof	n/a	n/a	n/a	Section loss (approx. 30%) to bottom of timber member (202) Section loss to eaves beam. Approx. 80mm loss from top of member (203-204) Ceiling collapsed internally. Approx. 0.5m2 (205)

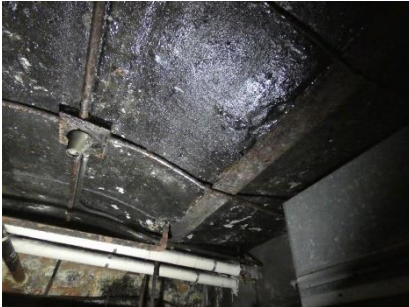
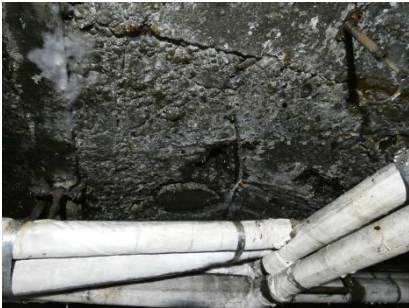
Defect ID	Photo Source	Defect Description	Defect Location	Crack Orientation	Crack Width (mm)	Crack Length (mm)	Comments	Photo	Severity Category
1.1	P1020922-0927	Water ingress	Boilerhouse - ceiling	n/a	n/a	n/a	Water ingress through ceiling. Location of room below leaking tank in roof (likely source of water) water ingress through joints and various spalled/damaged concrete.

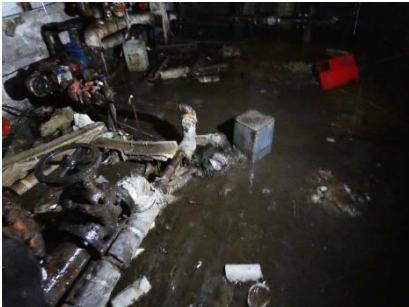
Amber
1.2	P1020928-0935	Water ingress	Boilerhouse - floor	n/a	n/a	n/a	Standing water on basement floor. Likely source from leaking tank in roof. Floor submerged therefore defects at floor level not visible

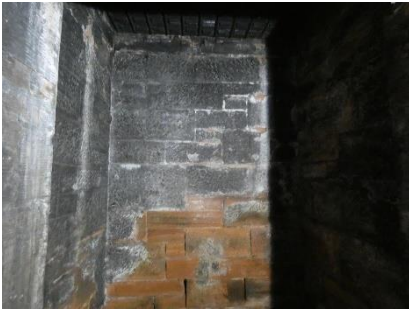
Amber
1.3	P1020912	Mortar loss to masonry	Boilerhouse - ceiling wall	n/a	n/a	n/a	Mortar loss from stonework.

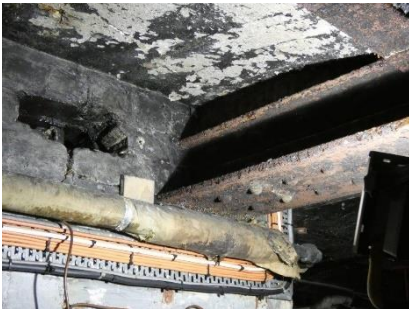
Green
1.44	P1020937	Metal corrosion	Boilerhouse - ceiling	n/a	n/a	n/a	Mild corrosion to main supporting beam (beam supports secondary metal beams and concrete arch) minimal section loss

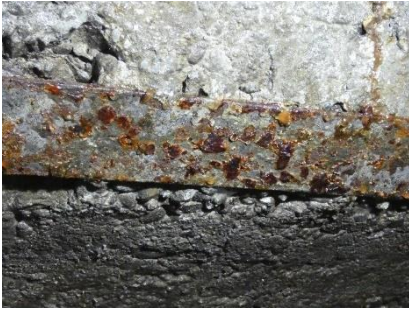
Defect ID	Photo Source	Defect Description	Defect Location	Crack Orientation	Crack Width (mm)	Crack Length (mm)	Comments	Photo	Severity Category
1.5	P1020940	Metal corrosion	Boilerhouse - ceiling	n/a	n/a	n/a	Mild corrosion to secondary supporting beams. Minimal section loss

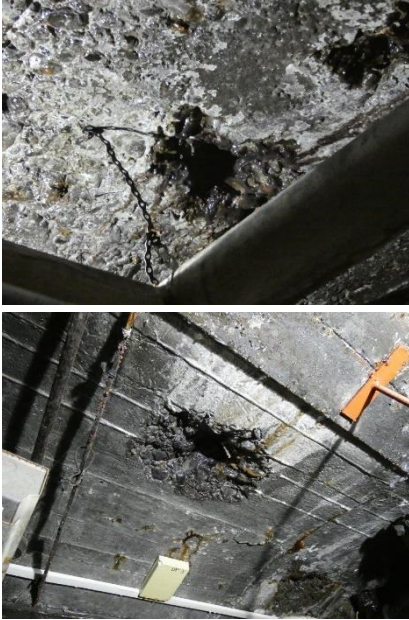
Green
1.6	P1020941	Missing concrete	Boilerhouse - ceiling	n/a	n/a	n/a	Missing concrete/holes in ceiling. Size varies. 8 no. Locations

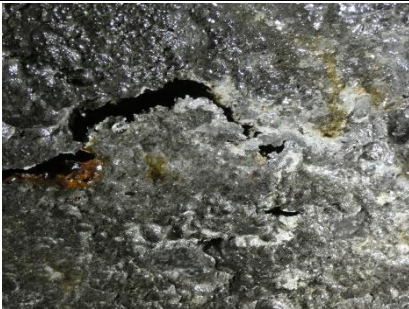
Defect ID	Photo Source	Defect Description	Defect Location	Crack Orientation	Crack Width (mm)	Crack Length (mm)	Comments	Photo	Severity Category
1.7	P1020942	Spalled concrete	Boilerhouse - ceiling	n/a	n/a	n/a	Spalling concrete from arched concrete ceiling.

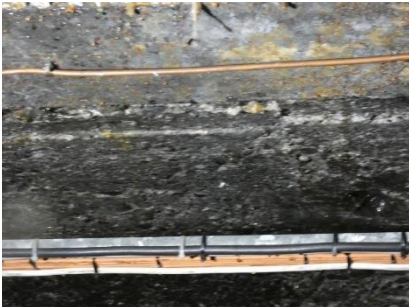
Amber
1.8	P1020954-957	Honeycombing to concrete	Boilerhouse - ceiling	n/a	n/a	n/a	Honeycombing, gaps to concrete where concrete arch meets metal beam. Construction of arch appears to be in-situ concrete cast between web of metal beam

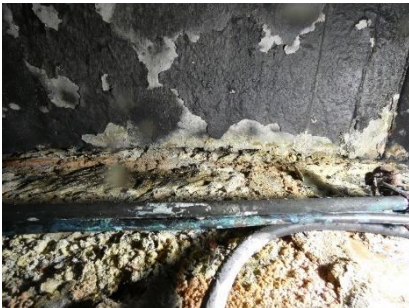
Green
1.9	P1020973-975	Crumbling/recessed masonry wall	Boilerhouse - ceiling	n/a	n/a	n/a	Crumbling/recessed masonry at junction between wall and concrete arch. 6no. Locations

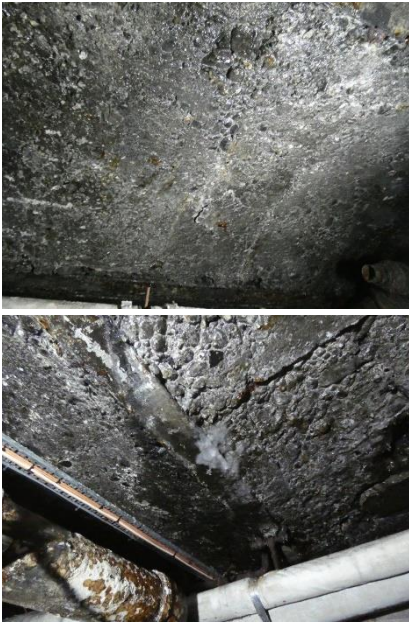
Defect ID	Photo Source	Defect Description	Defect Location	Crack Orientation	Crack Width (mm)	Crack Length (mm)	Comments	Photo	Severity Category
1.10	P1020925, 927	Poor quality concrete	Boilerhouse - ceiling	n/a	n/a	n/a	Poor quality concrete to arches. Aggregate and honeycombing evident. No sign of reinforcement at locations where concrete has collapsed

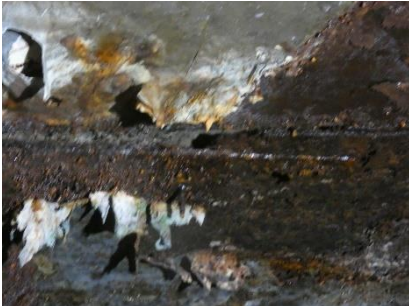
Green
2.2	P1030016	Metal corrosion	Oil Tank - ceiling	n/a	n/a	n/a	Loose/corroded metal plate to underside of concrete arch. Possible formwork for concrete pour

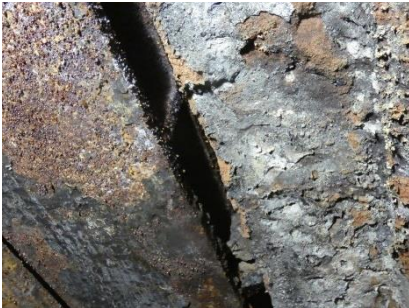
Defect ID	Photo Source	Defect Description	Defect Location	Crack Orientation	Crack Width (mm)	Crack Length (mm)	Comments	Photo	Severity Category
2.3	P1030008	Metal corrosion	Oil Tank - ceiling	n/a	n/a	n/a	Mild corrosion to metal support beam. Minimal section loss

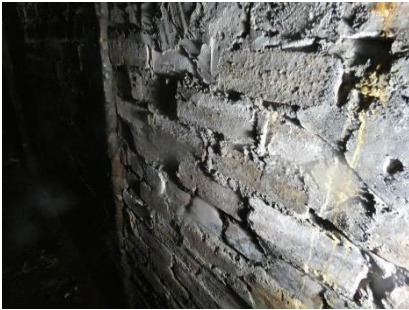
Green
2.4	P1020985	Poor quality masonry	Oil Tank - walls	n/a	n/a	n/a	Poor quality masonry work to internal walls. Large masonry joints. Loss of mortar.

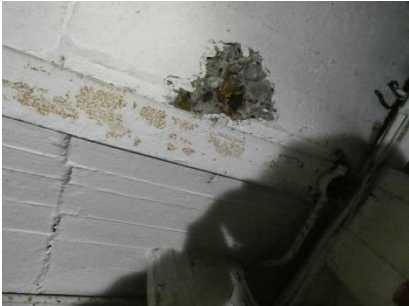
Green
3.2	P1030056-058	Missing/dislodged concrete	Battery Room - ceiling	n/a	n/a	n/a	Missing/dislodged concrete to arched ceiling

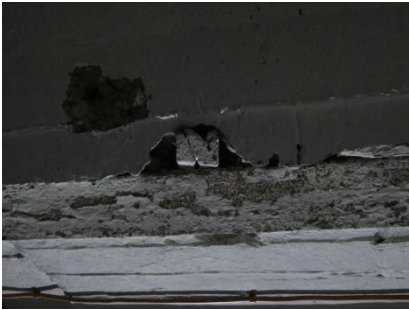
Green
3.3	P1030059-060	Gap in concrete at beam	Battery Room - ceiling	n/a	n/a	n/a	Missing concrete around beam at connection with concrete arch

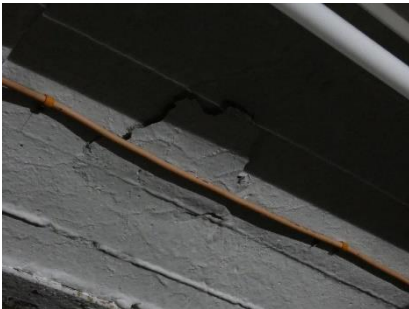
Green
3.4	P1030061-063	Spalled concrete	Battery Room - ceiling	n/a	n/a	n/a	Spalled concrete patch. No evidence of rebar in concrete

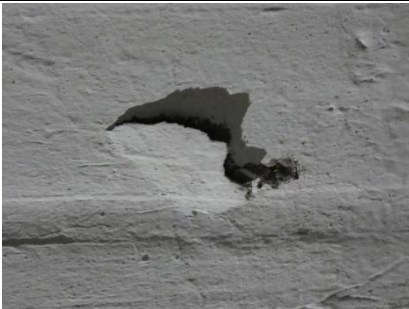
Defect ID	Photo Source	Defect Description	Defect Location	Crack Orientation	Crack Width (mm)	Crack Length (mm)	Comments	Photo	Severity Category
3.5	P1030064-065	Spalled concrete	Battery Room - ceiling	n/a	n/a	n/a	Spalled concrete patch. No evidence of rebar in concrete

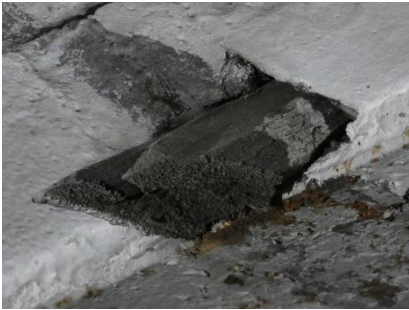
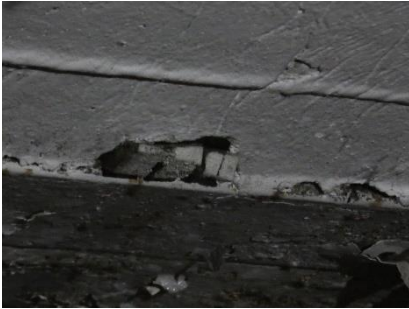
Green
3.6	P1030066-073	Concrete embedment	Battery Room - ceiling	n/a	n/a	n/a	Wooden wedges embedded in concrete arch. Appears to be left over from construction of arches.

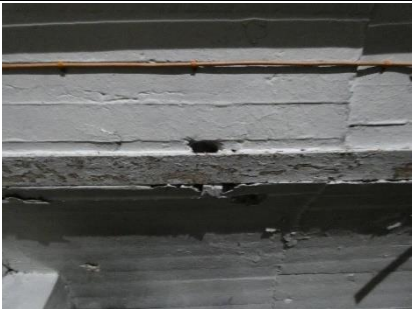
Defect ID	Photo Source	Defect Description	Defect Location	Crack Orientation	Crack Width (mm)	Crack Length (mm)	Comments	Photo	Severity Category
3.7	P1030073	Metal corrosion	Battery Room - ceiling	n/a	n/a	n/a	Mild corrosion to metal beam. Minimal section loss

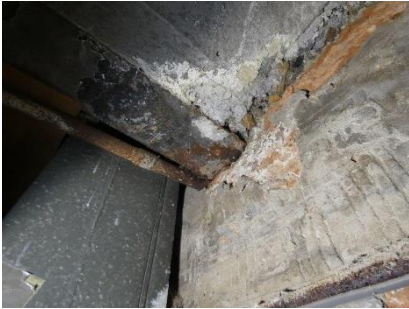
n/a
4.1	P1030084	Metal corrosion	Store 1 - ceiling	n/a	n/a	n/a	Moderate corrosion to metal beam. Minimal section loss. Surrounding concrete breaking away from beam.

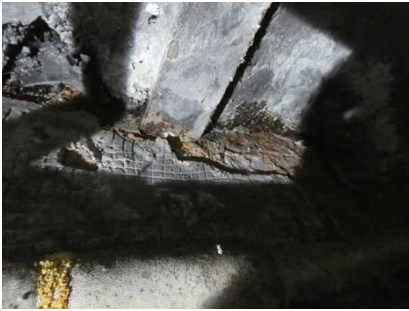
Defect ID	Photo Source	Defect Description	Defect Location	Crack Orientation	Crack Width (mm)	Crack Length (mm)	Comments	Photo	Severity Category
4.2	P1030086-087	Metal corrosion	Store 1 - ceiling	n/a	n/a	n/a	Mild corrosion to metal beam at connection to wall

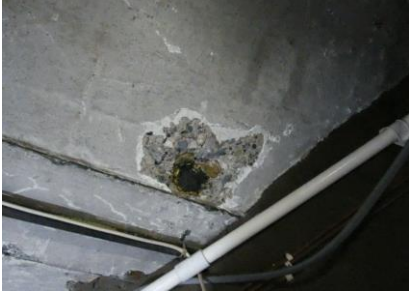
Green
4.3	P1030088-089 (MP4 file)	Concrete repair	Store 1 - ceiling	n/a	n/a	n/a	Missing concrete patch to ceiling

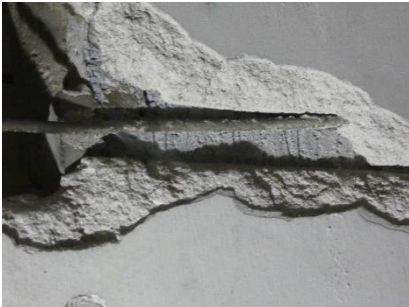
n/a
5.1	P1030164-165	Void in wall	Store 2 – wall	n/a	n/a	n/a	Hole knocked through wall to allow service penetrations. No lintel or support from framing noted

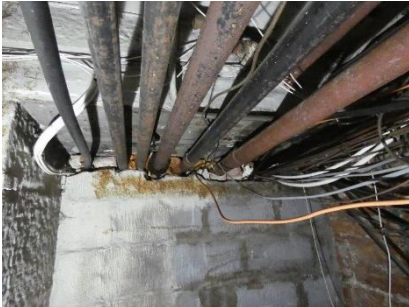
Defect ID	Photo Source	Defect Description	Defect Location	Crack Orientation	Crack Width (mm)	Crack Length (mm)	Comments	Photo	Severity Category
5.4	P1030172-173	Void in wall	Store 2 – wall	n/a	n/a	n/a	Hole knocked through wall to allow service penetrations. No lintel or support from framing noted

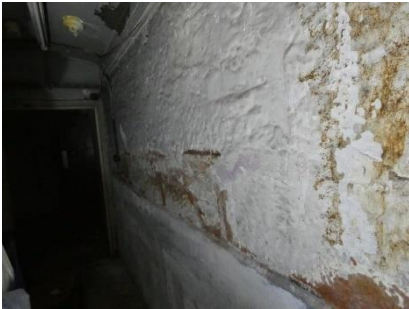
Amber
5.5	P1030174-175	Staining	Store 2 – wall	n/a	n/a	n/a	Staining to wall. Indicative of damp

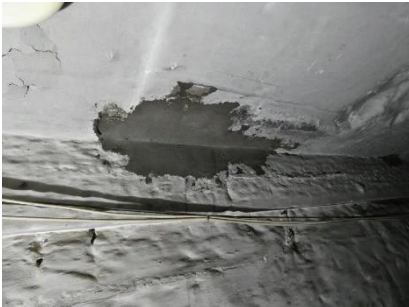
Green
5.6	P1030176-177	Concrete loss	Store 2 – ceiling	n/a	n/a	n/a	Evidence of spalled/missing concrete. Historic concrete repair noted

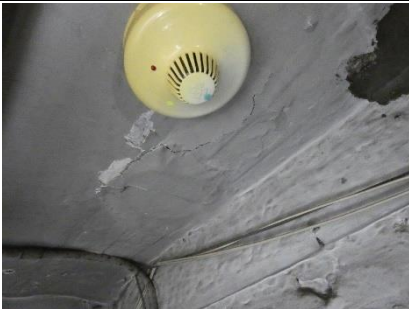
Defect ID	Photo Source	Defect Description	Defect Location	Crack Orientation	Crack Width (mm)	Crack Length (mm)	Comments	Photo	Severity Category
5.7	P1030178-181	Spalled concrete	Store 2 – ceiling	n/a	n/a	n/a	Cracks to concrete. Possible indication of early stages of spalling

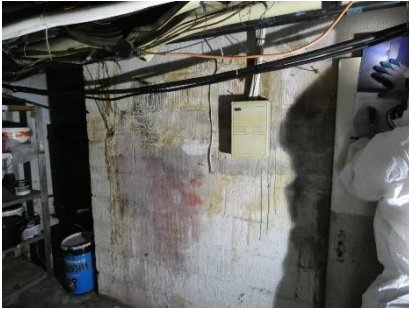
n/a
6.1	P1030138	Staining	Store 3 - wall	n/a	n/a	n/a	Staining to wall. Indicative of damp

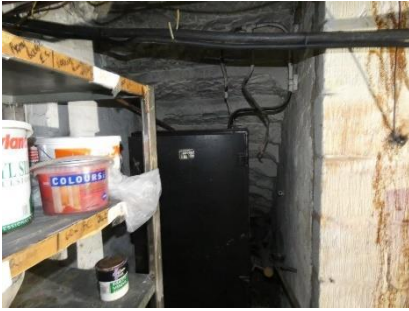
Defect ID	Photo Source	Defect Description	Defect Location	Crack Orientation	Crack Width (mm)	Crack Length (mm)	Comments	Photo	Severity Category
6.2	P1030139-140	Staining	Store 3 - wall	n/a	n/a	n/a	Staining to wall. Indicative of damp

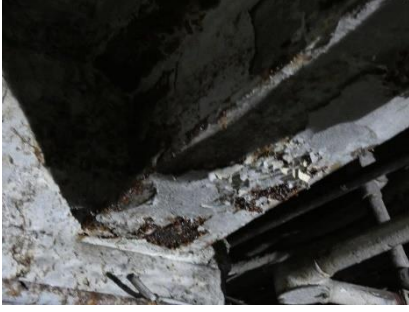
Green
6.3	P1030143-144	Metal corrosion	Store 3 - wall	n/a	n/a	n/a	Minor corrosion to metal beam end at connection to wall. Minimal section loss

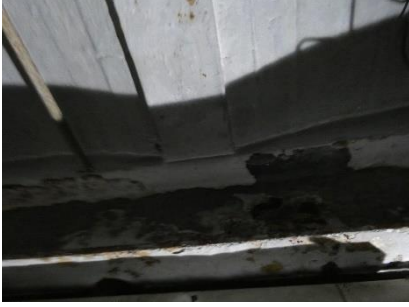
Green
6.4	P1030145-146	Metal corrosion	Store 3 - ceiling	n/a	n/a	n/a	Minor corrosion to metal beam. Minimal section loss

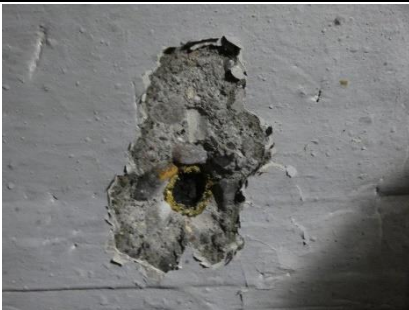
Defect ID	Photo Source	Defect Description	Defect Location	Crack Orientation	Crack Width (mm)	Crack Length (mm)	Comments	Photo	Severity Category
6.5	P1030147-148	Spalled/missing concrete	Store 3 - ceiling	n/a	n/a	n/a	Spalled/missing concrete from ceiling

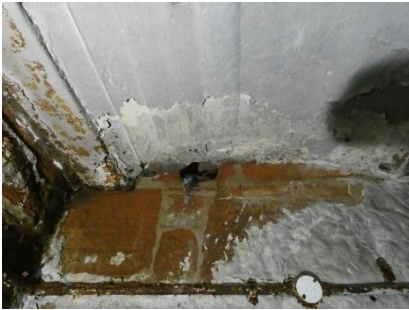
Green
6.6	P1030151-152	Hole in wall	Store 3 - wall	n/a	n/a	n/a	Void/hole in wall at corner

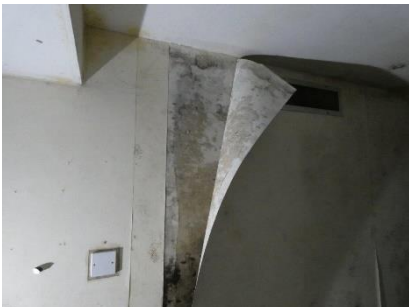
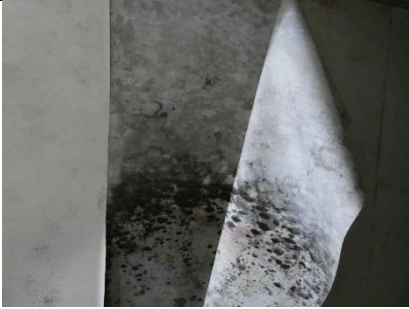
n/a
7.1	P1030245-250	Damp staining	Corridor 1 - walls	n/a	n/a	n/a	Damp staining to plasterboard walls

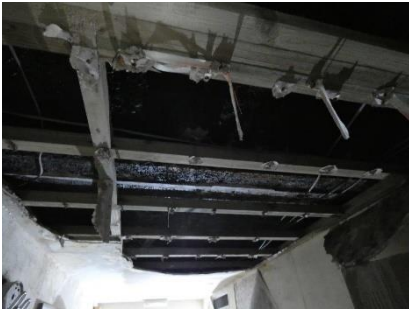
Green
7.2	P1030251-254	Collapsed ceiling	Corridor 1 - ceiling	n/a	n/a	n/a	Plasterboard suspended ceiling collapsed. Approx. 2m x 10m.

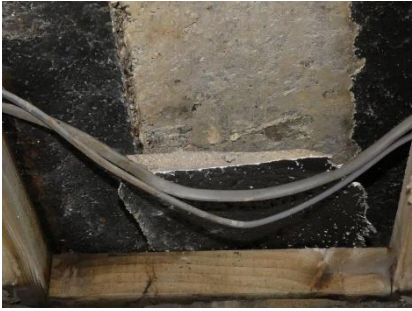
Defect ID	Photo Source	Defect Description	Defect Location	Crack Orientation	Crack Width (mm)	Crack Length (mm)	Comments	Photo	Severity Category
7.4	P1030257-259	Concrete damage	Corridor 1 - ceiling	n/a	n/a	n/a	Concrete/render collapse from ceiling

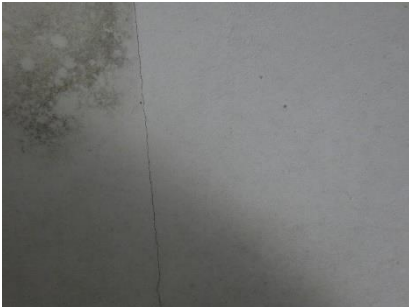
n/a
8.1	P1030216-219	Plaster crack	Hall 1 - ceiling	Horizontal	>1	3000	Crack to plaster ceiling

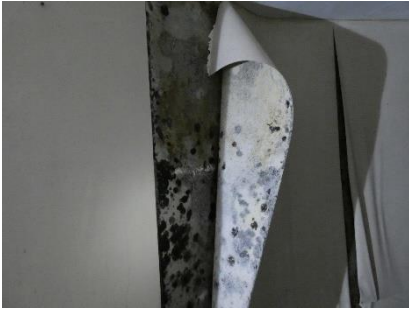
Defect ID	Photo Source	Defect Description	Defect Location	Crack Orientation	Crack Width (mm)	Crack Length (mm)	Comments	Photo	Severity Category
8.2	P1030220-227	Damp staining	Hall 1 - walls	n/a	n/a	n/a	Damp staining to walls. Wallpaper peeling. Indicative of water ingress

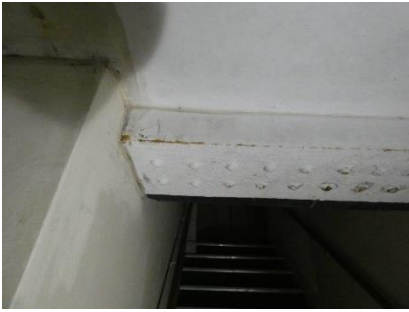
Green
8.3	P1030228-230	Metal corrosion	Hall 1 - ceiling	n/a	n/a	n/a	Mild corrosion to metal support beam. Minimal section loss

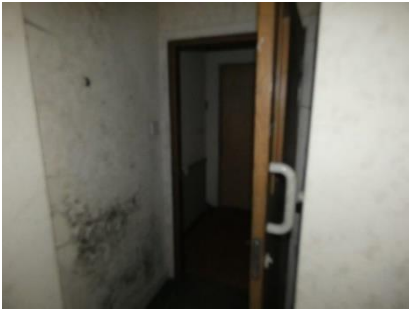
Green
8.4	P1030231-233	Damp staining	Hall 1 - walls	n/a	n/a	n/a	Damp staining to walls around staircase

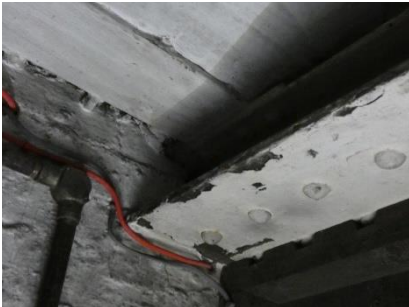
n/a
9.1	P1030189-190	Metal corrosion	Lift Motor Room - ceiling	n/a	n/a	n/a	Mild corrosion to metal support beam. Minimal section loss

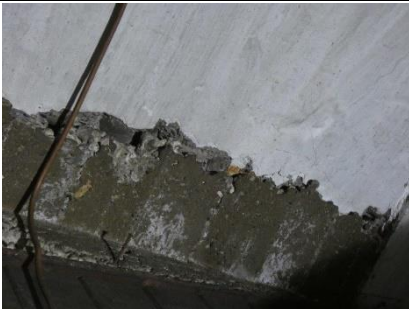
Defect ID	Photo Source	Defect Description	Defect Location	Crack Orientation	Crack Width (mm)	Crack Length (mm)	Comments	Photo	Severity Category
9.2	P1030191-196	Concrete/render failure	Lift Motor Room - ceiling	n/a	n/a	n/a	Concrete/render collapse from ceiling

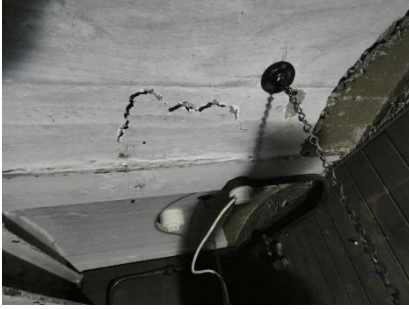
Green
9.3	P1030197-200	Spalled concrete	Lift Motor Room - ceiling	n/a	n/a	n/a	Spalled/damaged concrete to ceiling

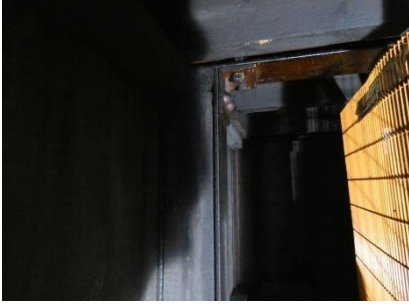
Green
9.4	P1030201-205	Metal corrosion	Lift Motor Room - ceiling	n/a	n/a	n/a	Corrosion to lift support steelwork

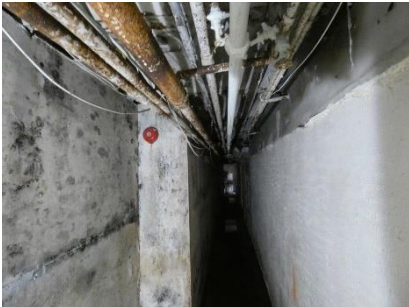
n/a
10.1	P1030322-332	Damp staining	Corridor 2 - walls	n/a	n/a	n/a	Damp staining to walls throughout corridor

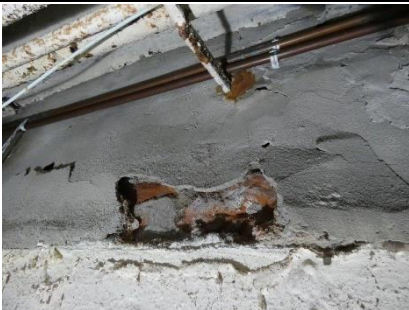
Defect ID	Photo Source	Defect Description	Defect Location	Crack Orientation	Crack Width (mm)	Crack Length (mm)	Comments	Photo	Severity Category
10.2	P1030333-338	Cracked render	Corridor 2 - walls	n/a	n/a	n/a	Cracking to render over stone walls

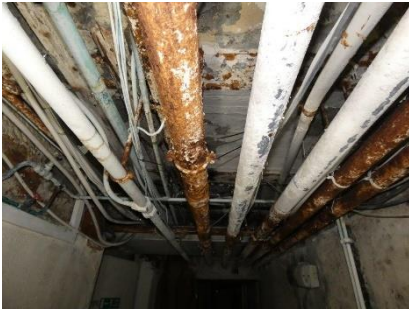
Green
10.3	P1030339-344	Metal corrosion	Corridor 2 - ceiling	n/a	n/a	n/a	Mild corrosion to steelwork and pipework in corridor

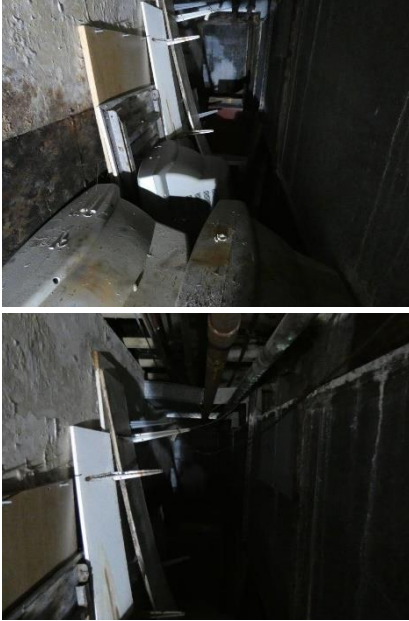
Defect ID	Photo Source	Defect Description	Defect Location	Crack Orientation	Crack Width (mm)	Crack Length (mm)	Comments	Photo	Severity Category
11	P1030261-264	n/a	Service Corridor	n/a	n/a	n/a	General images

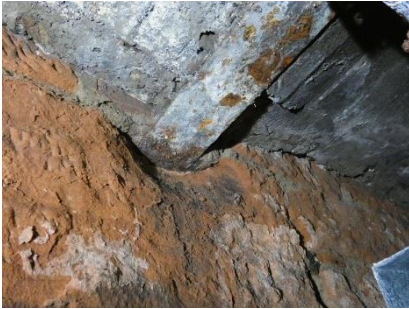
n/a
11.1	P1030265-266	Metal corrosion	Service Corridor - wall	n/a	n/a	n/a	Damp staining to stonework, mild corrosion to steelwork

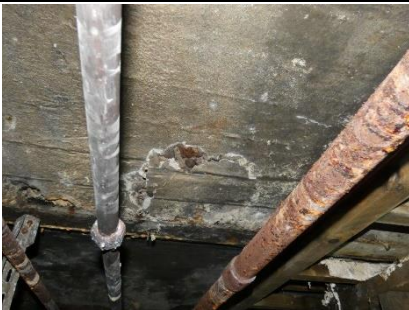
Defect ID	Photo Source	Defect Description	Defect Location	Crack Orientation	Crack Width (mm)	Crack Length (mm)	Comments	Photo	Severity Category
11.2	P1030267-268	Spalled concrete	Service Corridor - ceiling	n/a	n/a	n/a	Spalled/damaged concrete to ceiling

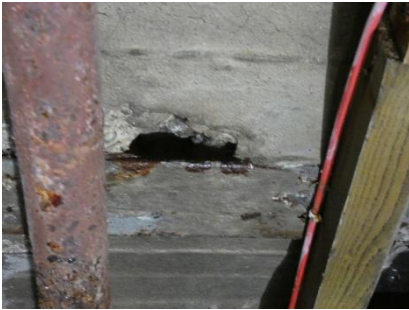
Green
11.3	P1030269-270	Missing/detached concrete	Service Corridor - roof/beam	n/a	n/a	n/a	Missing/detached concrete from interface between concrete arch and metal beam

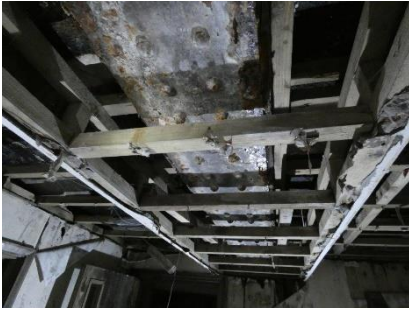
n/a
12.1	P1030281-286	Plaster failure	Gymnasium - ceiling	n/a	n/a	n/a	Missing plasterboard to suspended ceiling

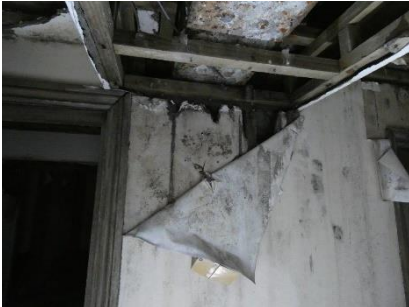
Defect ID	Photo Source	Defect Description	Defect Location	Crack Orientation	Crack Width (mm)	Crack Length (mm)	Comments	Photo	Severity Category
12.2	P1030287-293	Damp staining	Gymnasium - ceiling	n/a	n/a	n/a	Damp staining to walls, wallpaper peeling

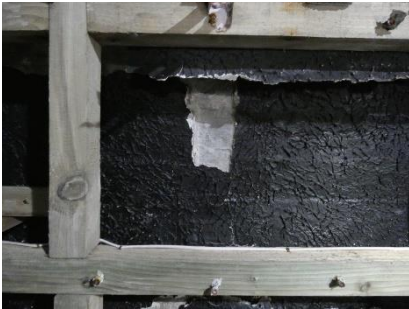
Green
12.3	P1030294-298	Cracked concrete	Gymnasium - ceiling	n/a	n/a	n/a	Concrete cracking around interface with metal beam

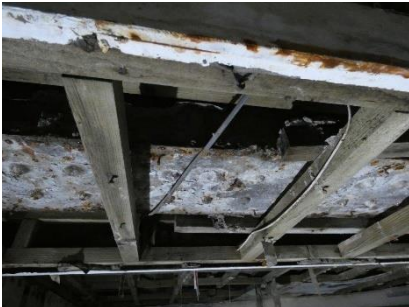
Green
12.4	P1030300	Metal corrosion	Gymnasium - ceiling	n/a	n/a	n/a	Mild corrosion to metal support beam. Minimal section loss

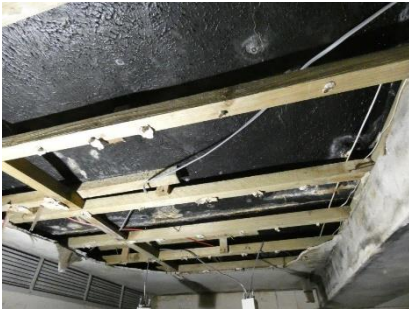
n/a
13.1	P1030369-373	Plaster failure	Reception - ceiling	n/a	n/a	n/a	Plasterboard ceiling collapse. Approx. 4m x 4m

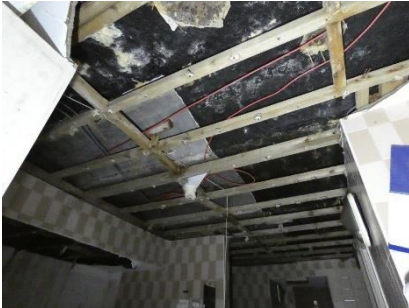
n/a
14.1	P1030443-450	Plaster failure	Changing room 1 - ceiling	n/a	n/a	n/a	Plasterboard ceiling collapsed. Approx. 3m x 6m

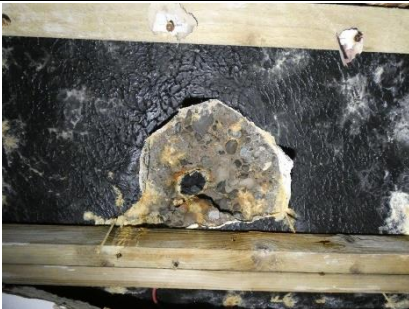
Defect ID	Photo Source	Defect Description	Defect Location	Crack Orientation	Crack Width (mm)	Crack Length (mm)	Comments	Photo	Severity Category
14.2	P1030451-452	Missing/detached concrete	Changing room 1 - ceiling	n/a	n/a	n/a	Missing/detached concrete from ceiling

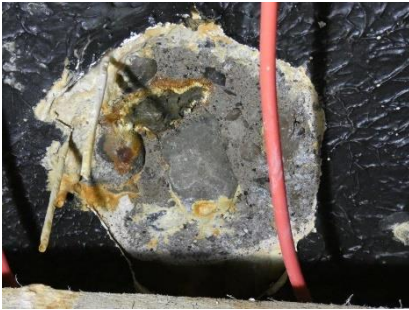
Green
14.3	P1030453-454	Missing/detached concrete	Changing room 1 - ceiling	n/a	n/a	n/a	Missing/detached concrete from ceiling

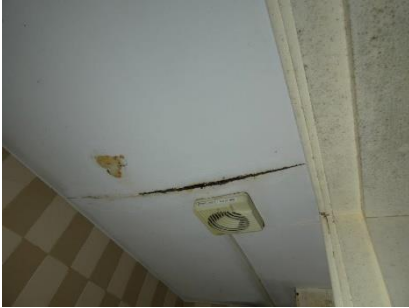
Green
14.4	P1030455-456	Crack	Changing room 1 - ceiling	Horizontal	2-5	1000	Crack to ceiling.

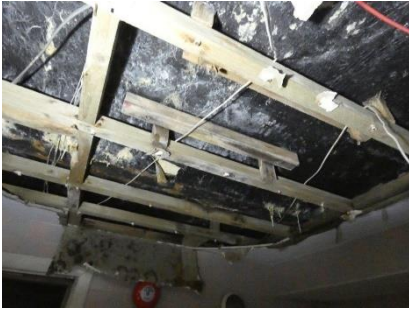
n/a
15.1	P1030479-482	Collapsed plasterboard ceiling	Changing room 2 - ceiling				Plasterboard ceiling collapsed. Approx. 3m x 3m

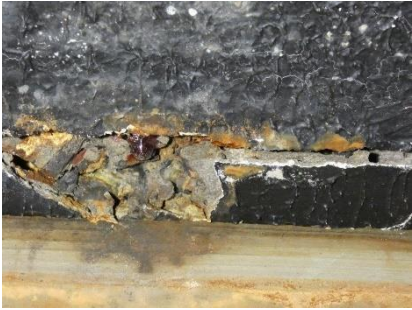
Defect ID	Photo Source	Defect Description	Defect Location	Crack Orientation	Crack Width (mm)	Crack Length (mm)	Comments	Photo	Severity Category
15.2	P1030483-486	Concrete failure	Changing room 2 - ceiling	n/a	n/a	n/a	Crumbling concrete at beam

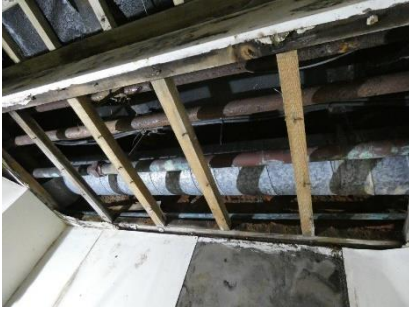
Defect ID	Photo Source	Defect Description	Defect Location	Crack Orientation	Crack Width (mm)	Crack Length (mm)	Comments	Photo	Severity Category
16.2	P1030400-403	Plaster failure	Solarium - ceiling	n/a	n/a	n/a	Plasterboard ceiling collapsed. Approx. 3m x 3m

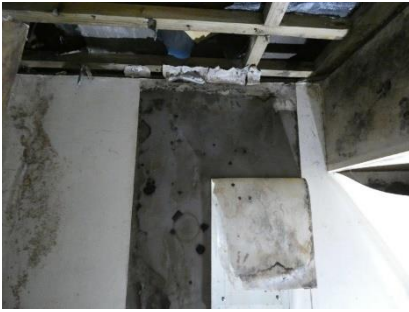
Amber
16.3	P1030404-410	Damp staining	Solarium - ceiling	n/a	n/a	n/a	Damp staining to walls. Wallpaper peeling. Evidence of water ingress

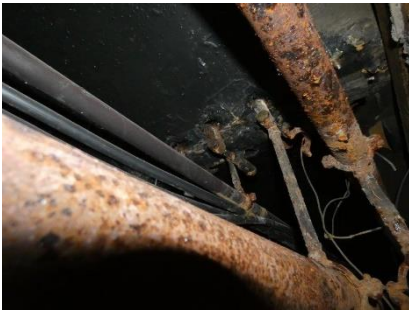
Green
16.4	P1030411-413	Metal corrosion	Solarium - ceiling	n/a	n/a	n/a	Corrosion to metal around pipes and brackets in ceiling

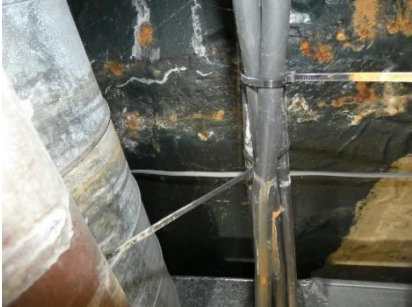
Defect ID	Photo Source	Defect Description	Defect Location	Crack Orientation	Crack Width (mm)	Crack Length (mm)	Comments	Photo	Severity Category
17.3	P1030426-428	Metal corrosion	Store 4 - ceiling	n/a	n/a	n/a	Mild corrosion to metal beam in ceiling. Beam obscured by ceiling finishes. Extent of corrosion not clear

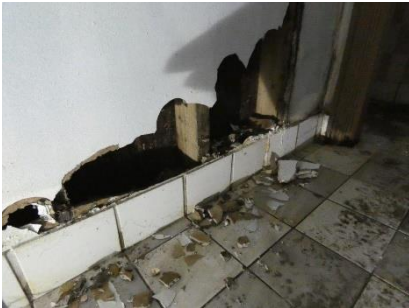
Defect ID	Photo Source	Defect Description	Defect Location	Crack Orientation	Crack Width (mm)	Crack Length (mm)	Comments	Photo	Severity Category
18.2	P1030507-510	Plaster failure	Corridor 4 - wall	n/a	n/a	n/a	Hole in plasterboard wall

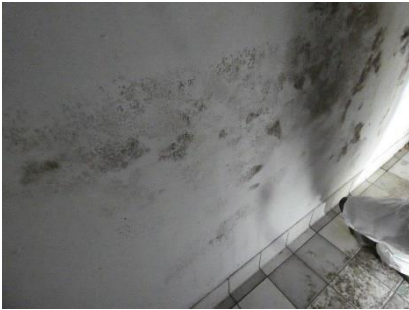
Green
18.3	P1030511-516	Damp staining	Corridor 4 - wall	n/a	n/a	n/a	Damp staining to walls

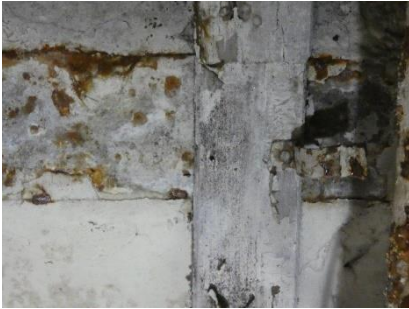
n/a
19.1	P1030544-553	Metal corrosion	Corridor 3 - ceiling	n/a	n/a	n/a	Mild corrosion to metal support beam. Minimal section loss

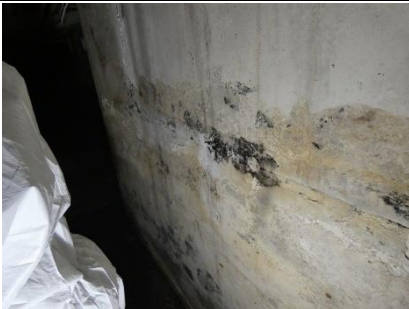
Defect ID	Photo Source	Defect Description	Defect Location	Crack Orientation	Crack Width (mm)	Crack Length (mm)	Comments	Photo	Severity Category
19.2	P1030554-560	Damp staining	Corridor 3 - wall	n/a	n/a	n/a	Damp staining to walls throughout corridor

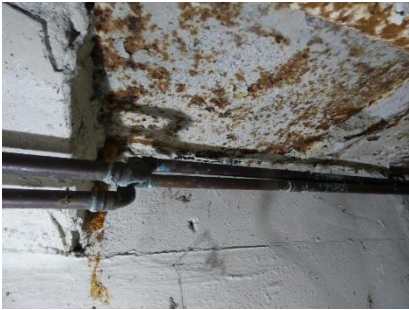
Green
19.3	P1030561-564	Metal corrosion	Corridor 3 - ceiling	n/a	n/a	n/a	Mild corrosion to metal support beam. Minimal section loss

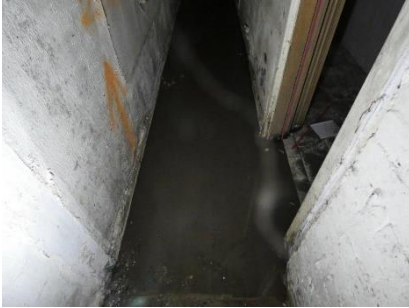
Green
19.4	P1030565-568	Standing water	Corridor 3 - floor	n/a	n/a	n/a	Standing water on floor.

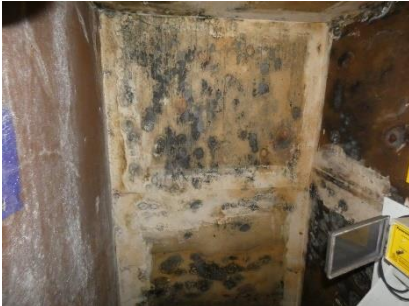
n/a
20.1	P1030577-580	Damp staining	Plant Room - wall	n/a	n/a	n/a	Damp staining to ceiling and walls

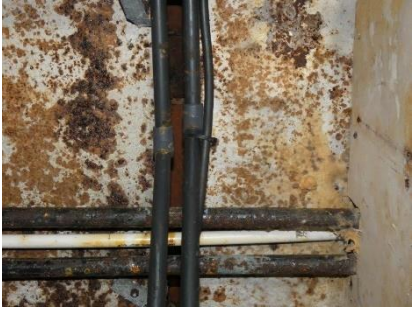
Defect ID	Photo Source	Defect Description	Defect Location	Crack Orientation	Crack Width (mm)	Crack Length (mm)	Comments	Photo	Severity Category
20.2	P1030587-591	Metal corrosion	Plant Room - ceiling	n/a	n/a	n/a	Mild corrosion to metal support beams. Minimal section loss

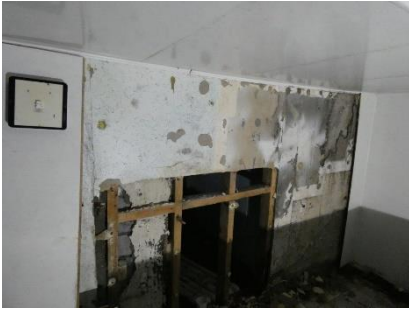
n/a
21.1	P1030605-608	Plaster failure	Jacuzzi - wall	n/a	n/a	n/a	Area of pvc missing and plaster missing behind

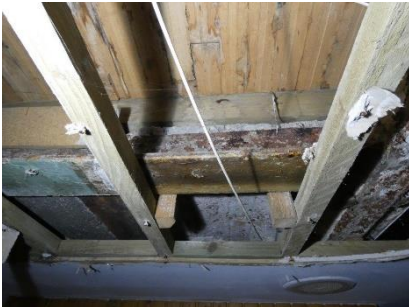
Defect ID	Photo Source	Defect Description	Defect Location	Crack Orientation	Crack Width (mm)	Crack Length (mm)	Comments	Photo	Severity Category
21.2	P1030609-610	Plaster failure	Jacuzzi - ceiling	n/a	n/a	n/a	Plasterboard ceiling collapsed. Approx. 2m x 2m	 	Amber
21.3	P1030611-615	Metal corrosion	Jacuzzi - ceiling	n/a	n/a	n/a	Mild corrosion to metal support beams. Minimal section loss

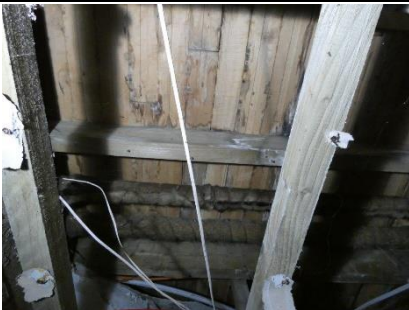
Defect ID	Photo Source	Defect Description	Defect Location	Crack Orientation	Crack Width (mm)	Crack Length (mm)	Comments	Photo	Severity Category
21.5	P1030619-625	Timber defect	Jacuzzi - ceiling	n/a	n/a	n/a	Evidence of warping to timber floor

Amber
21.6	P1030626-628	Metal corrosion	Jacuzzi - ceiling	n/a	n/a	n/a	Mild corrosion to metal support beams. Minimal section loss

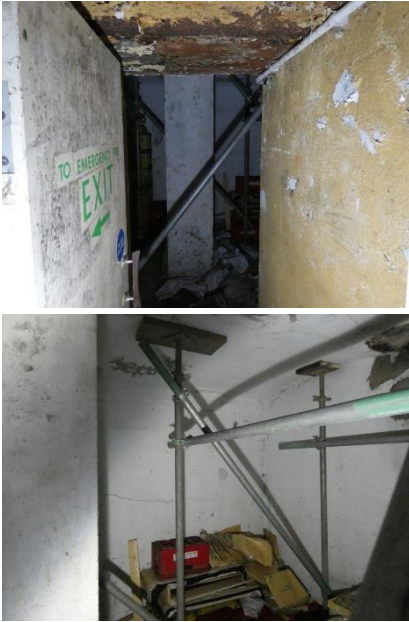
Defect ID	Photo Source	Defect Description	Defect Location	Crack Orientation	Crack Width (mm)	Crack Length (mm)	Comments	Photo	Severity Category
22	P1030636-643	n/a	Store 5	n/a	n/a	n/a	General images

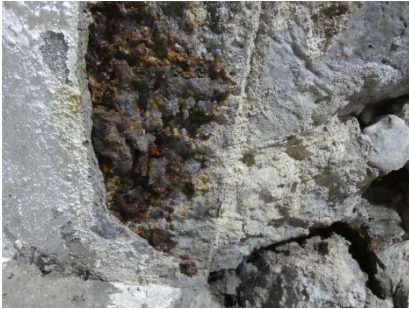
n/a
22.1	P1030644-648	Render failure	Store 5 - ceiling	n/a	n/a	n/a	Localised render collapse

Green

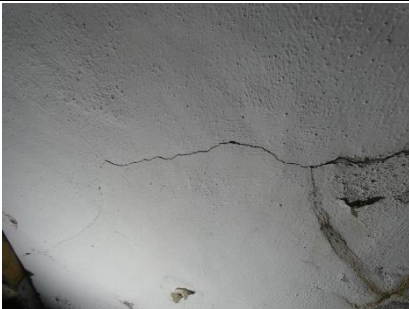
Defect ID	Photo Source	Defect Description	Defect Location	Crack Orientation	Crack Width (mm)	Crack Length (mm)	Comments	Photo	Severity Category
22.2	P1030649-653	Cracking to render	Store 5 - ceiling	n/a	n/a	n/a	Cracking to render on ceiling

Green
22.3	P1030654-655	Missing/detached concrete	Store 5 - ceiling	n/a	n/a	n/a	Missing/detached concrete from ceiling

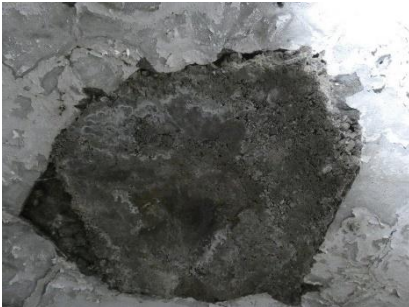
Green
22.4	P1030656-661	Cracking to render	Store 5 - wall	n/a	n/a	n/a	Cracking to render on wall

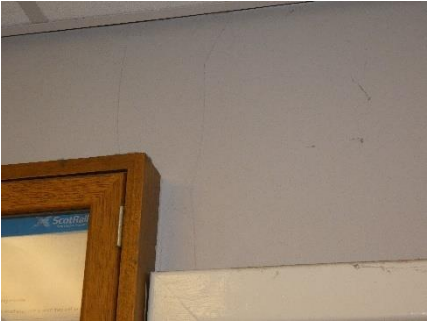
Defect ID	Photo Source	Defect Description	Defect Location	Crack Orientation	Crack Width (mm)	Crack Length (mm)	Comments	Photo	Severity Category
1	P1020757	Crack to plaster	Entrance - Wall	n/a	n/a	n/a	Vertical plaster crack

Green
2	P1020784	Damp patch	Corridor - Ceiling	n/a	n/a	n/a	Damp patch to ceiling tiles. Evidence of water ingress or leak within ceiling void

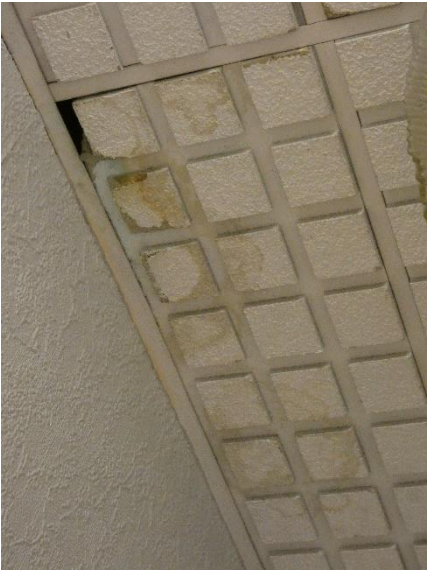
Defect ID	Photo Source	Defect Description	Defect Location	Crack Orientation	Crack Width (mm)	Crack Length (mm)	Comments	Photo	Severity Category
3	P1020789	Damp patch	WC2 - Ceiling	n/a	n/a	n/a	Damp patch to ceiling tiles. Evidence of water ingress or leak within ceiling void

Green
4	P1020836	Spalled plaster	Office1 - Wall	n/a	n/a	n/a	Spalled plaster on vertical wall. Possibly from minor takedown works
