Former Ayr Station Hotel Building Structural Condition

Independent Report

03 October 2019

Document reference: 399316/SNI/GLA/DOC/S2/REP/002

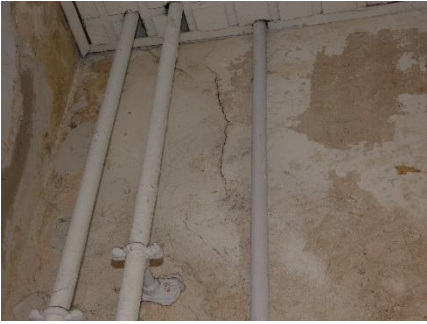
Defect ID	Photo Source	Defect Description	Defect Location	Crack Orientation	Crack Width (mm)	Crack Length (mm)	Comments	Photo	Severity Category
5	P1020837	Crack to plaster	Office1 - Wall	n/a	n/a	n/a	Cracking to plaster on wall

Green
6	P1020842	Damaged plaster	Mess - Ceiling	n/a	n/a	n/a	Original plaster to ceiling missing/damaged. Possibly removed as part of refurbishment works. Limited view due to presence of false ceiling

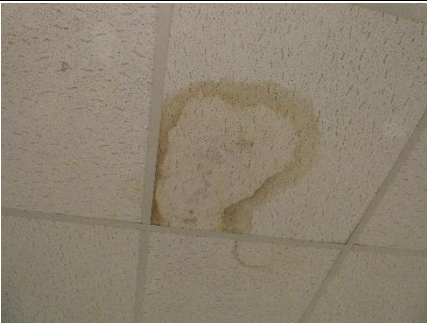
Defect ID	Photo Source	Defect Description	Defect Location	Crack Orientation	Crack Width (mm)	Crack Length (mm)	Comments	Photo	Severity Category
8	P1020858	Water ingress	ER2 - Ceiling	n/a	n/a	n/a	Damp patch to ceiling tiles. Evidence of water ingress or leak within ceiling void

Green
9	P1020862	Water ingress	Entrance2	n/a	n/a	n/a	Damp patch to ceiling tiles. Evidence of water ingress or leak within ceiling void

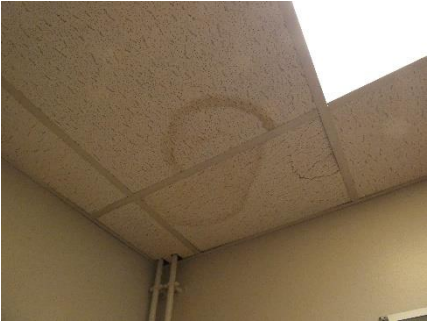
Green
10	P1020867	Water ingress	Mess2 - Ceiling	n/a	n/a	n/a	Damp patch to ceiling tiles. Evidence of water ingress or leak within ceiling void

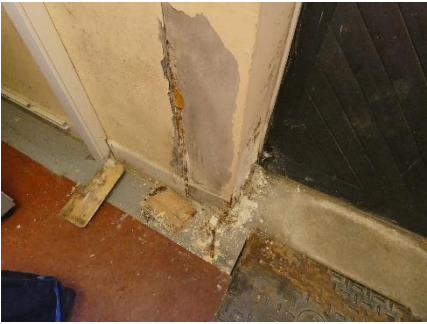
Defect ID	Photo Source	Defect Description	Defect Location	Crack Orientation	Crack Width (mm)	Crack Length (mm)	Comments	Photo	Severity Category
11	P1020885	Corrosion	Office3	n/a	n/a	n/a	Corrosion to steel angles and spalled plaster to pier behind door

Amber
12	P1020904	Water ingress	WC5	n/a	n/a	n/a	Damp patch to ceiling tiles. Evidence of water ingress or leak within ceiling void
